Upper Court Barn, Higher Collaton, Halwell, Devon

Results of historic building recording and an
archaeological watching brief

Document No: ACD91/2/0

Date: August 2009

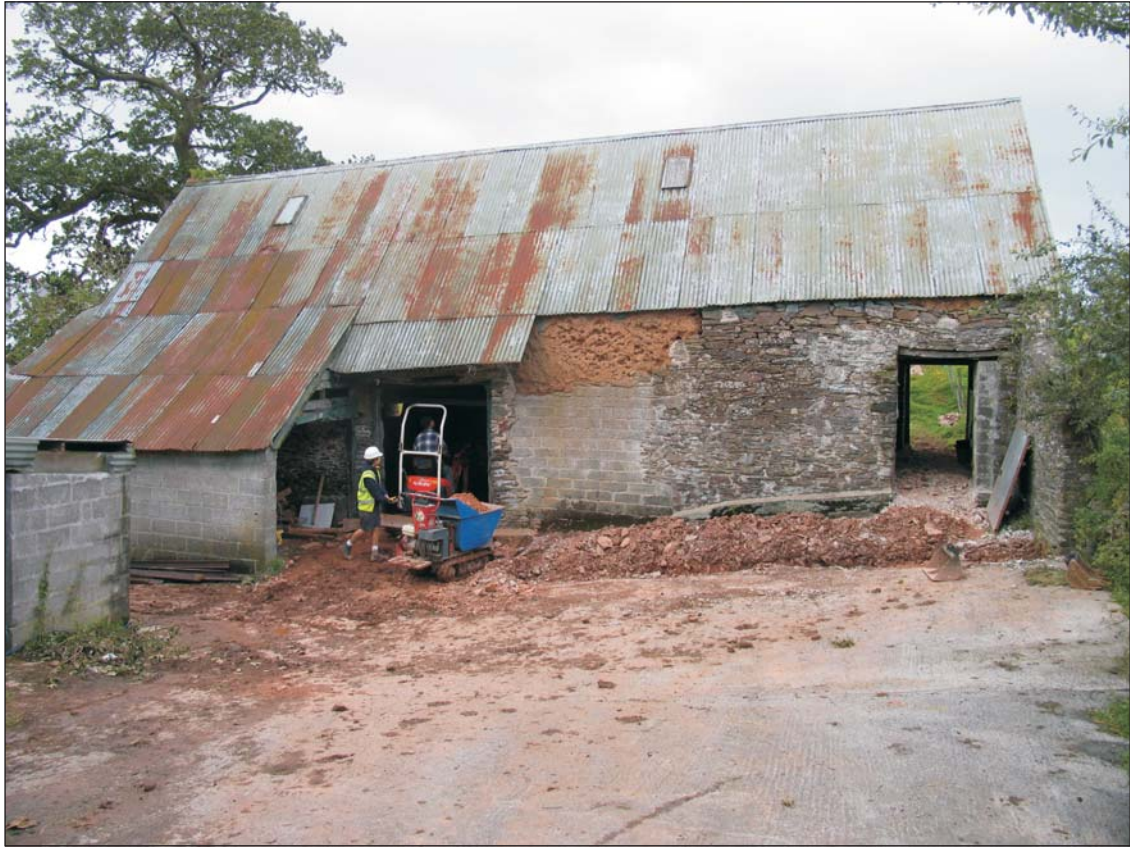
The barn is a low, two-storey structure aligned north-south (Plate 1). It is built mainly of coursed stone rubble with large areas of cob at first floor level. The roof is a modern replacement of corrugated metal sheets. It has a lean-to at the southern end of its eastern elevation and a sloping length of wall at the northern end, indicating the former presence of a second lean-to. Internally, the main building has two compartments divided by a split floor level/revetment (Fig. 2). The walls have remains of limewash and prior to conversion works there were surviving feeding troughs and hayracks.

Plate 1: Eastern elevation of the building during early phases of groundworks.
View to west

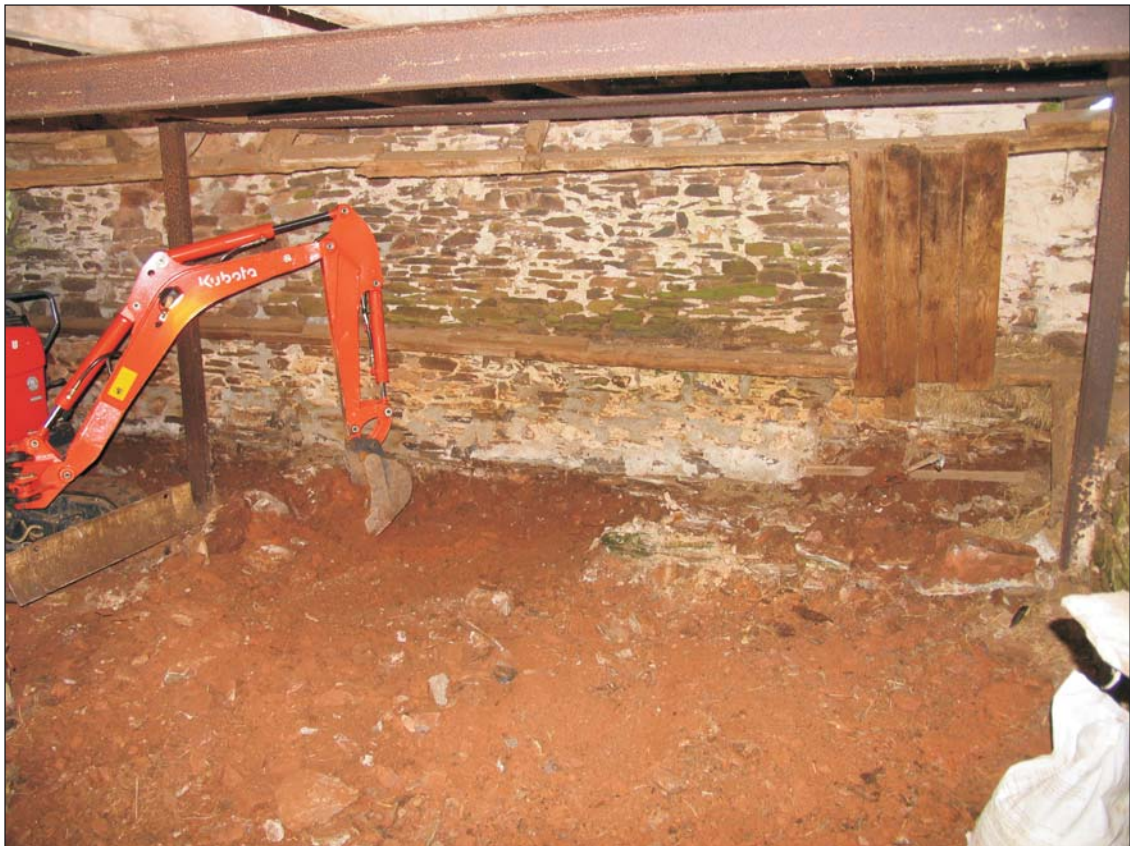
The removal of the cobbled floor (Plate 2) and stone feed trough showed these features to be directly above natural subsoil, which was composed of red clay with angular slate stone inclusions. There were no buried remains present for any other internal fixtures or fittings, such as cattle stalls.

Plate 2: Interior of Lower Compartment following removal of cobbled floor.
View to west

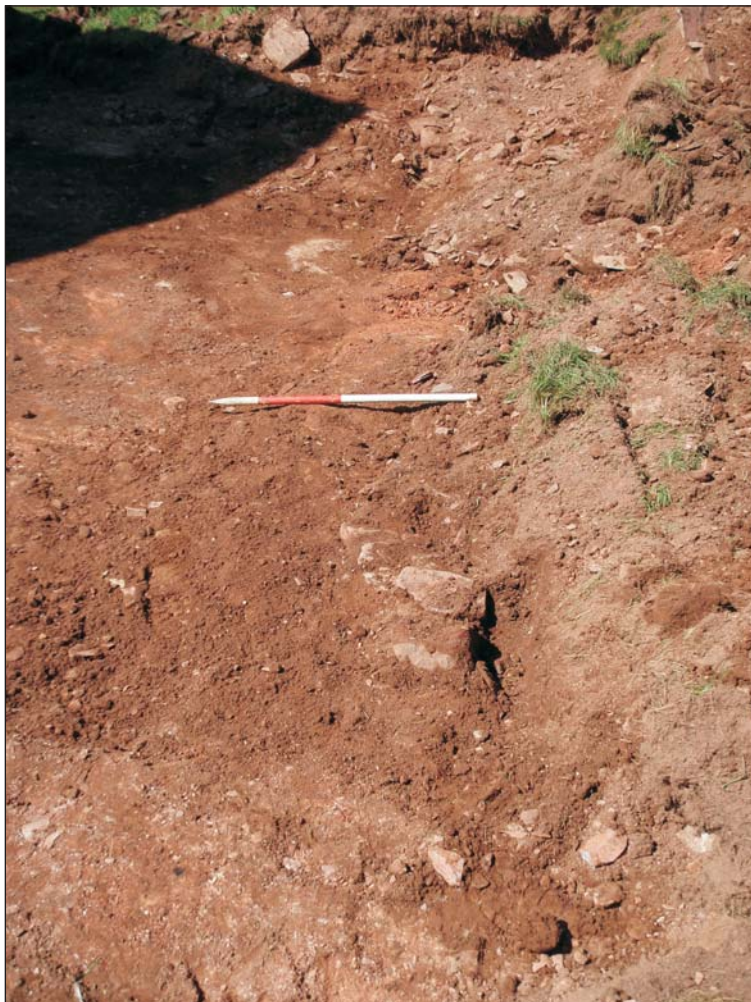
Groundworks immediately to the north of the barn revealed stone footings and an associated foundation trench, representing a former continuation of the building in this direction (Fig. 2 and Plate 4). Sufficient remains were uncovered to establish a full plan, with the footings and foundation trench extending internally for a further 5.7m northwards. A flat slate slab in the eastern wall may denote a threshold and a stone cobbled floor was partly exposed within the interior. The ground immediately adjacent to the present end wall of the barn was not subjected to any groundworks and therefore the relationship between the exposed and existing walls was not established.

Plate 4:
Remnants of wall footings, north
side of standing barn.
View to west (scale 1m)

- 6.1** The recording of the building has not identified any significant new information relating to its phasing, but it has confirmed that it was originally a much larger structure which extended further to the north, as depicted on the Halwell parish tithe map of 1839 (Waterhouse 2004, Map 1). The positions of the exposed wall foundations line up with the main walls to the existing barn, perhaps confirming the original (?17th century) function of the building as a longhouse with shippen, with the former living area at the northern, now demolished upper end as suggested by Waterhouse (2004, 4). The historic map evidence confirms that this part of the building was removed before 1886.
