Results of archaeological recording of groundworks on land north of Mill Lane, Creech St Michael, Somerset

Document No: ACD64/2/0

Date: September 2009

RESULTS OF ARCHAEOLOGICAL RECORDING OF GROUNDWORKS ON LAND NORTH OF MILL LANE, CREECH ST. MICHAEL, SOMERSET (CENTRED ON ST2712325379)

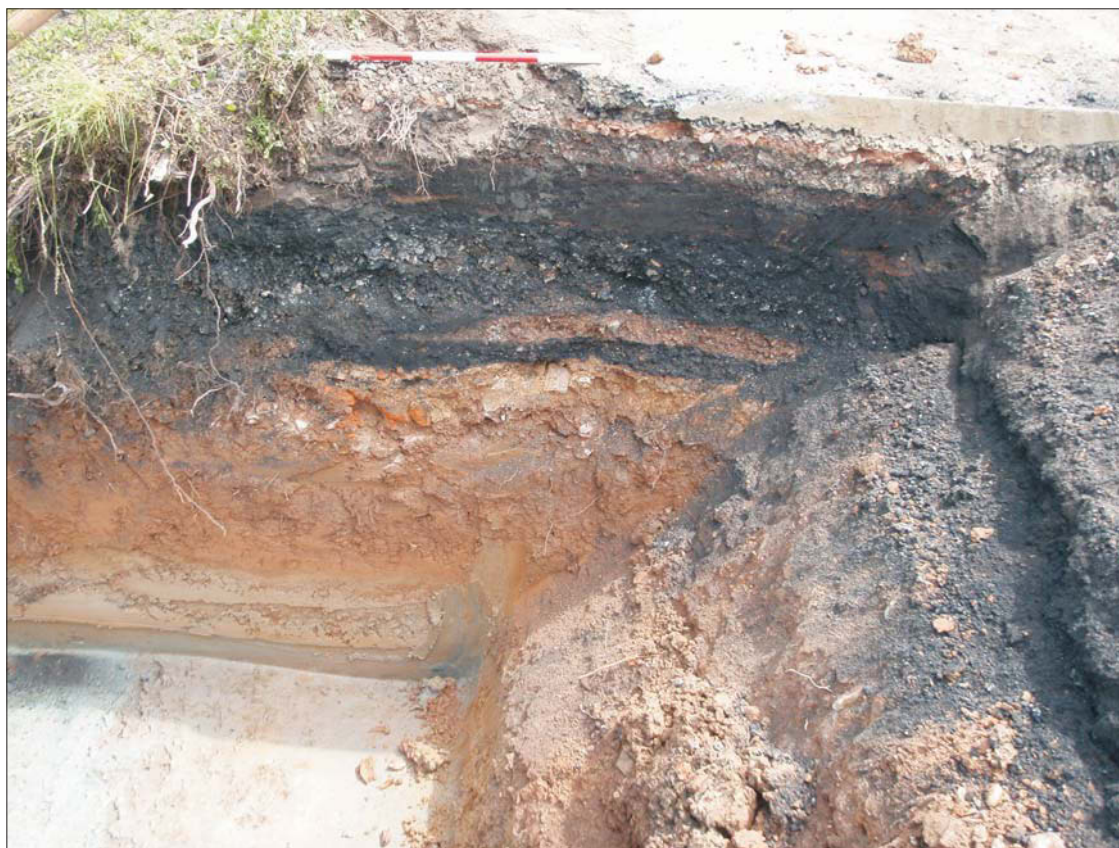
Plate 2: Section showing the recorded layer sequence, looking to the east (scale 1m)

- 5.1** The area of excavation for the box culvert and gabions measured approximately 4m x 3.6m and was dug to a depth of approximately 2.4 m below ground level into a homogenous alluvial clay deposit (context 105). The recorded layer sequence is summarised in Table 1 below and shown on Fig. 3 and Plate 2.

Context	Depth below ground level (m)	Description	Interpretation
100	0-0.3	Existing tarmac surface with gravel bedding	Existing road surface of Mill lane
101	0-0.3	Dark brown friable silt with occasional small-medium sub-angular stones <0.05m	Bank material
102	0-1	A mix of dark grey and black compact sand, gravels and clay with abundant clinker and small-medium stones <0.05m, moderate stones >0.05m and occasional brick fragments	Levelling deposit
103	1-1.7	Light brown firm silty clay	Redeposited layer
104	1.70-2.2	Light greyish-brown firm silty clay with rare small-medium stones <0.05m	Alluvial clay
105	2.2+	Light blue/grey firm silty clay	Alluvial clay

- 6.1** The watching brief has established the presence in the lower layer sequence of alluvial clay deposits (104) and (105). These were probably deposited as a result of undated successive episodes of flooding from the River Tone. The accumulation of overlying subsoil layer (103) represents a period of greater stabilisation within the river floodplain area when it was less prone to such flooding. The original millstream, which would have played an important role in providing water to the nearby mill during the post-medieval period, was most likely cut into this layer.

- 6.2** During the late 19th or early 20th-century an up to 1m thick rubble and cinder layer (102) was deposited within the area, either as a levelling deposit for the construction of the existing Mill Lane or as a dump of residual waste material from the construction of the railway line and embankment located immediately to the north. This layer was partly overlain by a brown silt (101), which was probably deposited as part of the reinstatement of the southern millstream bank.

- 6.3** No *in situ* archaeological deposits or features were exposed during groundworks and no palaeoenvironmental deposits were recorded. No pre-modern finds were recovered either from the spoil or from the exposed deposits.
