Land at Great Shelfin Farm, North Devon

## Results of an archaeological trench evaluation

# LAND AT GREAT SHELFIN FARM, NORTH DEVON

### RESULTS OF AN ARCHAEOLOGICAL TRENCH EVALUATION

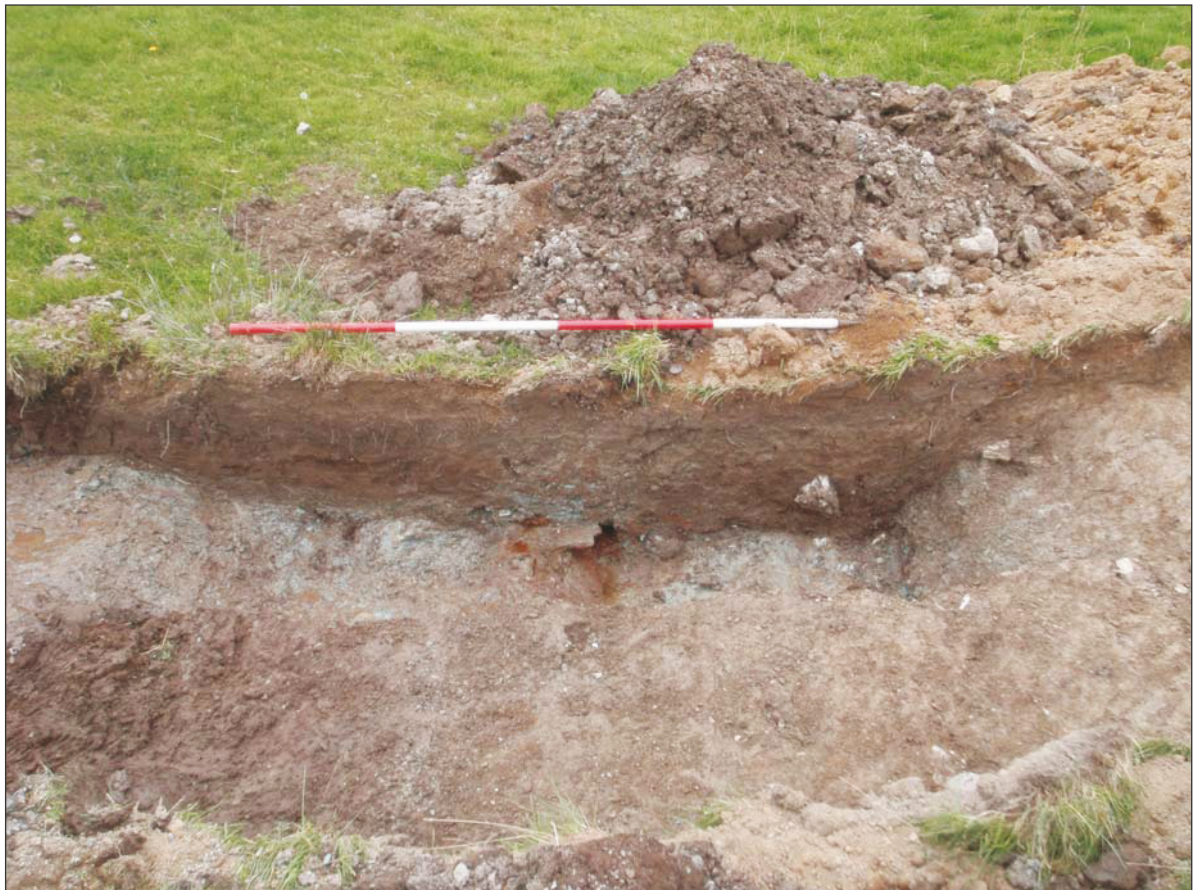
Plate 2: Ditches F607 and F609, Trench 6, east-facing section.  
View to the west (scale 2m)

Probable ditch F607 was northeast to southwest aligned and was a maximum of 0.9m wide and 0.17m deep. Two segments were excavated across the feature (603 and 605), which established that the ditch had gradual sloping sides and a concave base. A consistent and homogenous mid brown clay silt fill was present (604 and 606). Two small abraded sherds of medieval pottery and one piece of ironworking slag were recovered from fill 604.

Intercutting linear ditches/channels F608 and F612 were visible on the surface as a single, probably naturally-formed channel extending east-west across the field, which is likely to have been utilised to help drain the field. F608 was cut to the south by F612 and was 1.8m wide and 0.5m deep, with stepped moderate to steep sloping sides and a flattish base. It contained three fills, comprising a thin basal fill (609) of organic-rich material, beneath two dark brown to dark greyish-brown clay silt accumulation deposits (609 and 610). No finds were recovered.

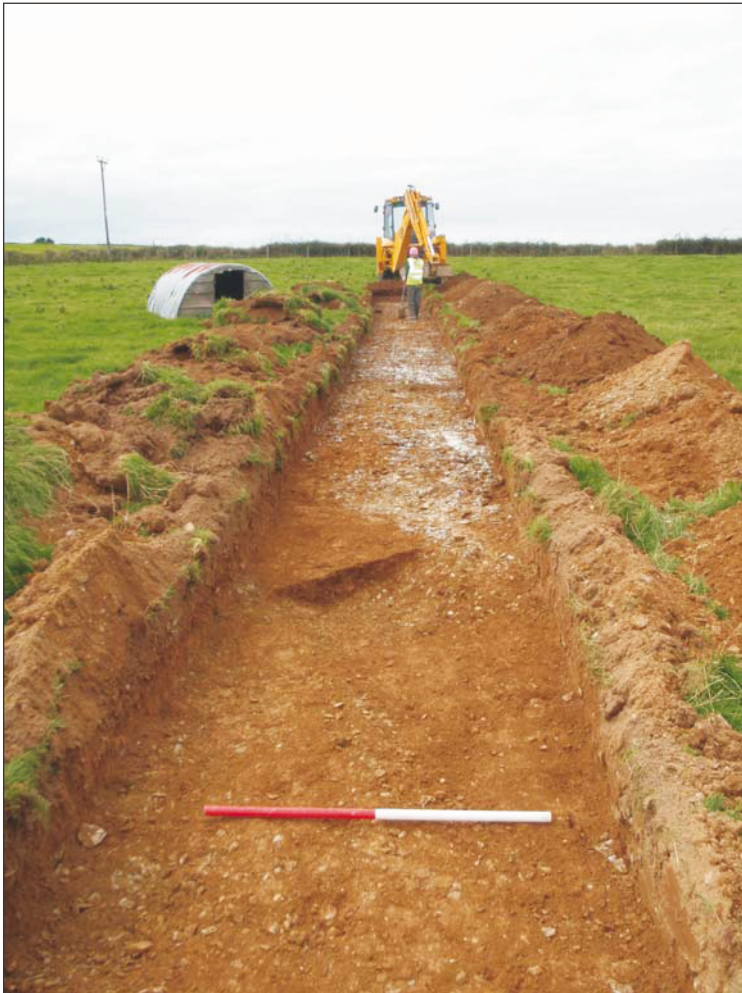
Plate 3:  
General view of Trench 6 with  
ditch F607 in the foreground.  
Looking to the west (scale 1m)

This trench was excavated through topsoil (context 600) and an interface layer (601) to a general depth of 0.35m onto weathered slate and reddish-brown silty clay natural subsoil (602). A linear feature (F607) was located towards the centre of the trench and two intercutting ditches/channels (F608 and F612) at the southern end.

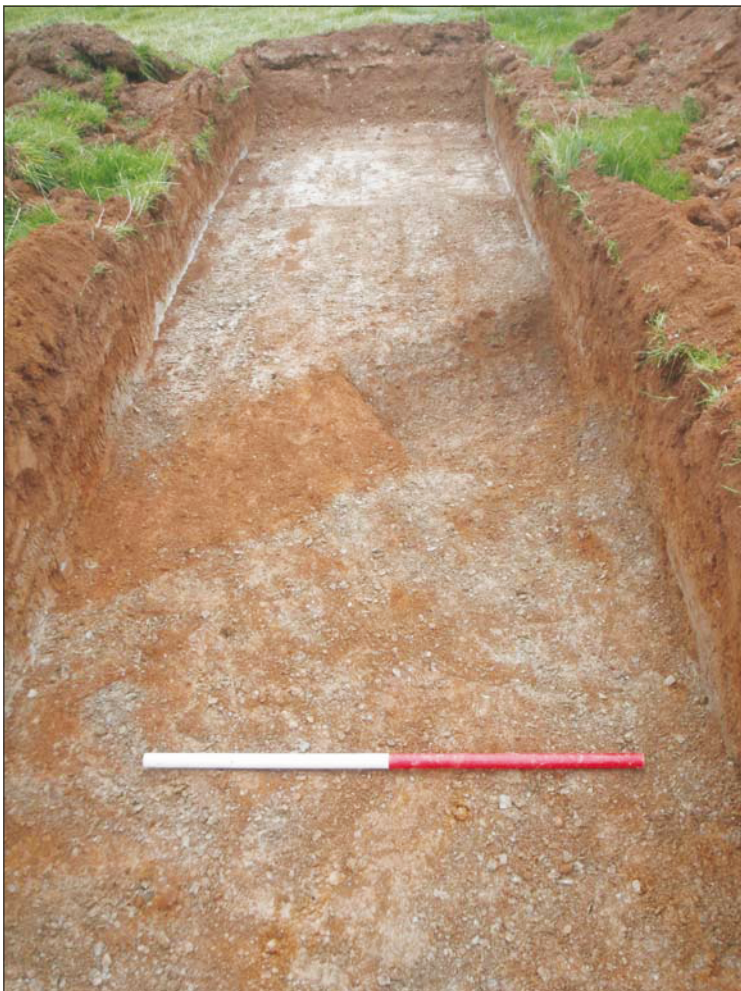
Plate 4:  
Ditch F903, Trench 9.  
View to the southeast (scale 1m)

The trench contained a single northeast to southwest aligned linear feature (F903) located towards the centre of the trench. This probable ditch was 0.64m wide and 0.41m deep, with moderately sloping sides and a concave base. A single homogenous mid reddish-brown clay silt fill was present and no finds were recovered.
