Land at Manor Farm, Down Thomas, Wembury, Devon

Results of an archaeological trench evaluation

Document No: ACD95/2/0

Date: October 2009

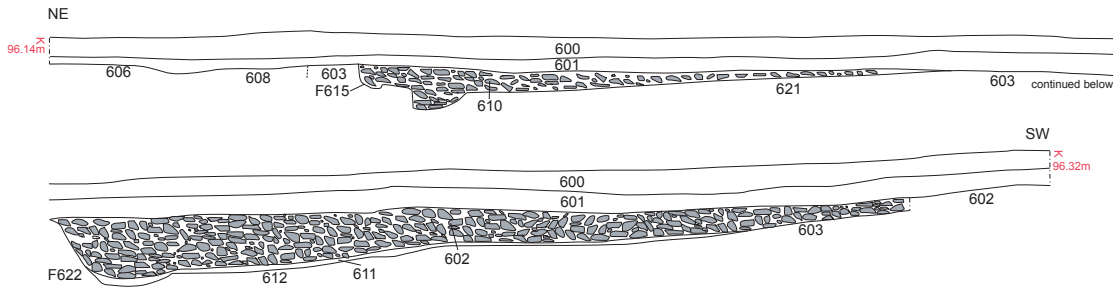
Fig. 8:
Plan and sections, Trench 6

a) Plan

b) Section

d) Section F607 and F609

c) Section F604

5.4 Trench 6 (Detailed plan Fig. 8a and sections Fig. 8b-d; Plate 3)

This trench was 19m long and excavated onto natural subsoil (603) and archaeological deposits, present at a depth ranging from 0.33m in the northeast to 0.49m in the southwest. These were beneath subsoil (601) and then topsoil (600). The trench contained a number of features and structures, which comprised two partly intercutting and parallel ditches (F607 and F609), structure footings (614, 616, 618 and 620), with associated surface (F621) and a terrace cut (F622/F623) that contained a posthole (F604) and a surface (612).

East to west aligned parallel and intercutting ditches F607 and F609 were located at the far northeast end of the trench. These were each around 0.6m wide and a maximum of 0.1m deep, with both having shallow, gradually sloping sides and concave bases. Ditch F607 was filled with a mid brown silt fill (606) containing abundant slate rubble inclusions, while F609 was filled with a mid brown silt fill (608), which contained common small slate fragments. No finds were recovered from either ditch.

East to west aligned masonry footings 614 were 0.22m wide and composed of roughly-faced slate stone bonded in a lime mortar. The footings were largely truncated from above and survived to a height of 0.17m. They were within a construction cut (F613) that had been terraced into the natural slate geology. Adjacent footings 616 extended to the east and were composed of roughly-faced slate along the northern face and a water-worn cobble core bonded with a lime mortar. The footings were within a construction cut (F615) that was also terraced into the natural slate geology. Footings 618 extended south from 614 and were heavily truncated with limited stone masonry surviving within a 0.27m wide construction cut (F617). North to south aligned footings 620 were 0.6m wide and composed of slate rubble in a lime mortar bond, with a stepped kerb along the western side. The footings were within a construction cut (F619), which had been terraced into the slate geology. The footings were 0.2m thick and were heavily truncated from above and to the south.

Within the flat terraced area created by construction cuts F613, F615 and F619 was the remnants of a stone surface (621). This was composed of thin slate stone slabs measuring up to 0.35m long and it was directly overlying natural bedrock. The surface was overlain by a demolition deposit (610), composed of abundant slate rubble and lime mortar pieces and this had filled the terrace created by the footing construction cuts.

To the southwest of footings 620 was terrace cut F622/F623. This was c. 8m across and was cut to a maximum depth of 0.6m into natural bedrock. The base of the cut sloped moderately to the east and within it there was a stone surface (612). The surface was a

Cut into western edge of the terrace (F623) was an oval posthole (F604). This was 0.38m wide and 0.6m deep with vertical sides and a flat base. The posthole contained a mid brown sandy silt fill (605), containing abundant slate fragment inclusions. One iron nail was recovered.

The fill of posthole F604 and surface 612 were overlain by a thick demolition deposit (602) of slate rubble and mortar that filled the terrace created by cuts F622/F623. A range of finds was recovered from the demolition deposit, including five sherds of post-medieval pottery, animal bone fragments, shell, glass fragments, a stone roof tile fragment and two iron objects.

- 7.2 Structural remains relating to this complex were present in Trenches 6 and 8, partly beneath demolition or levelling layers. The wall footings exposed towards the northeast end of Trench 6 were heavily truncated, surviving to less than 0.2m in height, but are approximately in the position of the most northerly building shown on early maps. Wall footings 616 and 614 may represent the remnants of the external northern wall to this building. These two footings are on the same alignment but are of different construction styles, perhaps representing some degree of phasing or rebuild/repair of the structures. Wall footings 618 and 620 could represent internal partitioning within the building, while 621 probably represents remnants of internal flooring.

- 7.3 The edges to the terrace cut in Trench 6 (F622/F623) were located in an area which is shown on the 1862 map as part of the central courtyard. Within the cut there was a well-constructed stone surface (612), which was probably part of this courtyard.

- 7.5 The shallow double ditch (F607 and F609) recorded at the far northeast end of Trench 6 is likely to represent the northern boundary to the building range, while the extant stone field boundary adjacent to Trench 8 is probably the former southern limit, although the most eastern building does project slightly to the south of this on the 1862 map (Fig. 4).

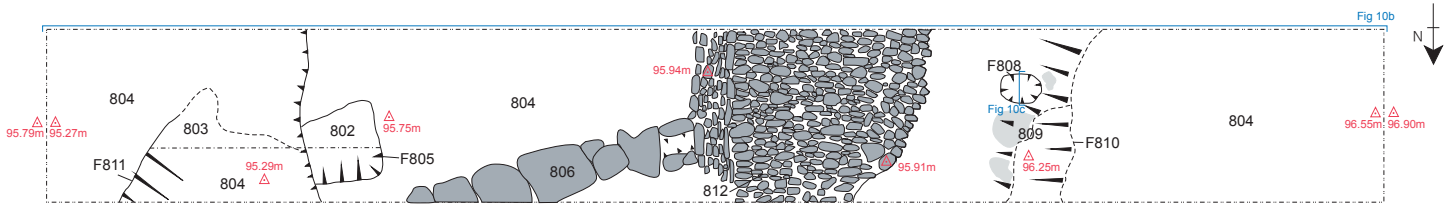
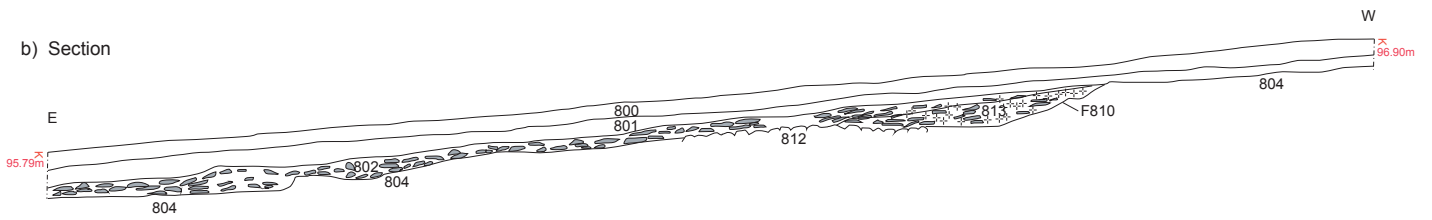
Fig. 10: Plan and sections, Trench 8

a) Plan

b) Section

c) Section F808

5.6 Trench 8 (Detailed plan Fig. 10a and section Fig. 10b-c; Plate 4)

This trench was 12m long and excavated onto the top of natural subsoil (804) and archaeological deposits, present at a maximum depth of 0.54m below subsoil (801) and then topsoil (800). The trench contained a terrace cut (F810/F811), a stone drain (F806), a cobbled surface (812), a posthole (F808) and a possible pit (F805).

The edges for terrace cut F810/F811 were located towards opposing ends of the trench and were aligned approximately east to west. Each edge was cut into the gently sloping ground by approximately 0.15m. At the base of the western edge there were patches of truncated *in situ* lime mortar (809) which were adhered to the natural subsoil. On the east side of the base was a thin spread of silty sand (803) containing abundant pieces of mortar.

Within the terrace was a cobbled surface (812), which was 2.3m wide and composed of water-worn pebbles pressed into a dark brown silty clay. The surface had a curved perimeter on the east side and a north to south aligned stone gutter to the west. The gutter was 0.4m wide and fed into a stone drain (F806) which extended to the east.

Stone drain F806 was a maximum of 0.5m wide and approximately 0.25m deep. The drain construction comprised a roughly-faced slate vertical coursed lining with flat capstones.

Posthole F808 was 0.39m long, 0.22m wide and 0.15m deep, with vertical sides and a flat base. It was filled with a mid reddish-brown clayey sandy silt (807), containing common slate fragment inclusions. No finds were recovered.

Possible pit F805 was located to the west of terrace cut 811 and was 0.7m wide and 0.02m deep. It had been filled with the overlying demolition material (802), described below. Above the archaeological features were two layers of demolition material, a mortar rich deposit (813) and a general rubble deposit (802).

- 7.4 In Trench 8 the two edges to the terrace (F810/F811) possibly represent the position of former walls to the former western building as indicated by patches of mortar and a mortar spread, although no *in situ* masonry was present. These structural remains suggest that the construction of at least this building initially comprised the excavation of a terrace into the naturally sloping ground, within which the walls were probably then built. A stone surface and gutter (812) was within the terrace, with these features are normally associated with agricultural buildings, perhaps a barn or shippon. The associated stone-lined drain (806) extended from the gutter towards the former courtyard area.

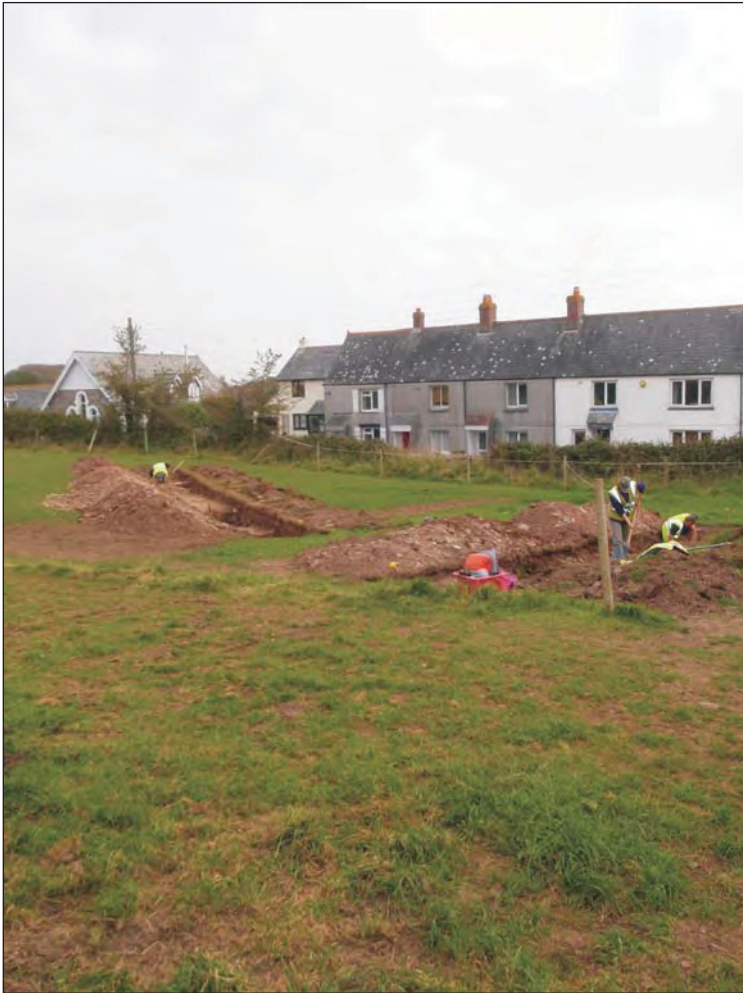
Plate 1:
General view of site showing
Trenches 6 and 8.
Looking northeast

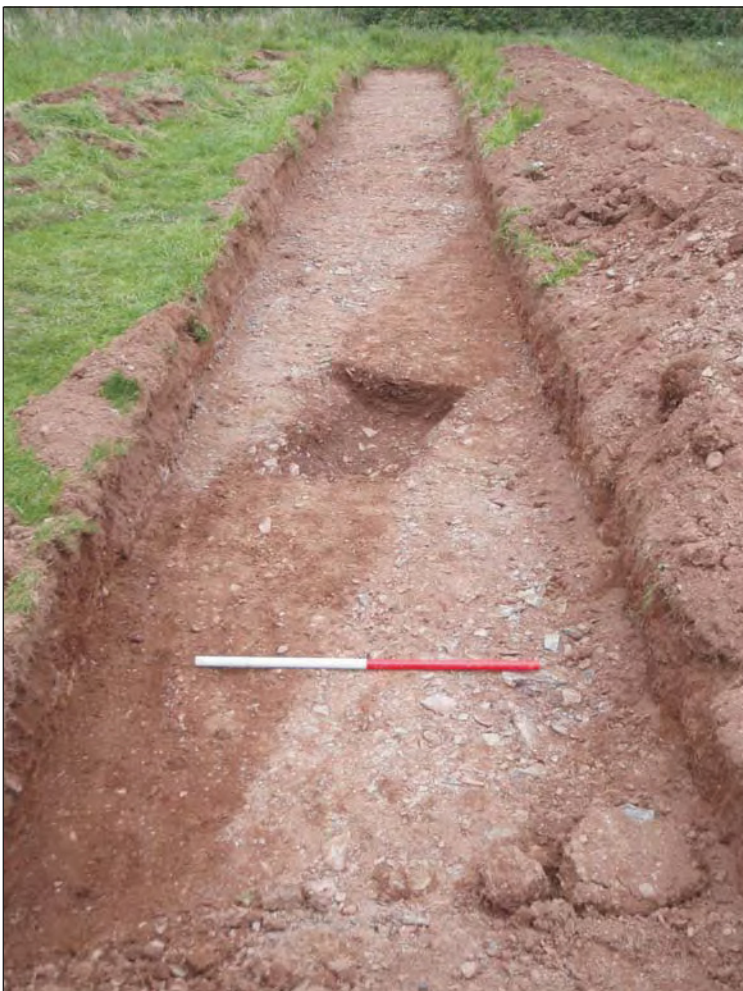
Plate 2:
Ditch F503, Trench 5.
View to the northeast (scale 1m)

The trench contained an approximately east to west aligned linear feature (F503). This probable ditch was 0.71m wide and 0.25m deep, with moderately steep-sloping sides and a concave base. It contained a mid brown clay sandy silt fill (502) and one fragment of stone roof tile was recovered.

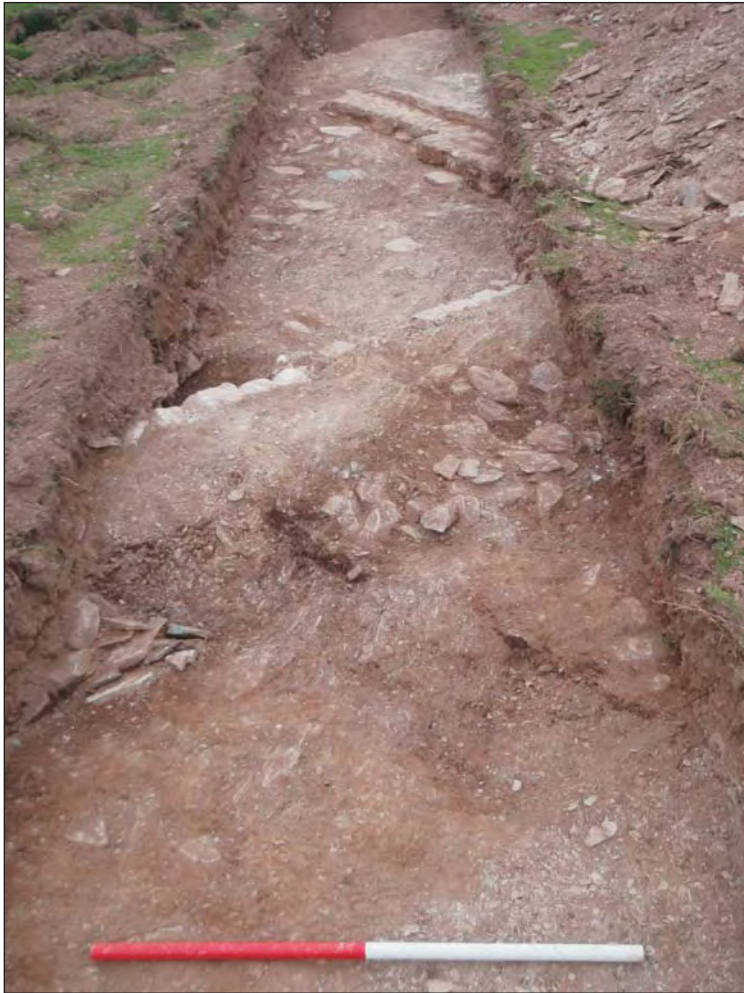
Plate 3:
General view of Trench 6,
northeast end.
Looking southwest (scale 1m)

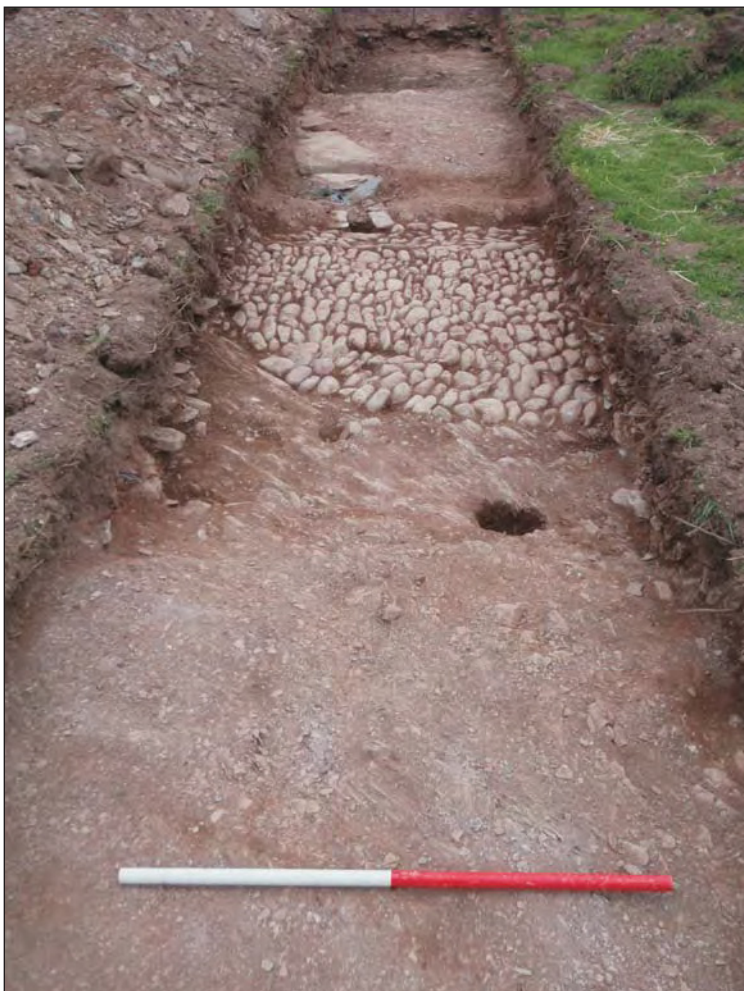
Plate 4:
General view of Trench 8. Looking
east (scale 1m)
