Plymouth City Airport Enhancement, Infrastructure Works

Results of an archaeological trench evaluation

Document No: ACD105/2/1

Date: November 2009

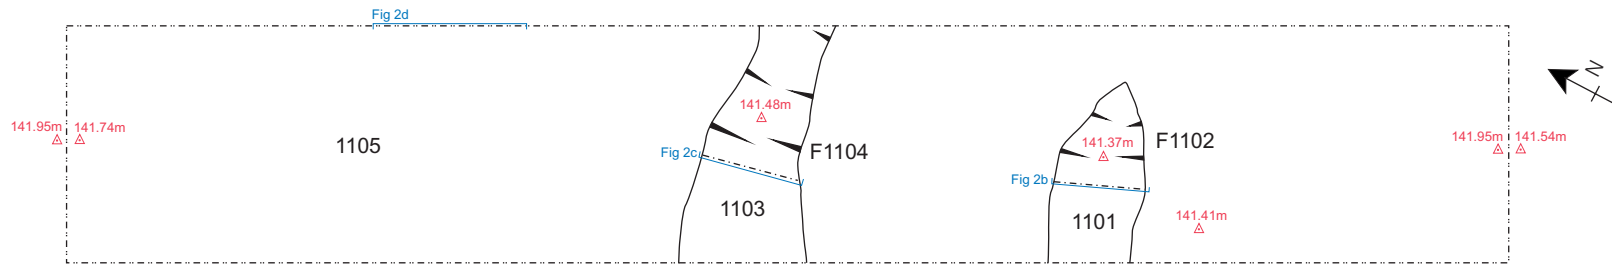
a) Plan

This trench was excavated through a mid brown clay silt topsoil (context 1100) to a general depth of 0.25m onto weathered slate and reddish-brown silty clay natural subsoil (1105). Two approximately northeast to southwest aligned parallel linear features (F1102 and F1104) were located towards the centre of the trench.

Probable ditches F1102 and F1104 were a maximum of 0.65m wide and 0.03m deep, with each having shallow, gradually sloping irregular sides and concave bases. Ditch F1102 petered out towards the northeast. Both contained similar mid brown clayey silt fills (1101 and 1103). A fragment of modern window glass was recovered from fill 1103.

5.2 Trench 11 (Detailed plan Fig. 2a and sections 2b to 2d; Plate 2)

- 6.1 The linear features exposed in Trenches 11 and 12 are probably agricultural ditches and boundaries. Parallel linear features F1102 and F1104 in Trench 11 are likely to represent ditches either side of a former hedge boundary, dated by the fragment of window glass to the 19th or 20th century. Ditch F1202 is likely to be a similarly dated small drainage ditch or boundary. These features probably relate to agricultural land-use pre-dating the construction of the airport in 1923.

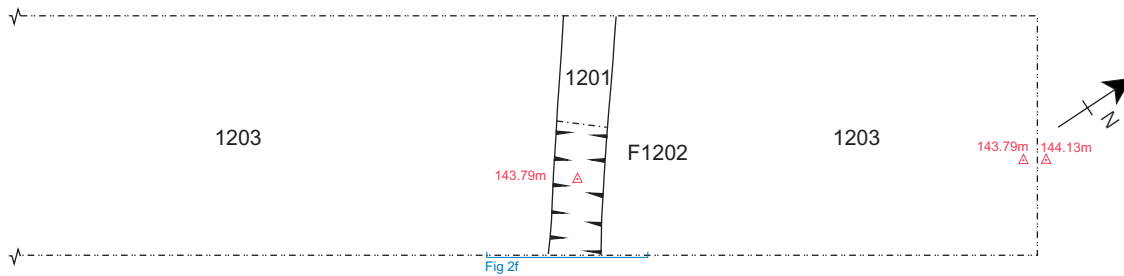
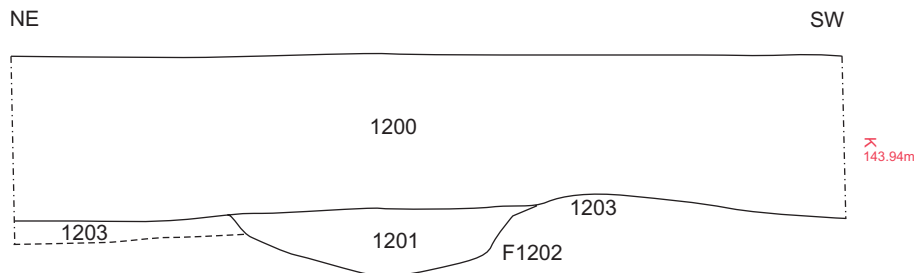
e) Plan

This trench was excavated to a depth of 0.23m onto weathered slate and mid brownish-red sandy clay natural subsoil (1203). This was below a layer of mid brown clay silt topsoil (1200). A linear feature (F1202) was located towards the northeast end of the trench, which was 0.4m wide and 0.09m deep, with moderately sloping sides and a concave base. A single mid brown clayey silt fill (1201) was present and no finds were recovered.

5.3 Trench 12 (Detailed plan Fig. 2e and section 2f; Plates 3 and 4)
