Results of a trench evaluation at 3 Broadway, adjacent to Hemyock Motors, Culmstock Road, Hemyock, Devon

Interim Archaeological Statement

Planning reference: Mid Devon DC 09/01576/FULL

Document No: ACD133/2/1

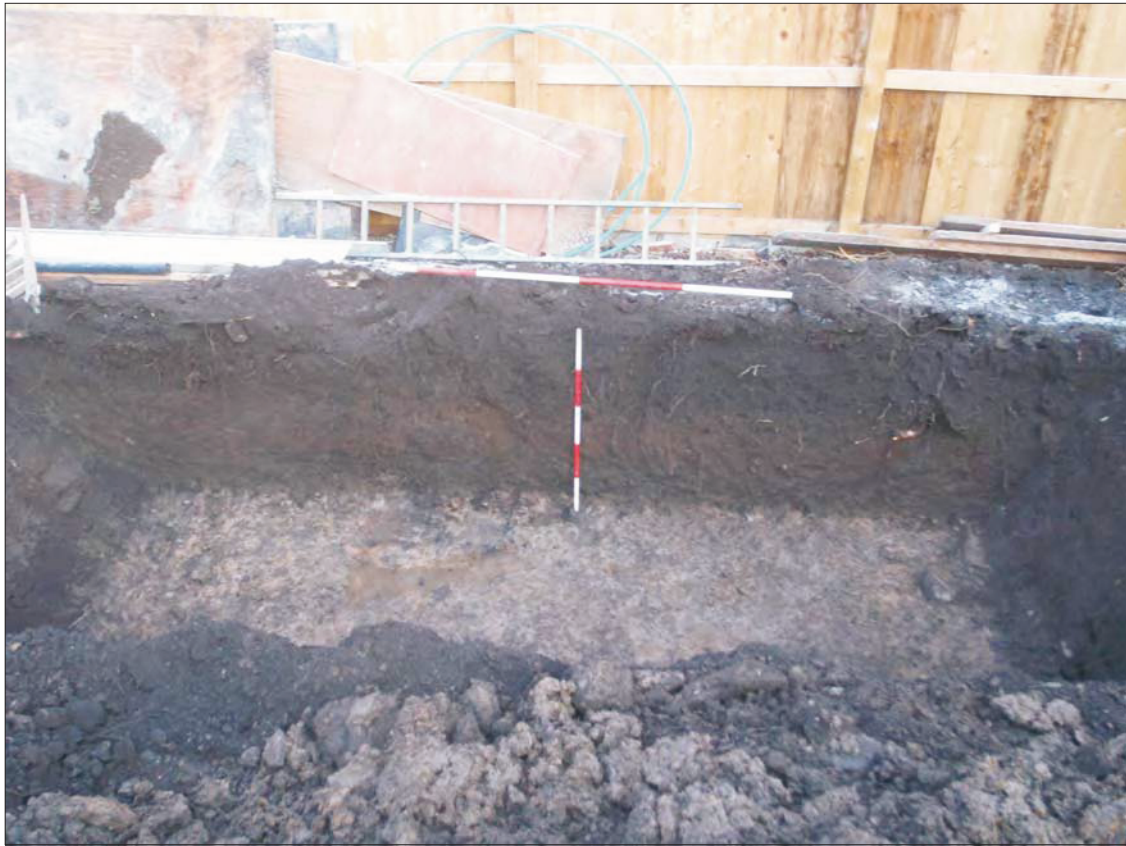
Plate 1: Trench 1, south facing section (scales 2m and 1m)

This trench was 5.8m long and was orientated approximately east to west. It was excavated onto yellow clay natural subsoil (context 103), present at a depth of 1.04m below existing ground level. The natural subsoil was overlain by a series of three soil layers that comprised a dark grey silty-clay alluvium (102) sealed by a mid brown clayey-silt subsoil (101) and a final garden soil (100).

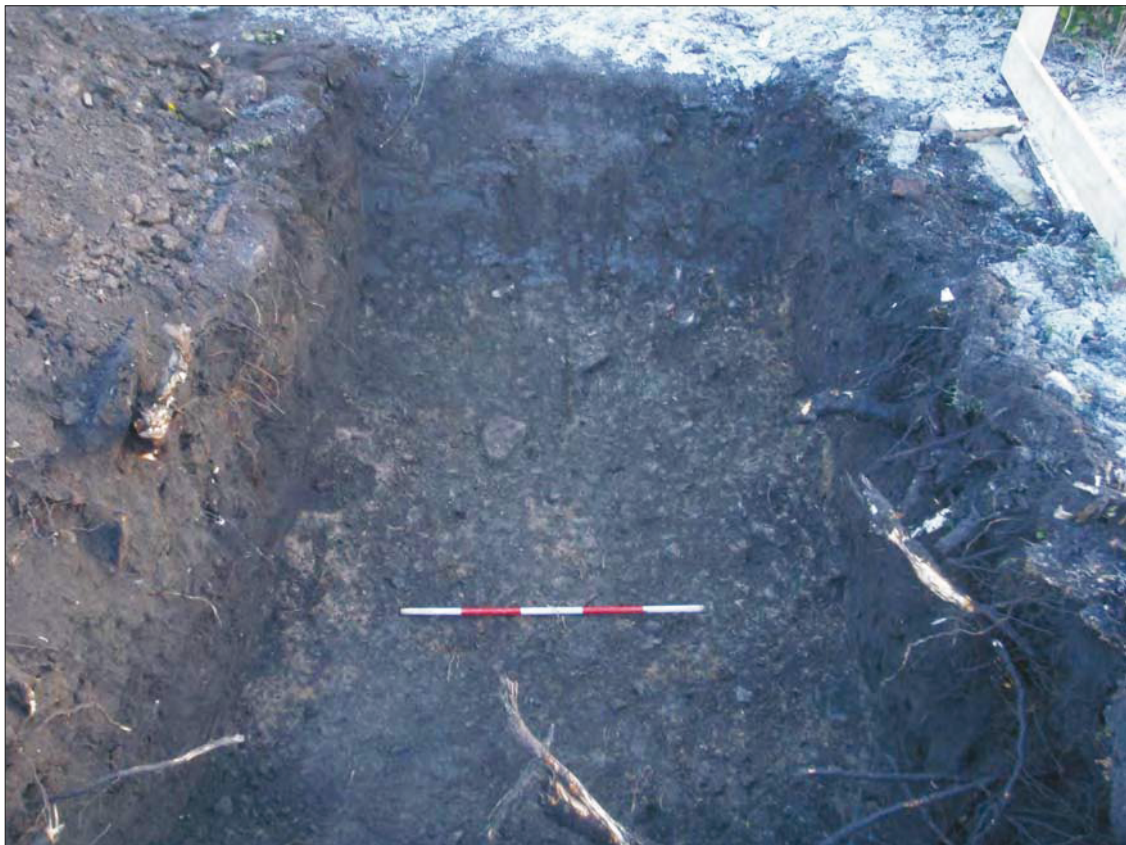
Plate 2: View of Trench 2, looking east towards ditch F204 (scale 1m)

This trench was 3.8m long and orientated approximately east to west. It was excavated to a depth of 1m into natural subsoil (203). The natural subsoil was overlain by a layer of dark grey silty-clay alluvium (202), which was cut by a ditch (F204) and a posthole (F206) located towards the east end of the trench.

Ditch F204 was 1.1m wide and 0.3m deep with moderate sloping sides and a flattish base. It contained a dark brownish-grey silty-clay fill (205). One sherd of green-glazed 15th to 16th century pottery and three pieces of iron smelting slag, including tap and furnace slag, were recovered from its fill.
