# Chopes and Bridge Street Car Parks, Bideford, Devon

Results of an archaeological trench evaluation

Document No: ACD126/2/0

Date: April 2010

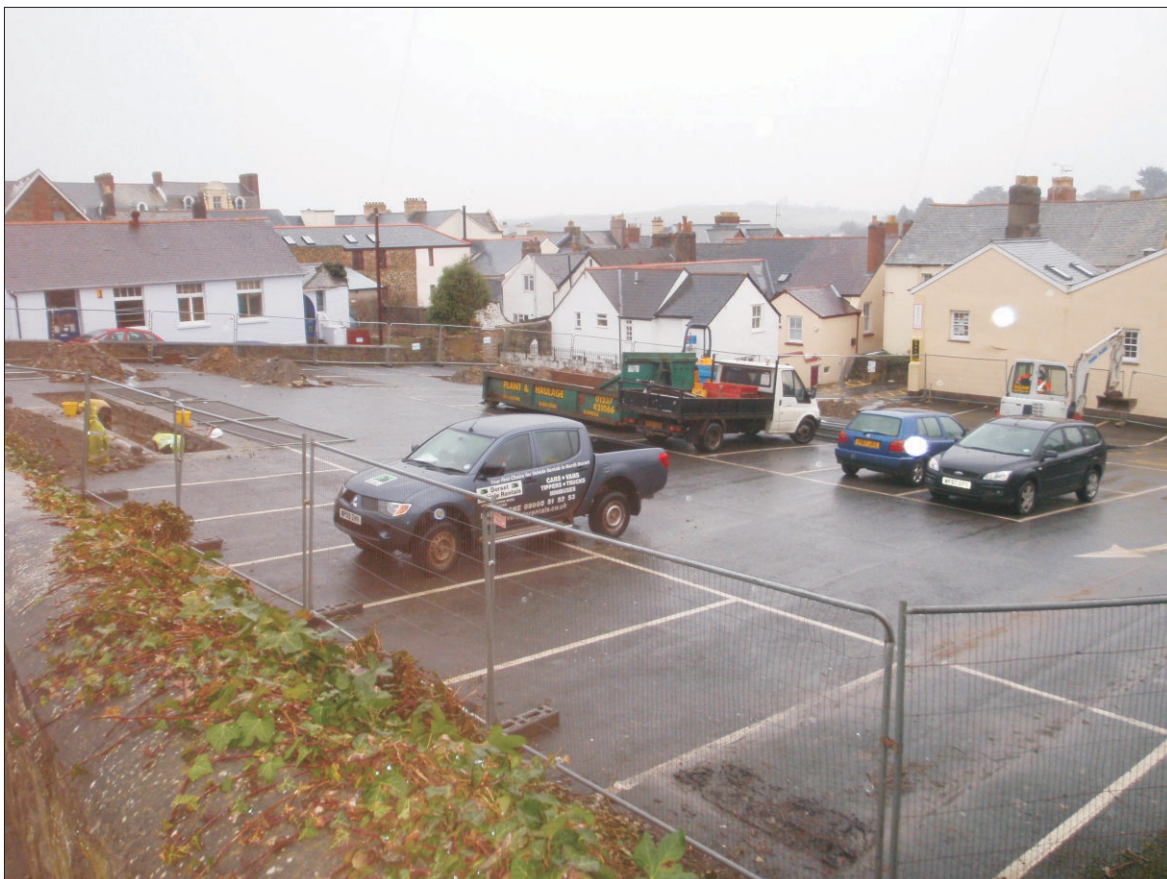
Plate 2: Excavations in Bridge Street car park. Looking northeast

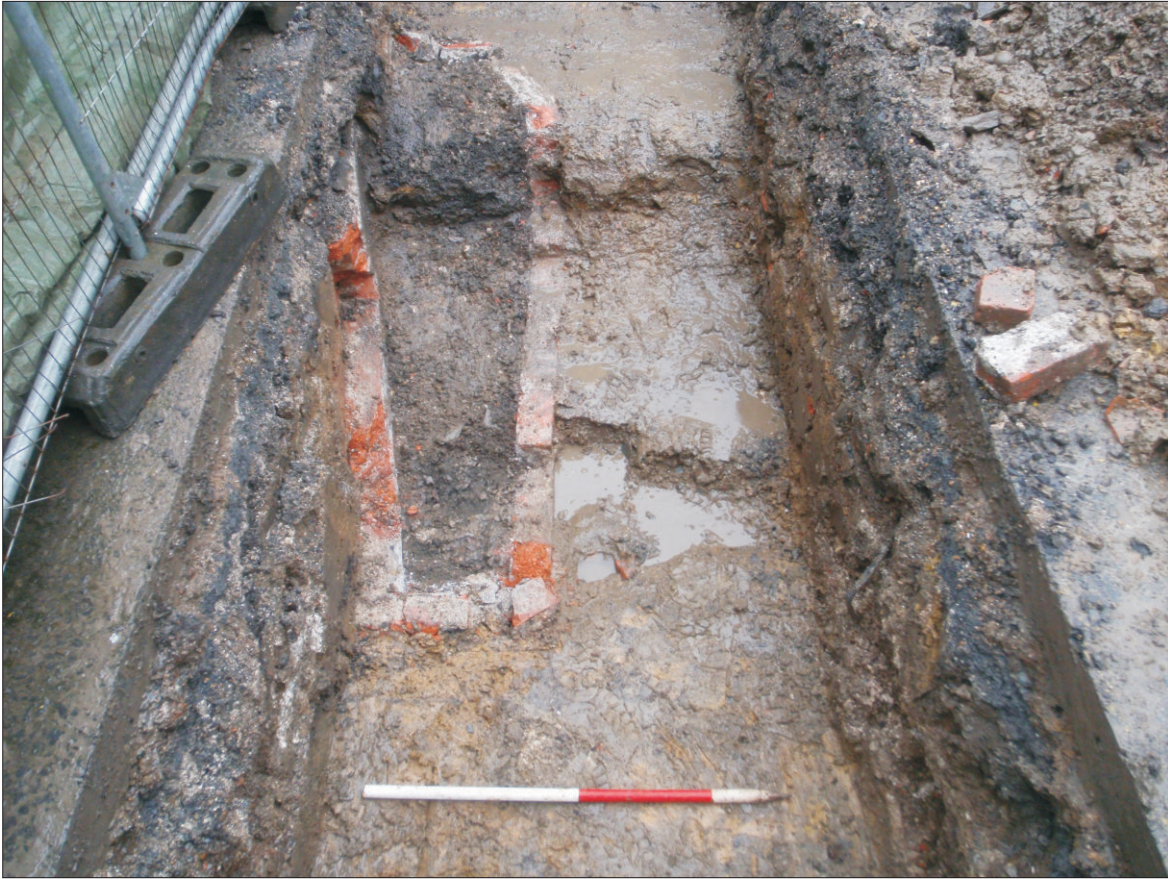
Plate 3: Trench 1 showing brick grave vault 106. Looking southeast (scale 1m)

#### 5.1 Trench 1 (Plan and section Fig. 2a and 2b; Plate 3)

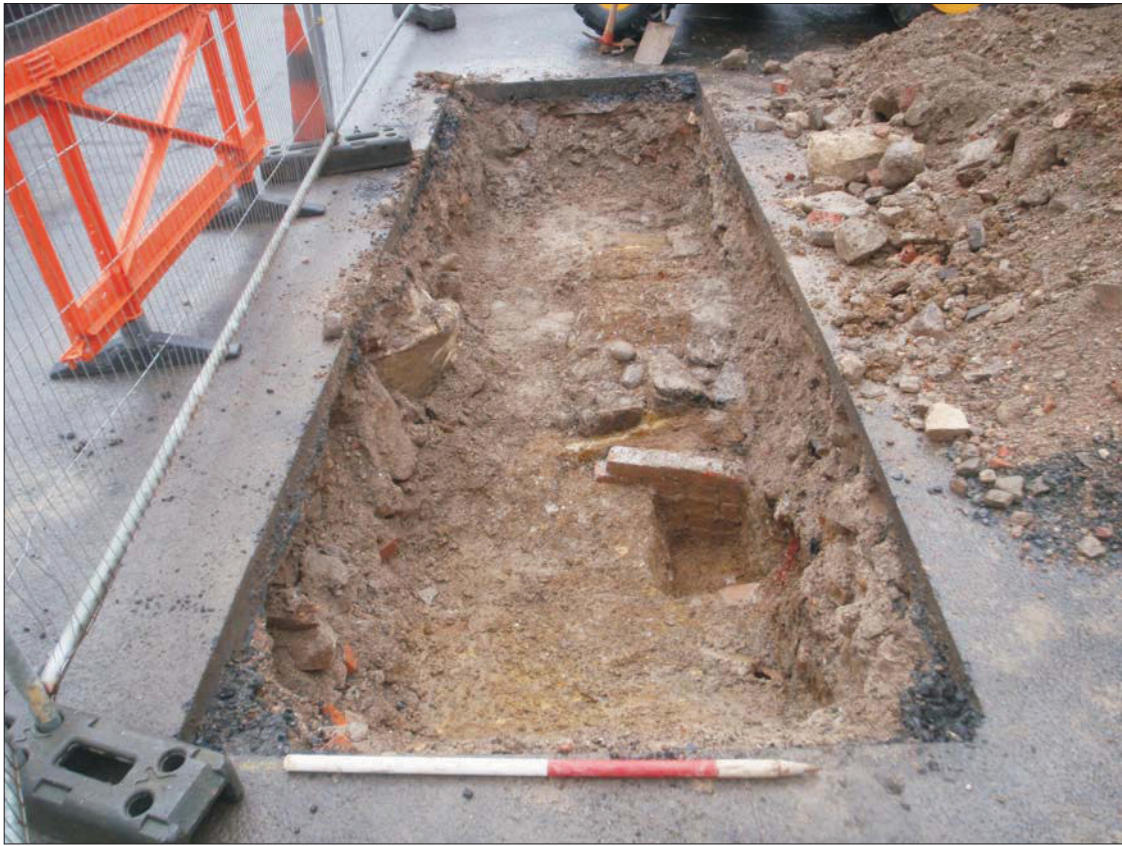
Plate 4:  
General view of Trench 2 from west (scale 1m)

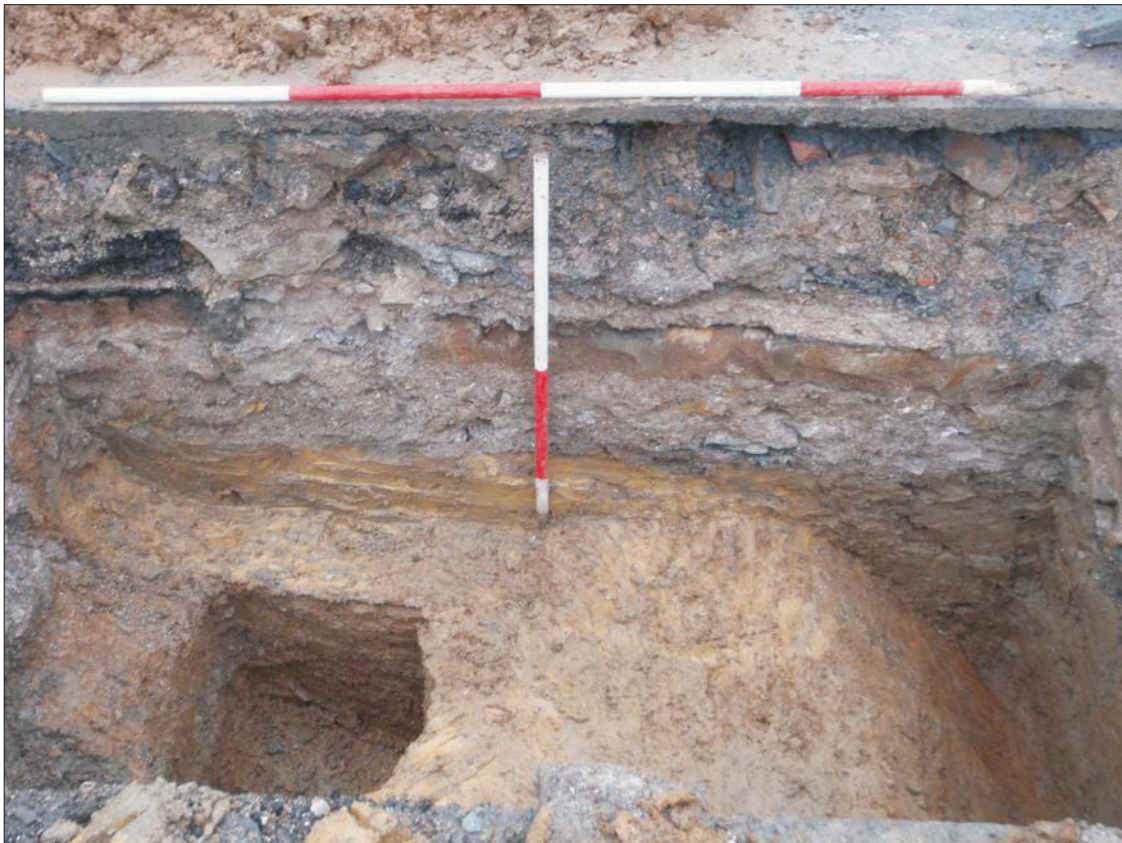
Plate 5: General view of Trench 3 showing grave vault 310. Looking south (scale 1m)

Probable grave cut F311 was partially exposed towards the north end of the trench and was 0.73m wide. Set within the cut was a brick vault lining (310) that was filled with a mid yellowish-brown silty-clay (309). An iron sickle blade was recovered from fill 309. The grave was truncated by a service trench cut (F306) that contained a ceramic sewer pipe.

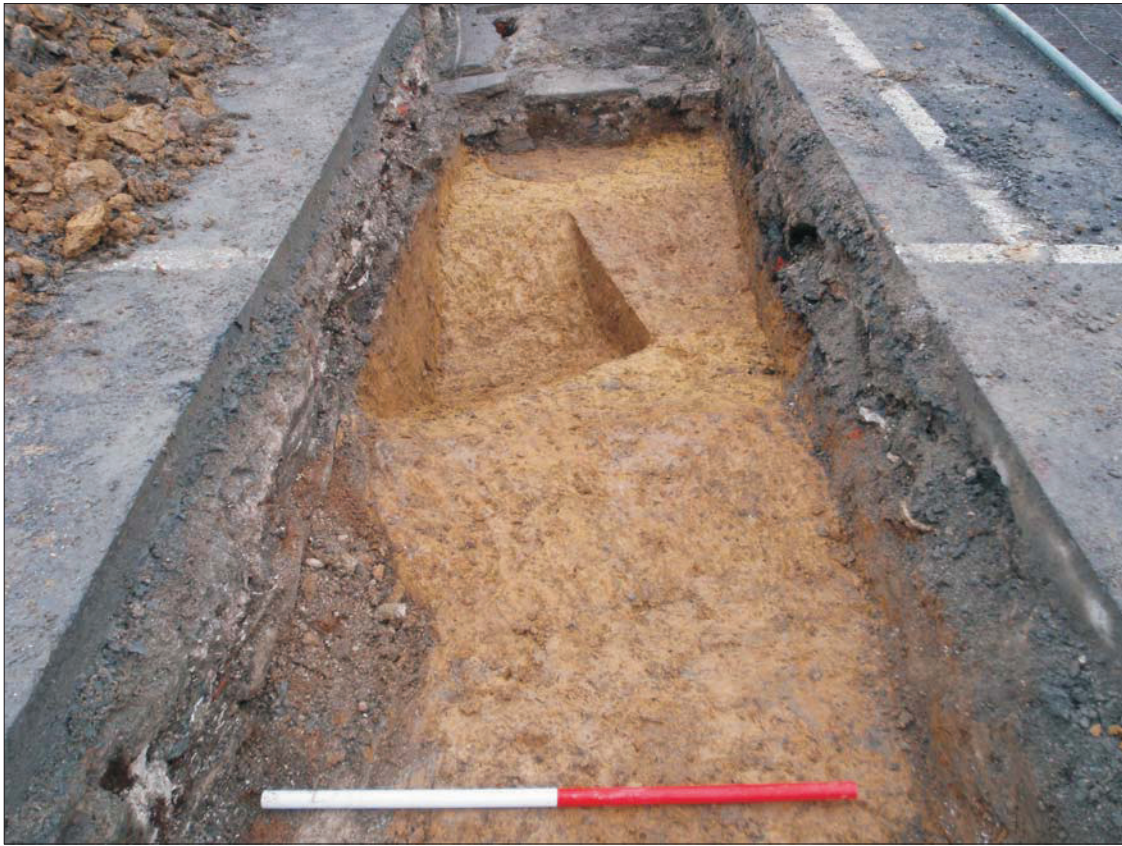
Plate 6: The general layer sequence Trench 6. Looking south (scales 1m and 2m)

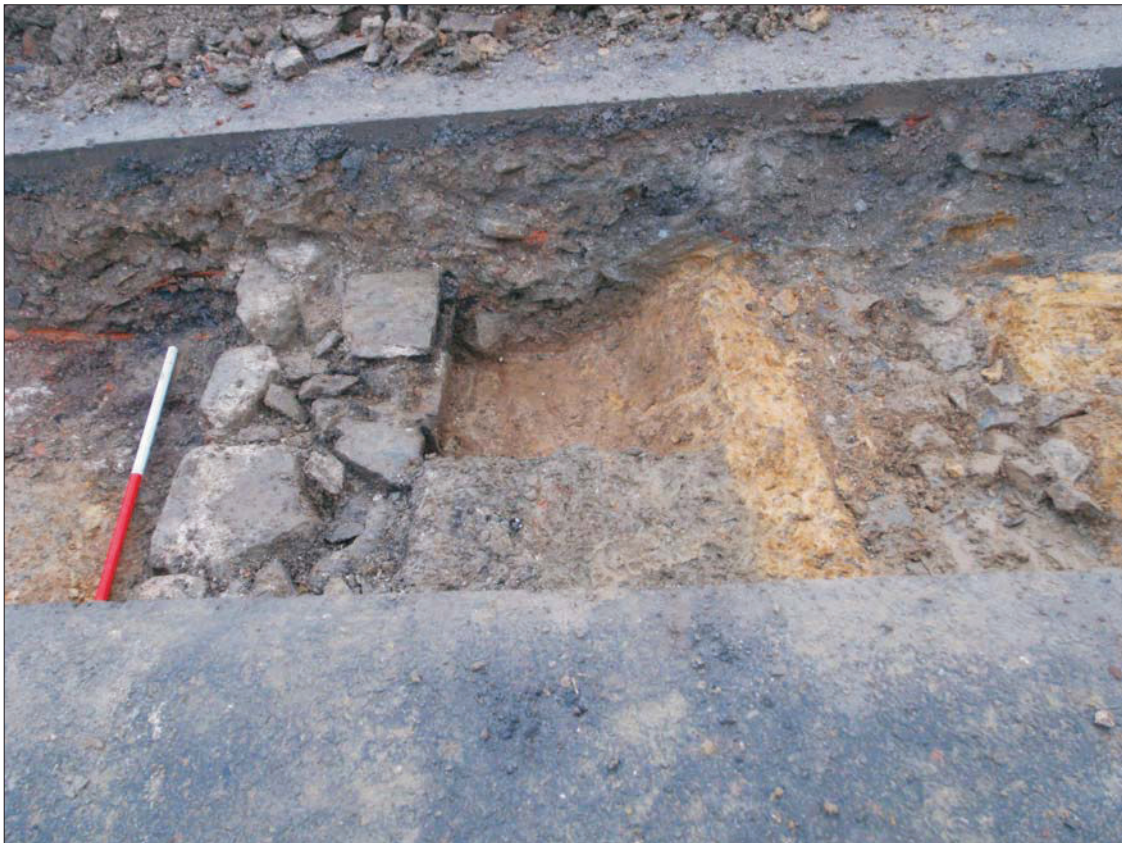
Plate 7: Ditch F808, Trench 8. Looking north (scale 1m)

Northeast to southwest aligned ditch F808 was 1.4m wide and 0.53m deep, with moderately steep sloping sides and a concave base. The ditch contained a series of three yellowish-brown clay fills (807, 806 and 805), with no finds recovered. To the north of ditch F808 was pit F810 which had a diameter of 0.61m wide and was 0.06m deep, with moderately sloping sides and a flat base. The pit contained a mid yellowish-brown clay fill (809), which was cut by a later footings construction cut (F817). Two sherds of medieval courseware pottery was recovered from fill 810.

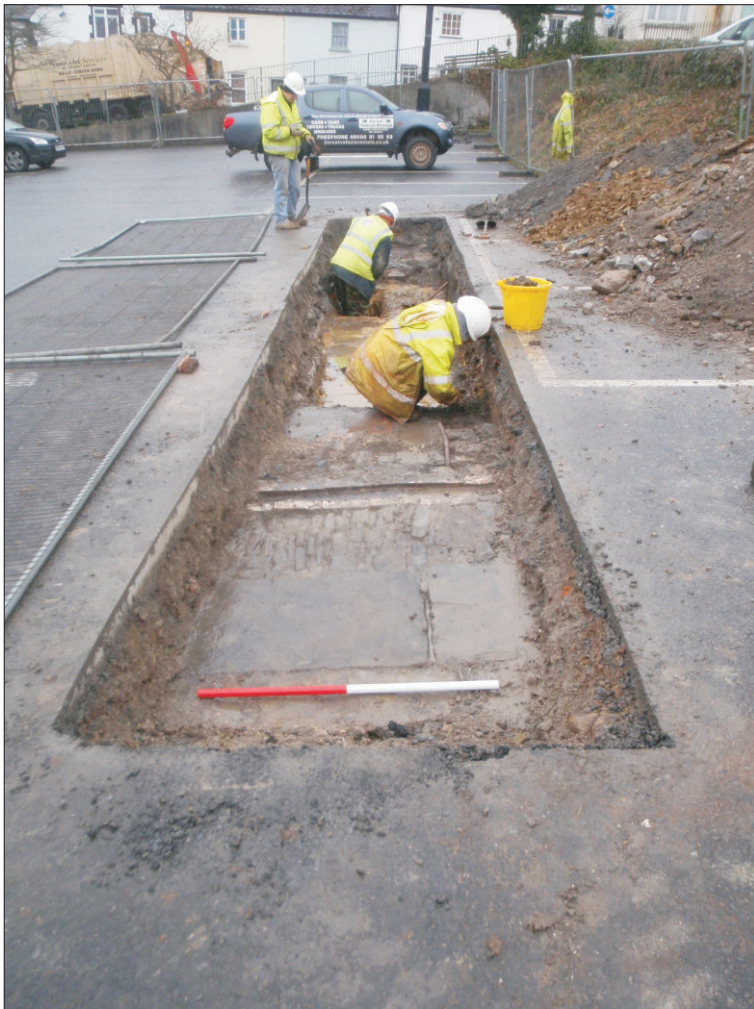
Plate 8: Ditch F908 and wall footing 907, Trench 9. Looking south (scale 1m)

This trench was excavated to a depth of 0.52 into natural subsoil (910), which was present at 0.44m below ground level. The natural subsoil was cut across the centre of the trench by a north to south aligned ditch (F908). This was 0.33m deep and had moderately steep sloping sides and a flat base. It contained a single mid greenish-grey silty clay fill (909) with common medium sub-angular stone and slate fragment inclusions. The ditch was heavily truncated to the east by a footings construction cut (F906). Finds recovered from the fill of the ditch comprised 34 pieces of animal bone, an oyster shell, two floor tile fragments and 85 sherds of post-medieval pottery.

Construction cut F906 was 0.6m wide and contained a roughly-faced and randomly-coursed limestone wall footing (907) in a lime mortar bond. There were two construction cuts abutting the wall to the east (F902 and F914), with these extending beyond the trench edge.

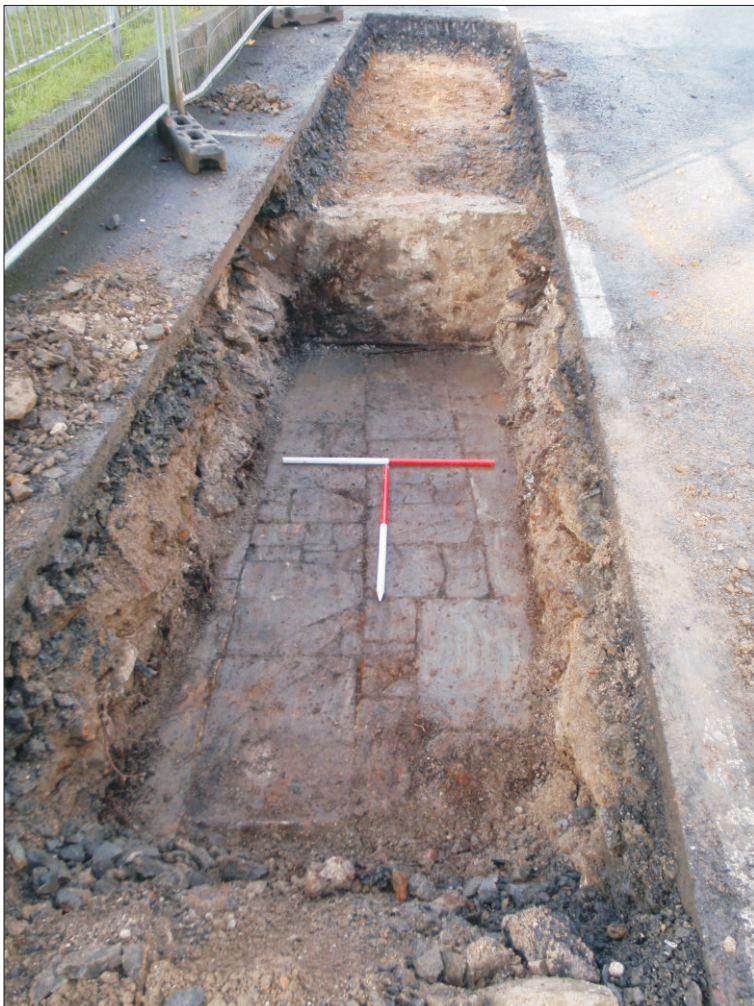
Plate 9:  
General view of Trench 11. Looking north  
(scale 1m)
