# The proposed Crediton Link Road Hillside Route

## Results of archaeological investigations

Document No: ACD180/2/1

Date: September 2010

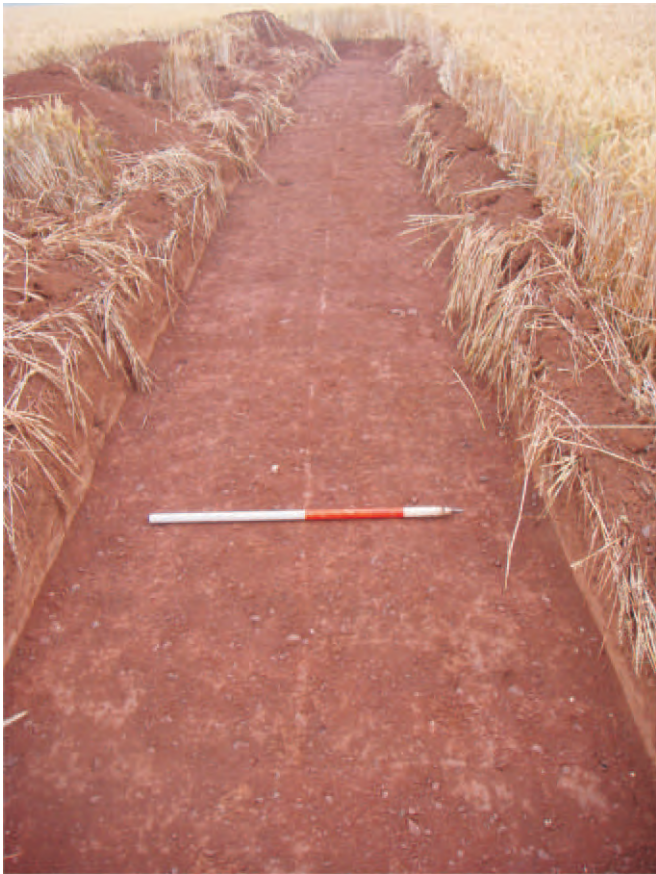
Plate 1: View of Trench 2 from the south (scale 1m)

Trench 2			Length 20m	Width 1.6m	Alignment N-S
Context	Description	Depth	Interpretation		
2200	Mid reddish-brown friable silty clay	0-0.27m	Ploughsoil		
2201	Mid red friable gravelly clay	0.27m+	Natural subsoil

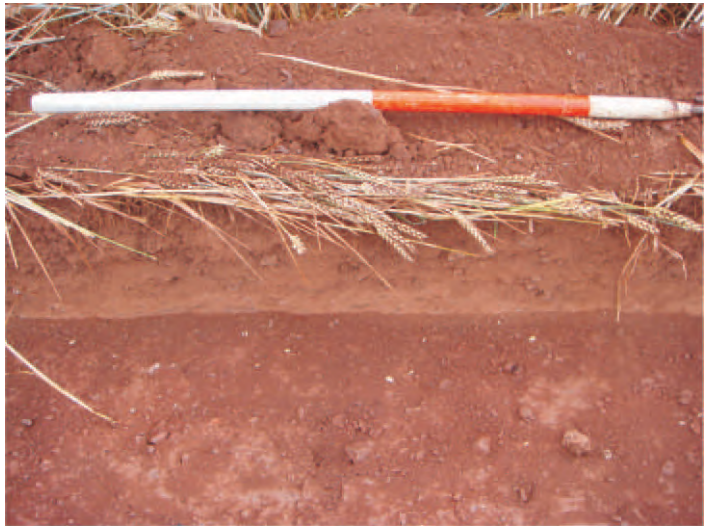
Plate 2: View of section at the south end of Trench 2, looking to west (scale 1m)

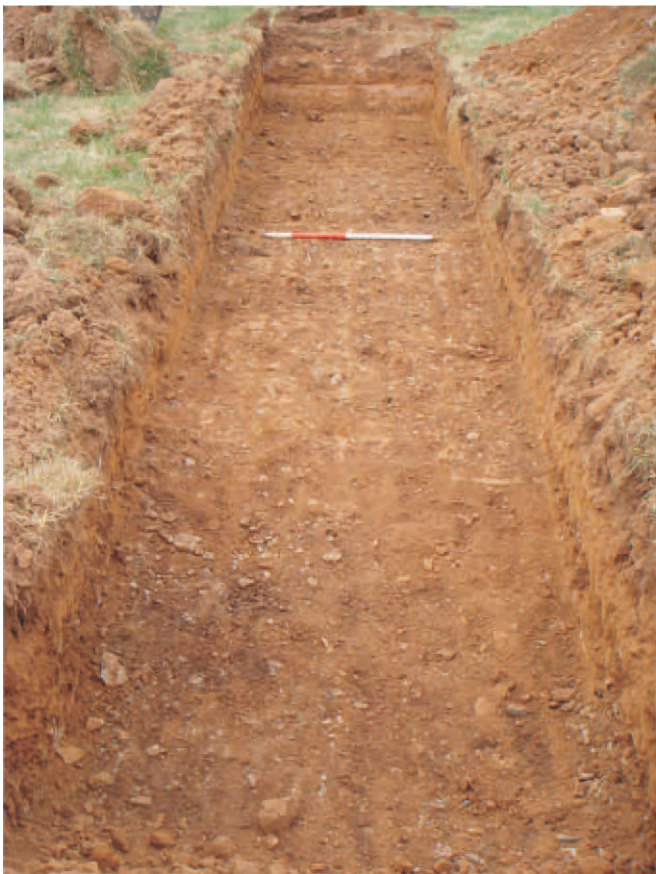
Plate 3: View of Trench 6 from the south (scale 1m)

Trench 6			Length 20m	Width 1.6m	Alignment N-S
Context	Description	Depth	Interpretation		
2600	Mid reddish-brown friable silty clay	0-0.26m	Ploughsoil		
2601	Mid yellowish-brown friable silty clay	0.26-0.61m	Colluvial layer		
2602	Mid yellow clay	0.61m+	Natural subsoil

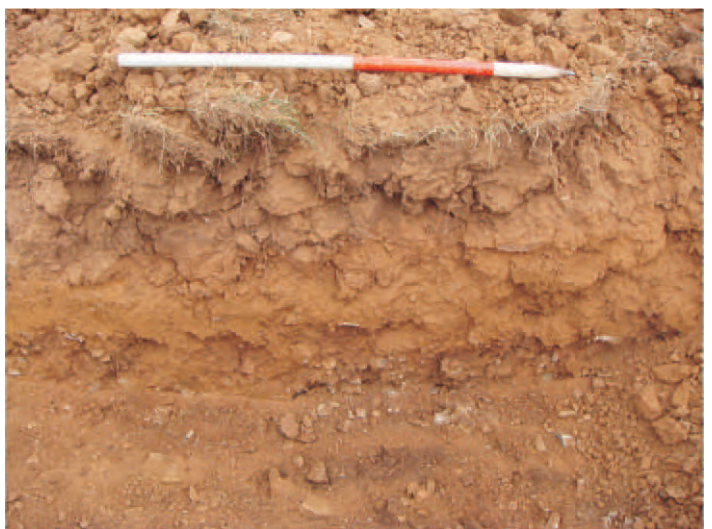
Plate 4: View of section at the south end of Trench 6, looking to west (scale 1m)
