An archaeological trench evaluation on land at 4 Wotter Bungalows, Wotter, Shaugh Prior, Devon

Document No: ACD209

Date: September 2010

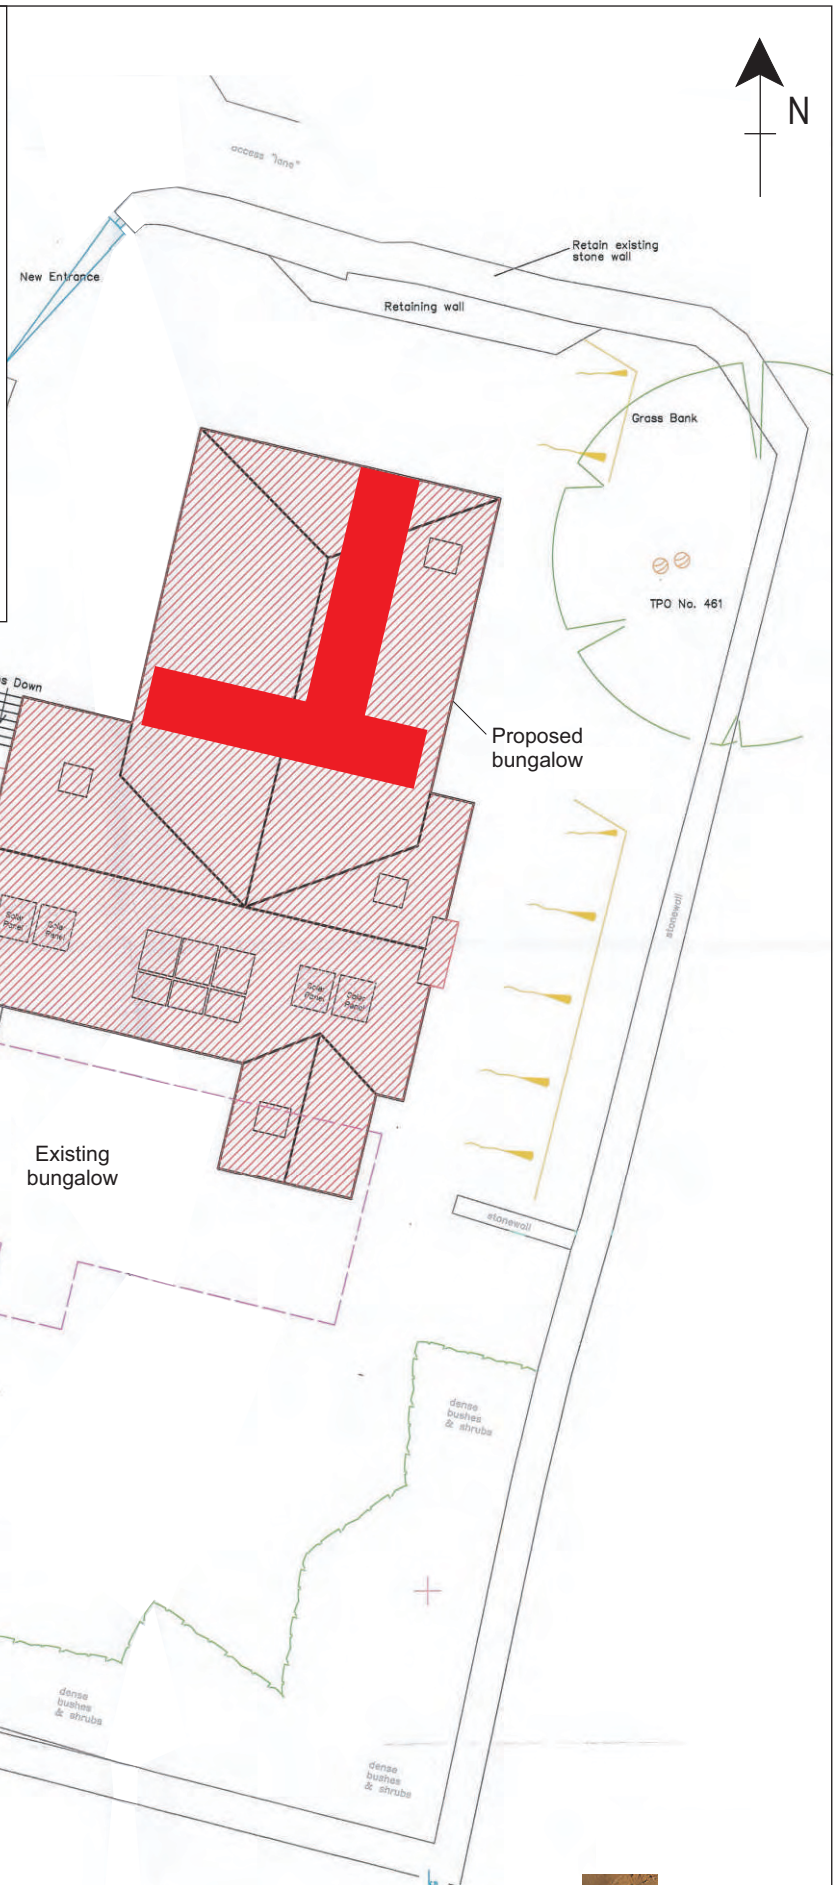
Fig 1. Site and trench location

Trench 1 location

Footprint of proposed buildings

Footprint of building to be demolished

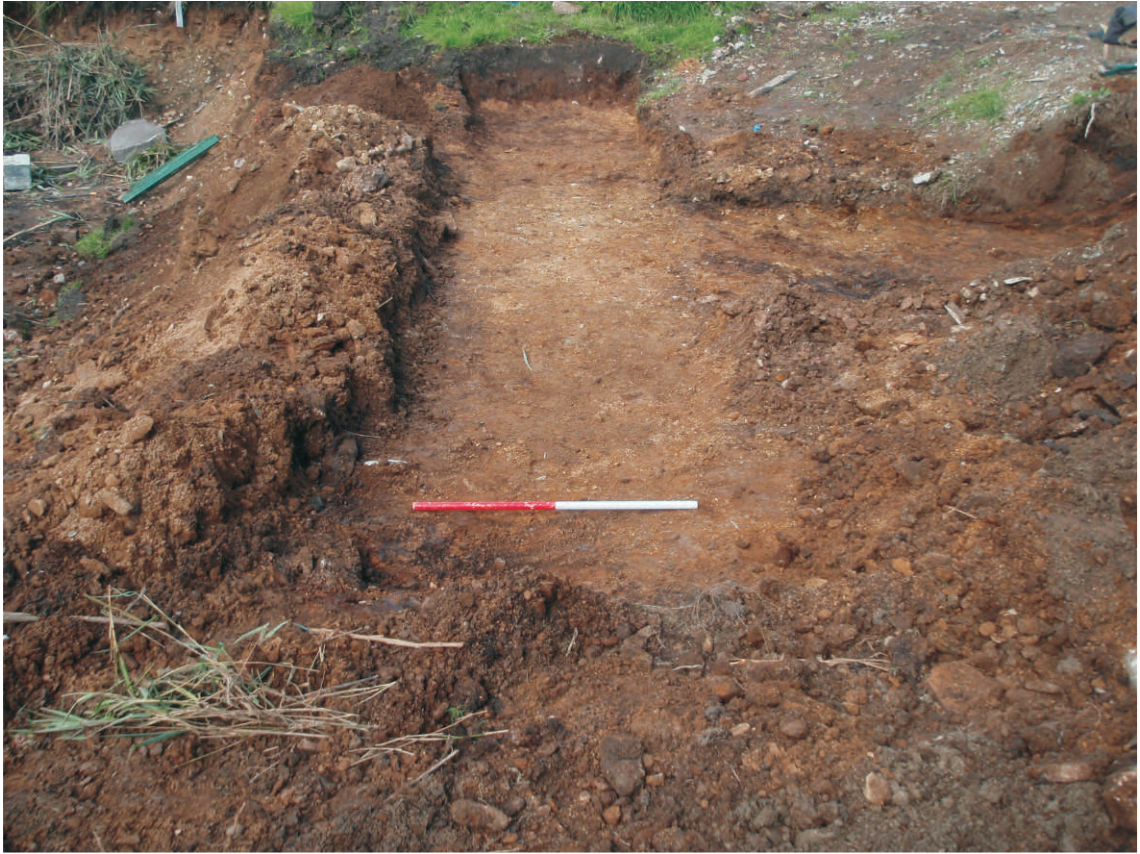
Plate 1. View of Trench 1, looking to northwest (Scale 1m)

<p>Comment</p> <p>No <i>in situ</i> pre-modern archaeological features or deposits were exposed within the evaluation trench. A small quantity of 20th pottery and general building debris was present within the excavated spoil, but this was not retained. The area surrounding the existing bungalow, particularly along its northern side, has been mostly terraced away to a depth of up to 1.50m prior to its construction sometime during the first half of the 20th century and, as such, any archaeological deposits or features within this area are likely to have been previously removed. Groundworks associated with construction are unlikely to impact upon any archaeological features or deposits.</p>			Context	Depth below ground level (m)	Description	Interpretation	100	0-0.20	Humic dark grey soft clay silt with occasional small-medium sub-rounded stones <0.05m	Topsoil	101	0.20-0.50	Mid-dark brown soft sandy clay silt with occasional-rare small-large sub-rounded stones <0.10m	Colluvial subsoil	102	0.50/0.80+	Light yellowish-brown friable sandy clay with frequent small-large sub-angular stones <0.10m	Natural subsoil	103	0-0.30	Mixed dark greyish-brown and light grey silty clay with loose medium-large gravels	Modern made ground
Context	Depth below ground level (m)	Description	Interpretation																			
100	0-0.20	Humic dark grey soft clay silt with occasional small-medium sub-rounded stones <0.05m	Topsoil																			
101	0.20-0.50	Mid-dark brown soft sandy clay silt with occasional-rare small-large sub-rounded stones <0.10m	Colluvial subsoil																			
102	0.50/0.80+	Light yellowish-brown friable sandy clay with frequent small-large sub-angular stones <0.10m	Natural subsoil																			
103	0-0.30	Mixed dark greyish-brown and light grey silty clay with loose medium-large gravels	Modern made ground																			
Recorder: Richard Sims, AC archaeology		Date sent to HER: 23 September 2010

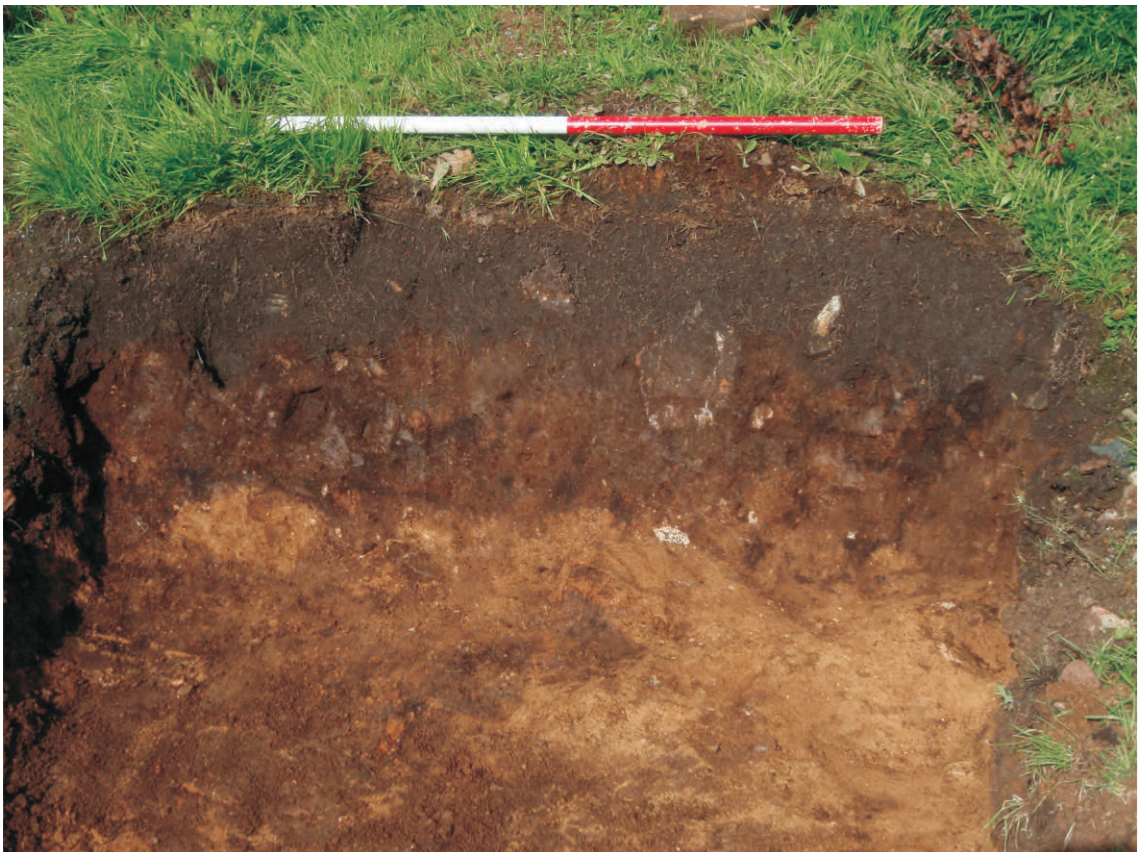
Plate 2. Representative section, northwest end of Trench 1 (Scale 1m)

<table><tr> <th>Context</th> <th>Depth below ground level (m)</th> <th>Description</th> <th>Interpretation</th> </tr><tr> <td>100</td> <td>0-0.20</td> <td>Humic dark grey soft clay silt with occasional small-medium sub-rounded stones <0.05m</td> <td>Topsoil</td> </tr><tr> <td>101</td> <td>0.20-0.50</td> <td>Mid-dark brown soft sandy clay silt with occasional-rare small-large sub-rounded stones <0.10m</td> <td>Colluvial subsoil</td> </tr><tr> <td>102</td> <td>0.50/0.80+</td> <td>Light yellowish-brown friable sandy clay with frequent small-large sub-angular stones <0.10m</td> <td>Natural subsoil</td> </tr><tr> <td>103</td> <td>0-0.30</td> <td>Mixed dark greyish-brown and light grey silty clay with loose medium-large gravels</td> <td>Modern made ground</td> </tr></table>
