# Land at Oakdale, North Jaycroft, Willand, Devon

## Results of an archaeological watching brief

Document No: ACD201/2/0

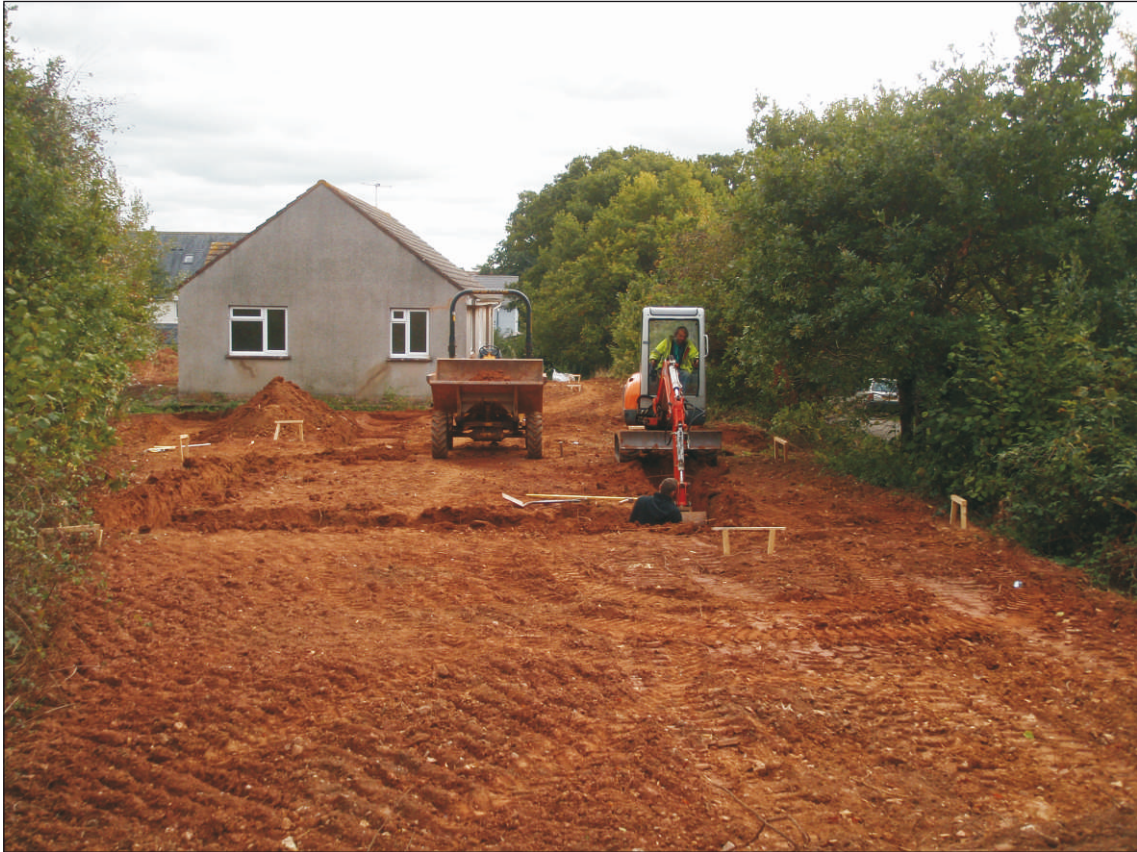
Plate 1 General view of site, facing southeast

The watching brief was carried out during excavation of footings for a new detached garage located to the northwest of Oakdale (Plate 1). General ground reduction for the new access drive and parking area to a depth of around 0.15m and measuring approximately 12m long by 10m wide was not monitored during the watching brief. Instead, three northwest-southeast aligned trenches located within the footprint of the area were excavated in advance of these groundworks, with each trench measuring 10m long by 1.60m wide. Groundworks associated with the construction of a small conservatory abutting the existing bungalow were not monitored as part of the watching brief.

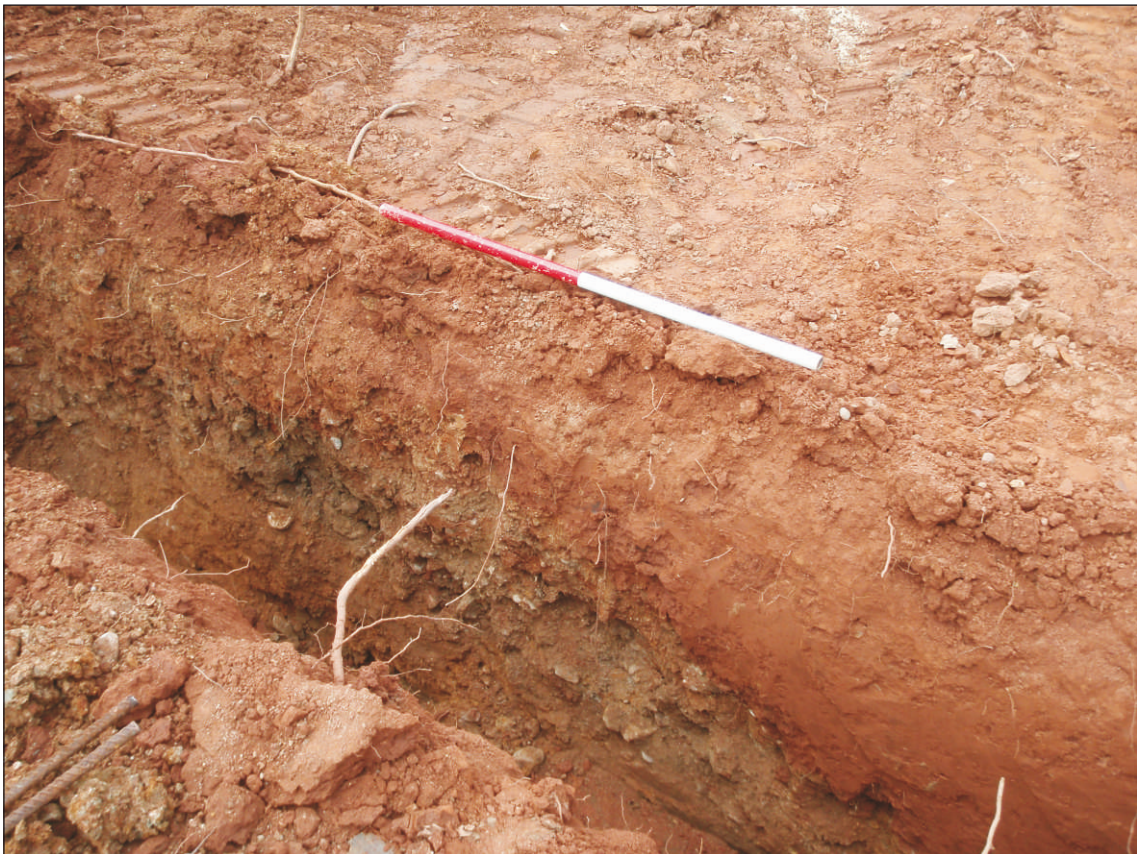
Plate 2 Representative section within garage foundation trench, facing northwest (Scale 1m)

The foundation trench for the garage measured 0.70m wide and was excavated to a maximum depth of 1.10m into undisturbed sand and gravel natural subsoil (103), present at a depth of between 0.80-1m below ground level. The overlying layer sequence comprised a series of modern-made ground deposits (100), (101) and (102), as summarised in the table below and shown on Plate 2.

The watching brief has established the presence of substantial modern-made ground deposits recorded across the site. These were recorded to a depth of between 0.80-1m and comprised a sequence of reinstated soil layer (100) over a clean red clay (101) onto a mixed deposit of gravels, sand and clay (102). A single red industrial brick was recovered from the base of layer (101), though this was not retained.

These deposits were most likely formed from the upcast material excavated during the construction of the railway line in the 19th century and which borders the northeast edge of the site. The resulting immediate landscape is one that forms a prominent raised bank onto which the existing house was constructed during the 20th century. No pre-modern archaeological deposits, features or finds were observed during the watching brief.
