Land at Holman Clavel (RAF Culmhead), Otterford, Somerset

Archaeological Desk-Based Assessment

David Etheridge B.A. M.Phil. FSA Scot
Avon Archaeological Unit Limited

Bristol: October 2011

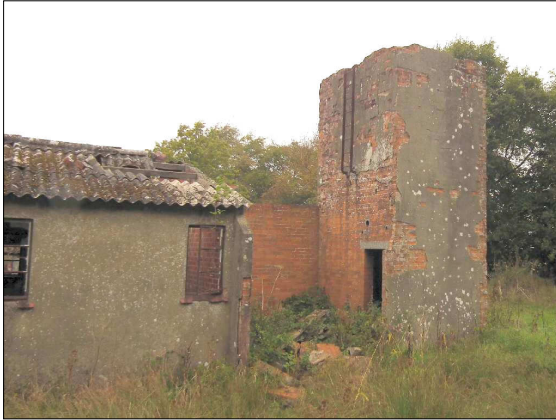
Plate a. The north end of Structure 1 with the tower attached, looking northwest.

Standing just to the north of *Structure 1*, and still connected to it, is a rectangular brick-built tower, about two storeys high, with no obvious roof, which appears to be a water tower (see **Plate a**). A short steel ladder leads down from the upper part of the tower for a short distance. The tower is still partially rendered. Entrance to the ground floor interior of the tower was via a doorway in the southern wall, with a concrete lintel over. The ground floor interior of the tower, and the space between the tower and the remains of *Structure 1*, are chocked with brick rubble. There is a low rectangular window in the north wall of the tower at ground floor level.

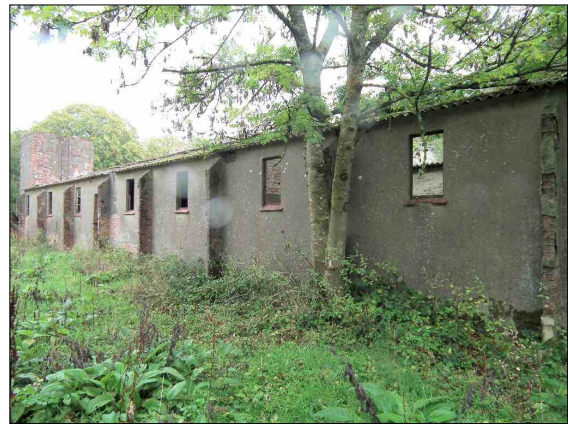
Plate b. The west face of Structure 1, looking north-eastward.

The west face of *Structure 1* is divided into bays by a series of brick built buttresses, with one simple rectangular window in each bay (see **Plate b**). Each window has sloping sills in ceramic tiles. Where the frames survive these are steel, and appear to be Crittall. The surviving east face is divided into four bays, two with two windows each and two bays with one each. The southern end of the east face is adjoined by a single-storey extension in rendered brick. The broad external entrance in the north face of the extension has been stopped with breezeblock walling. The mono-pitch corrugated concrete roof slopes down to eastward.

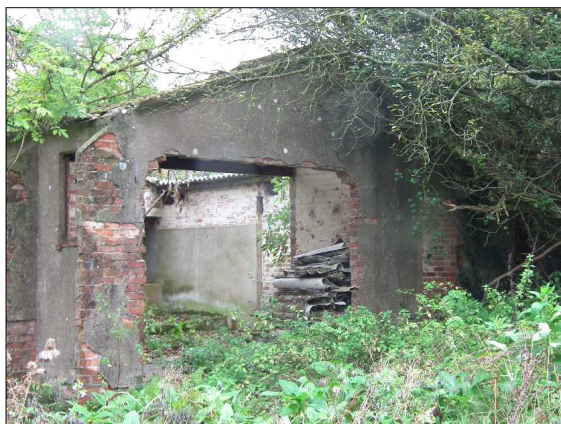
Plate c. The southern face of Structure 1, looking north-eastward.

There is a broad entrance in the southern wall of *Structure 1*, leading into a series of relatively large rooms, partially open to the elements as the roof has in places decayed and collapsed (see **Plate c**). The remains of this have been stacked inside against the southern wall. One of these rooms is the interior of the extension, described above. Some vandalism was observed on the walls of this structure. The main part of the block is divided into cubicles by brick partitions (see **Plate d**). While some pipework is extant there are no other fixtures and fittings that remain to indicate use.

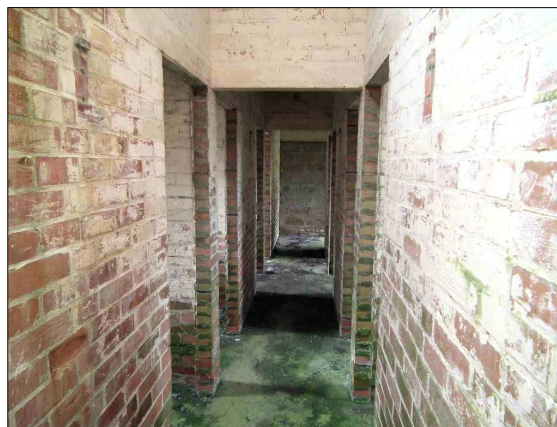
Plate d. Interior of Structure 1, looking north, showing central corridor with cubicles on either side.

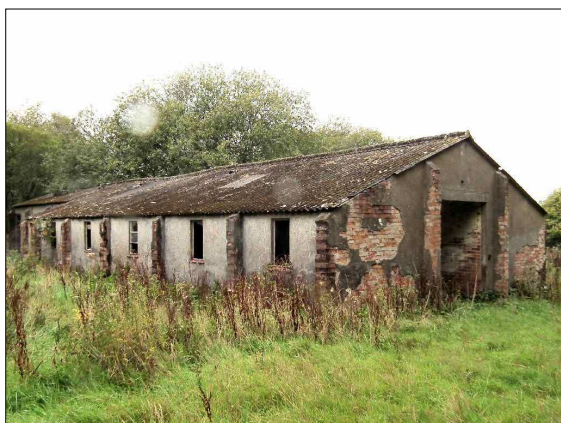
Structure 2 is of similar design and materials to Structure 1. As preserved it forms a simple rectangular block with a narrower rectangular block adjoining the southern side. There is no tower and the north-facing gable is in rendered brick. In the north-facing gable there is a broad entranceway with a steel joist over. Along the both east and west

Plate e. North and east faces of Structure 2, looking southwest.

faces there are five evenly spaced bays defined by brick buttresses, with a single rectangular window in each bay (as described above). It was noted that the northernmost two bays of the west face had lost part of their roofing and that at this location the external wall rendering has largely fallen off. The sixth bay from the north is considerably shorter. On the west face this has a regular rectangular window similar to the other bays. The east face has a side entrance at this location.

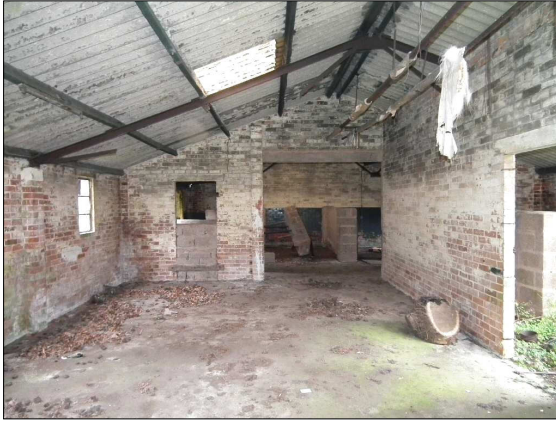
Plate f. Structure 2, northeast room, looking south.

Internally the northernmost three bays have been divided by a longitudinal brick wall, offset about 1 m west of the central axis. The western room is partially derelict as the roof is missing in places. A rendered breezeblock animal pen with tubular steel bars and a steel gate has been constructed in this room, but is no longer in use. The larger eastern room is vacant,

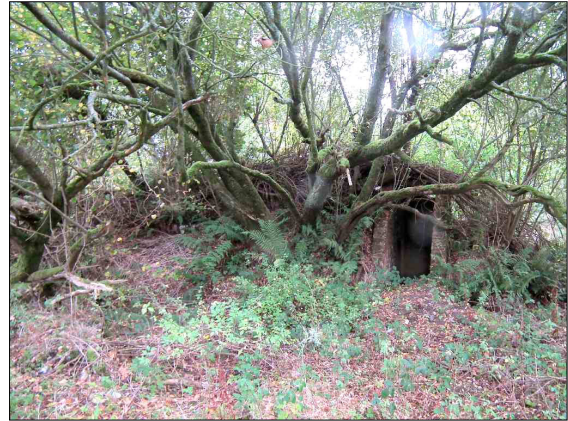
Structure 3 is a roughly north to south aligned semi-subterranean building located some distance to the west of Structure 2. Its presence is not immediately apparent due to a heavy overgrowth of shrubs and immature trees. Externally it appears as a long, low mound, with rectangular brick superstructure at either end. At the southern end, on the western side, a short flight of brick steps led down eastwards to a south facing doorway into the structure (see **Frontispiece**). The flanking walls on either side of the passage are

Plate g. Structure 3, looking northeast.

in brick, with a concrete slab roof. From the construction of this structure it was immediately apparent this was a former air raid shelter. The primary function of the southern wall was therefore to act as a blast wall.

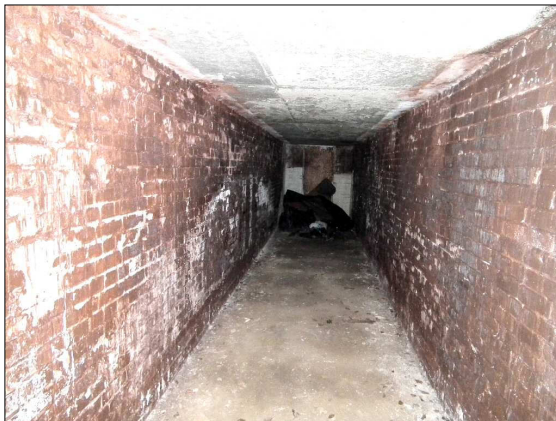
Plate h. Interior view of Structure 4, looking east.

On reaching the floor level, about a metre below present ground level, the structure was found to be flooded to a depth of about 50 mm, presumably with percolated ground water. The south facing steel blast door, which gives access to the central chamber, is intact, though surface rusting is evident. The central chamber was formed of two parallel-sided brick walls, with a concrete floor and a

concrete slab roof. The far end of the chamber could not be accessed at that time. It is postulated there was an opposed entrance at the northern end on the eastern face of the structure, but dense overgrowth made it impossible to confirm this externally, and nothing could be observed internally from the southern end, despite the use of a torch and flash photography.

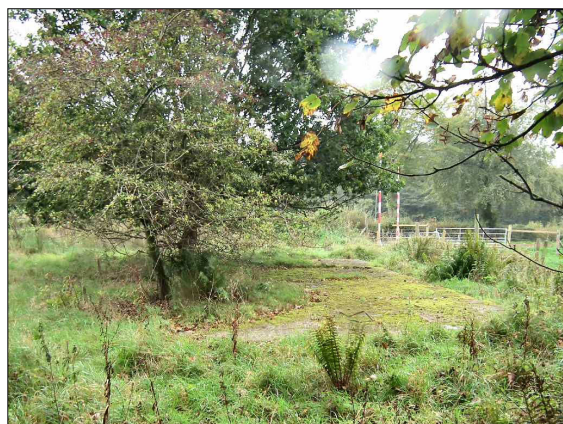
Plate i. A concrete plinth located towards the western edge of the study area, looking approximately southwards.

Dotted around the site, to the west of Structure 2, were various rectangular concrete plinths, taken to be the floor levels of other buildings formerly occupying the site. There was some evidence of buried underground services, a manhole cover was observed to the west of Structure 2, while a toilet was also located within Structure 2.

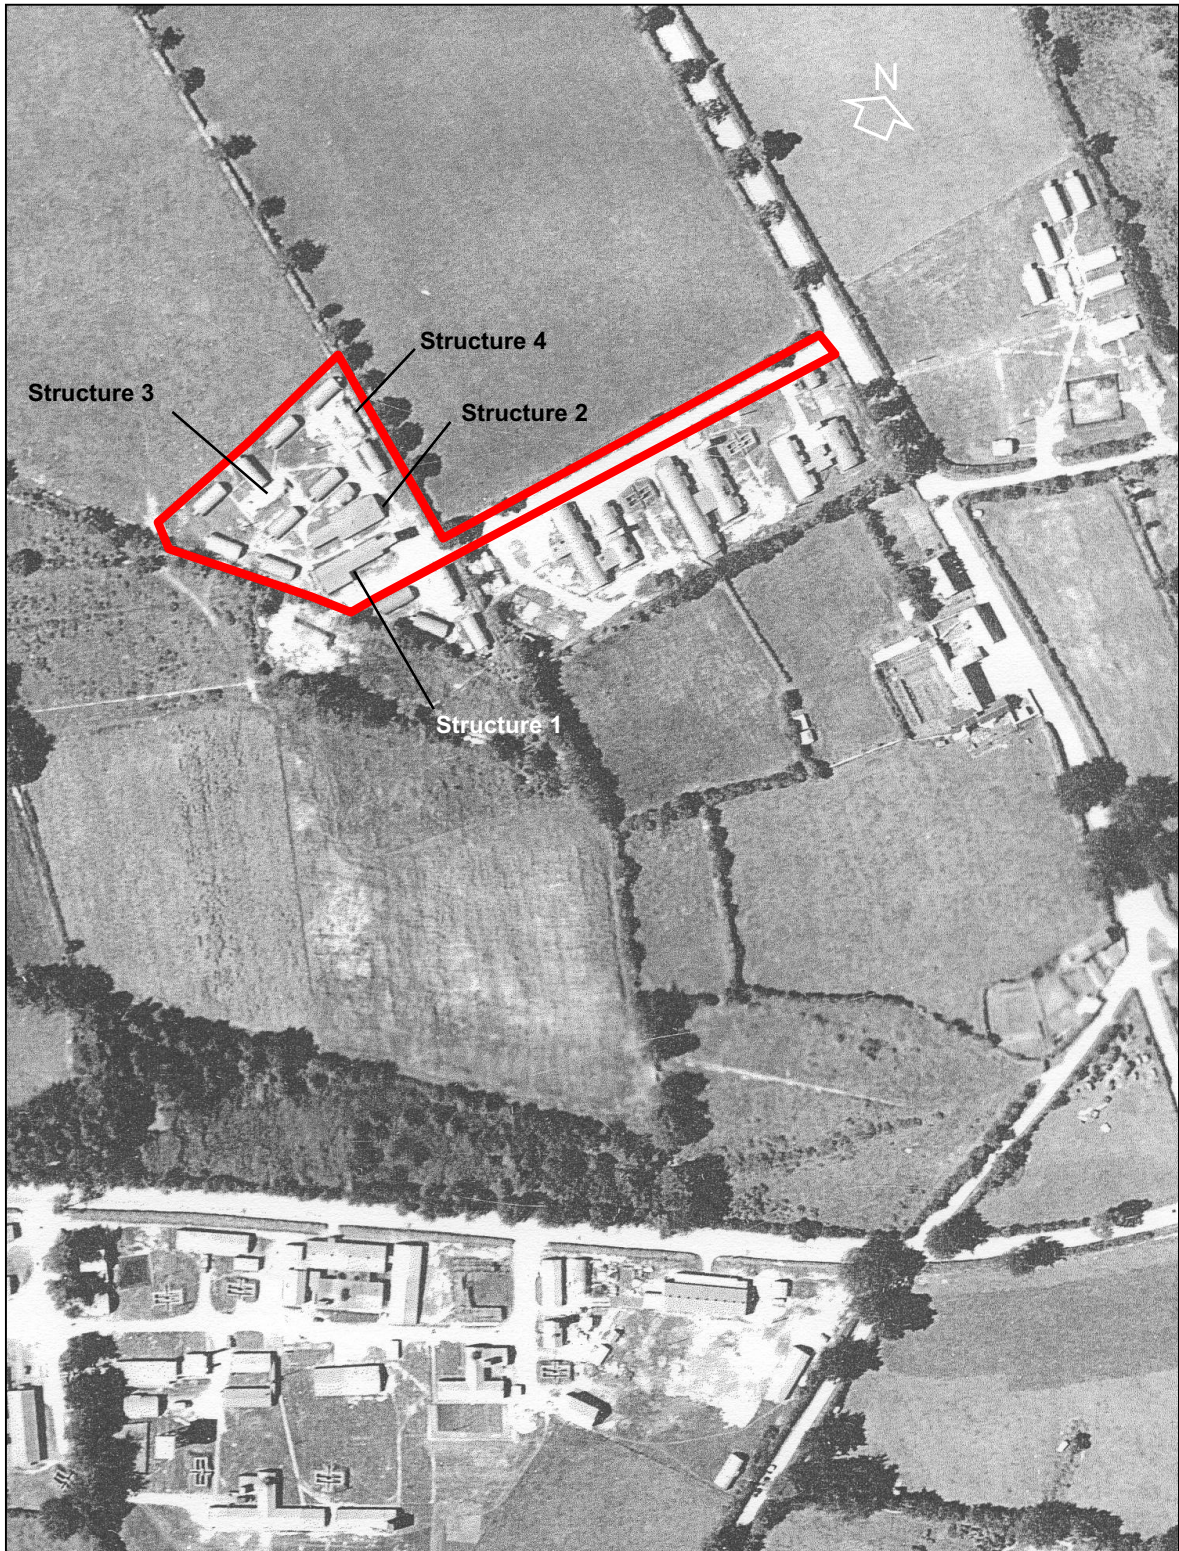
An extract from an August 1943 USAAF aerial photograph
Sortie US/7PH/GP/LOC14, Frame V 5033.

Approximate boundary of the study area outlined in red.
