Matford Bridge, Old Gloucester Road, Winterbourne, South Gloucestershire

Archaeological Monitoring and Recording Exercise

Report: SGHER 19887
BRSMG 2011.30

Archaeological Monitoring and Recording Exercise at
Matford Bridge, Old Gloucester Road, Winterbourne,
South Gloucestershire
NGR ST 63742 81810

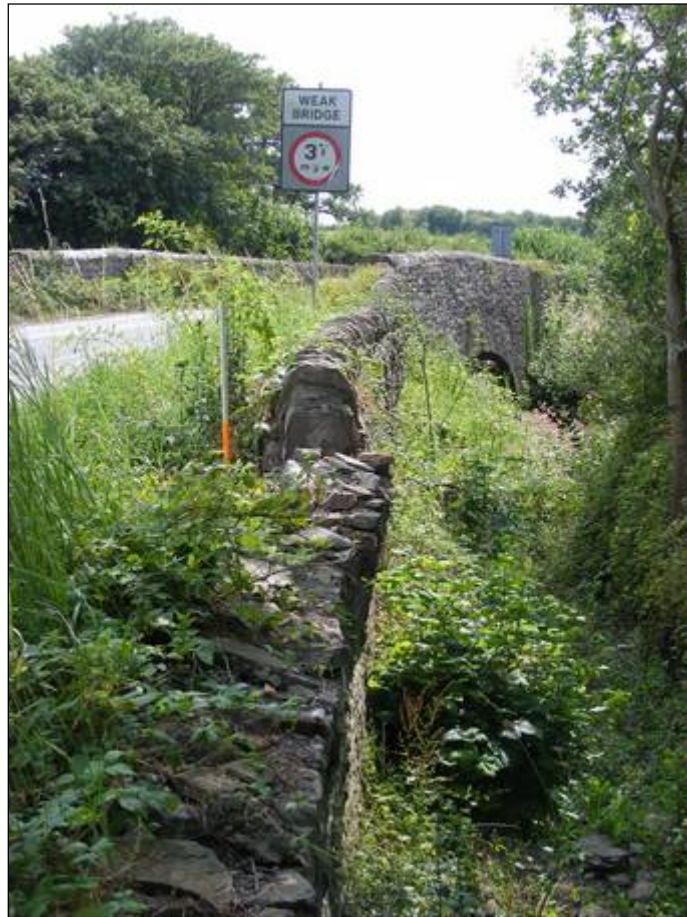
Cover West retaining and parapet walls, looking south

The carriageway retaining walls to the north were in a major state of disrepair (see cover photo). The terminal to the south-east retaining wall and some of the wall itself was found to be a modern re-build.

The retaining wall (Context 126) was found to consist of Pennant slabs (of maximum dimensions 350mm by 350mm by 100mm), bonded with a grey lime mortar flecked with charcoal. The majority of the slabs were unworked. It is possible that the wall was sited within a foundation cut, truncating the subsoil layer, Context 524. The wall measured a width of 530mm east-west at its northern terminal, which was in a state of disrepair (see cover photo).

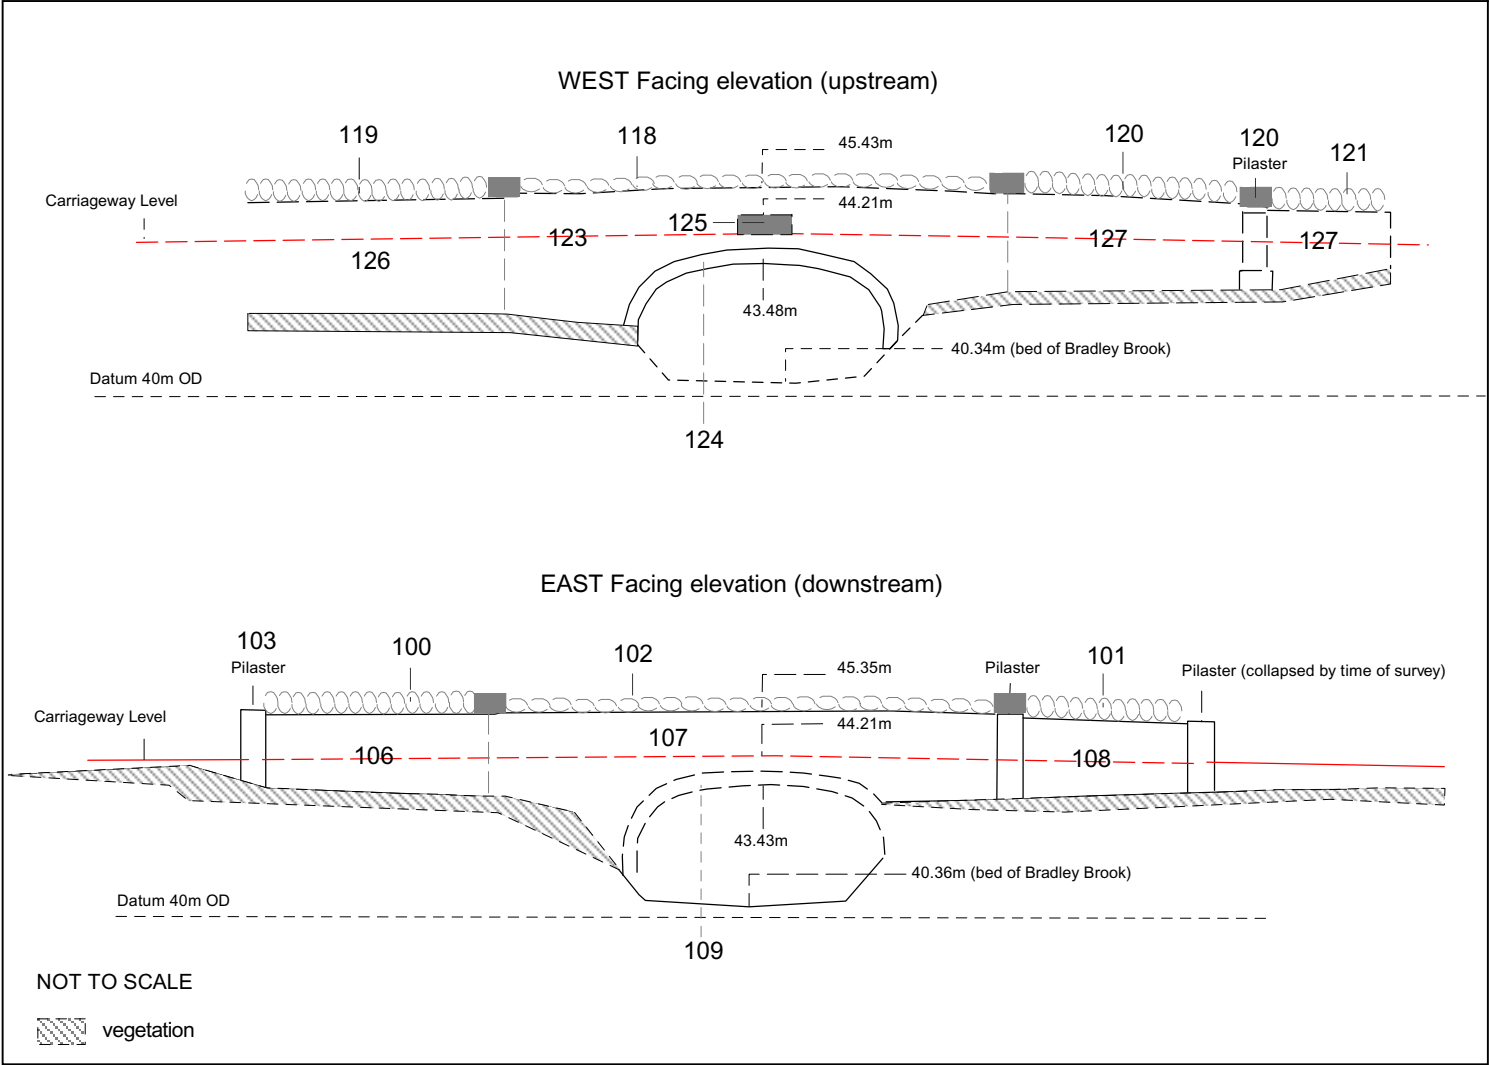
Figure 3
Schematic bridge elevations, showing contexts assigned prior to demolition

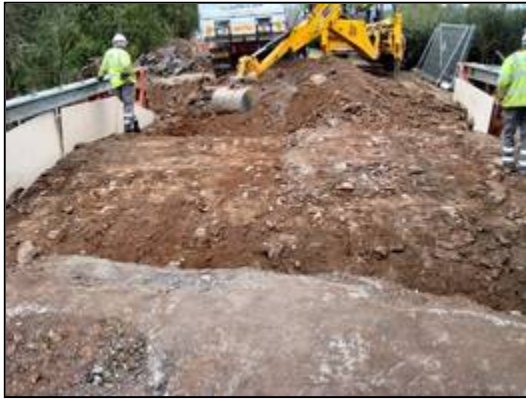
a) View of arch of Bridge, after removal of modern road surface, facing north, showing Context 520 to right of frame and Context 521 to left. No scale.

The most obvious feature revealed during the demolition was a distinction in the fabric of the arch, (pers.comm. Ron Keene, 13.10.11), showing clay bonding to the west of the longitudinal crack and grey mortar to the east (Plate a). The distinction was not traceable in the main fabric of the abutments, which were bonded with an indiscriminate variety of clay- and lime-

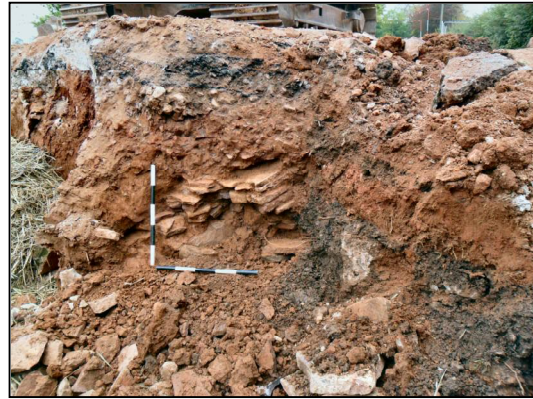
b) Block of masonry, Context 528, to west of retaining wall, Context 108 (in right foreground). North-west-facing view. Scales: 500mm.

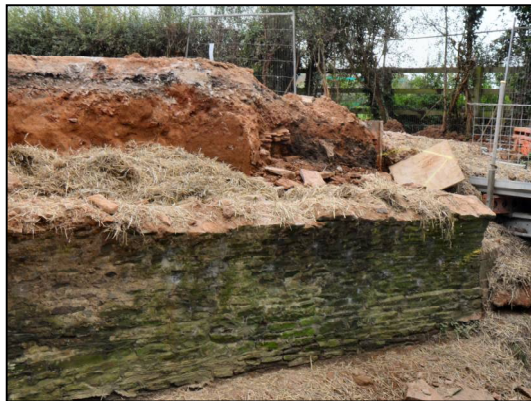
c) North-east facing view of section through redeposited clay to rear (north) of north abutment (Context 129), showing location of Masonry 528. No scale.

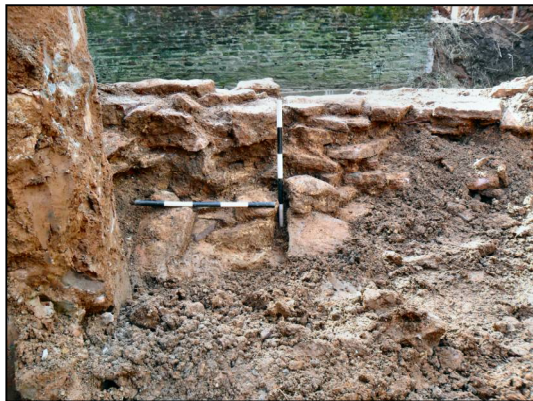
d) Detail of butt joint between Wall 518, to left and Wall 519, to right, facing south. Scales: 500mm.

The lower courses of Wall 518 were observed in north-facing elevation (see Plate d), in the southern face of the above cutting. The wall itself, measuring 270mm wide, rested on a lower foundation course, measuring a further 230mm wide. The fabric consisted of Pennant sandstone slabs, becoming more squared and regular towards the base, bonded with lime-based mortars including a creamy yellow mortar with frequent charcoal and clay, and a hard dark grey mortar. The lower three to five courses of masonry, which were observed in detail, measured a total of 300mm high (plate g). The lowest course was located at approximately 3.6m below the original carriageway level (40.61m a OD).

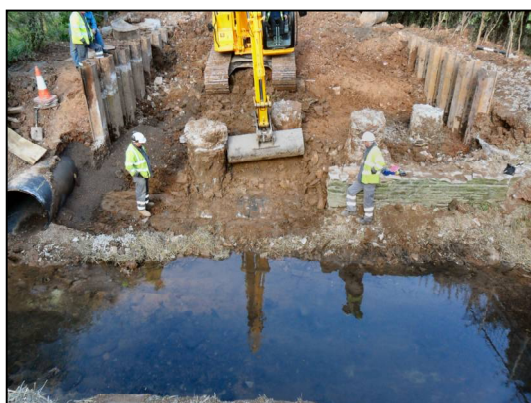
e) North bank of Bradley Brook, from south, showing concrete piles, metal shuttering and butt joint between Walls 518 (to right) and 519 (to left, mostly demolished). No scale.

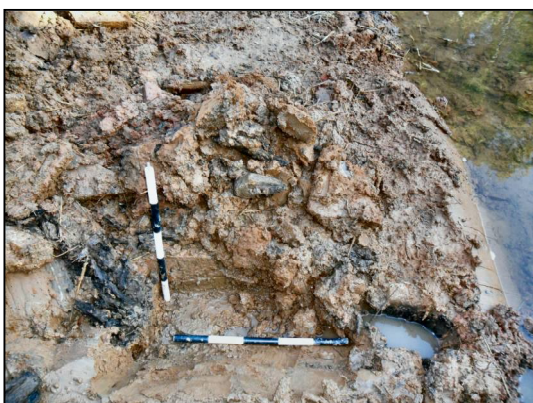
f) West end of Wall 519, from west, showing stepped foundation course and adjacent post-holes, Contexts 516 and 517. Scales: 500mm.

A further reduction in the level of Wall 519 revealed that the base of the masonry rested on a stepped foundation course, extending approximately 200mm beyond the western terminal of the wall (see Plate f). This foundation was flanked by two timber posts (Contexts 517/529 and 516; see Phase Plan, Figure 4b), approximately 160mm in diameter. Post 529, which was marked on its upper surface with the stamp, "TO", was retained for further examination. The foundation itself was located at a depth of between 3m and 4m below the original carriageway level (40.21m a OD and 41.21m a OD) and measured up to 500mm wide (north-south). At foundation level the Pennant sandstone slabs were bonded largely with red clay, but traces of dark grey lime mortar were also visible. It is likely that the foundation courses were trench built within Contexts 500 and 501, but the cut was not observed due to waterlogging.

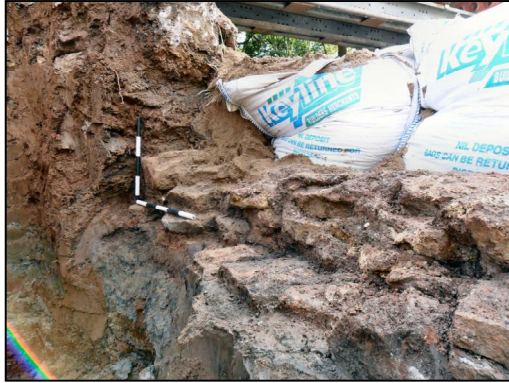
g) View of rear (north) elevation of Wall 518, showing Contexts 501, 500 and 503, from north-west. Scales: 500mm.

Wall 518 appeared to sit within a foundation cut (Context 507), which truncated a thin band of gingery clay (Context 501), visible at the south-eastern corner of the excavated cutting (Plate g). Context 501 overlay a thicker brown silty clay deposit (Context 500), which extended the entire width of the cutting (over 7.5m east-west) and over 1.4m north-south. Context 500

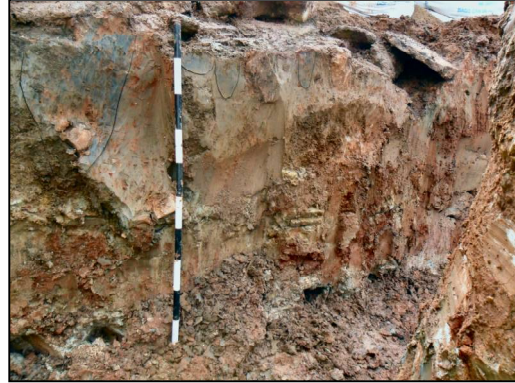
h) Oblique view of four of post-holes to rear of Wall 518, Contexts 510, 511, 512 and 513. These cuts truncate brown silty clay, Context 500. Viewed from north-east. Scale: 1m.

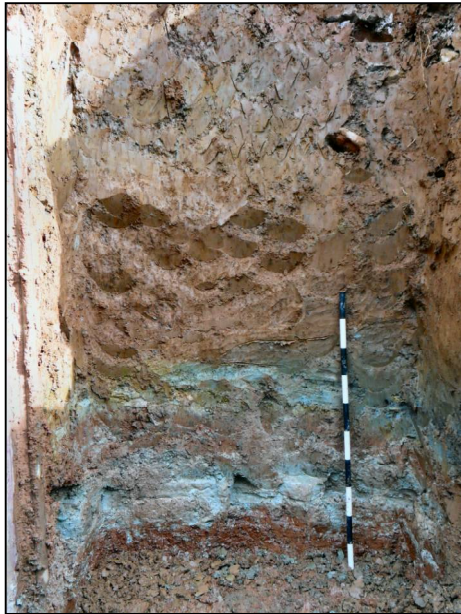
i) East-facing view of sequence of deposits to rear (north) of Wall 518. Shows Context 500, truncated by Cut 507 and Context 503, truncated by Cut 504. Scale: 1m.

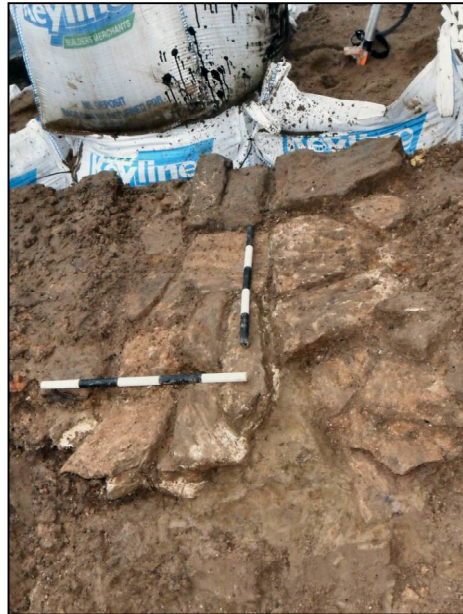
j) Butt joint between Wall 601, in Cut 607, to right and Wall 602, in Cut 605, to left. Viewed from south. Scales: 500mm.

The butt joint between the two walls, located at approximately 3.8m to the west of the east end of Wall 601, was revealed clearly on removal of the upper foundation courses. In section, Wall 602 was shown to be sited within a stepped cut (Context 606), measuring over 270mm deep, declining to the west. Wall 601 could be seen to be sited within a similarly stepped cut (Context 607), declining to the east, of slightly greater depth. It was not possible to determine which of the two cuts was the earlier.

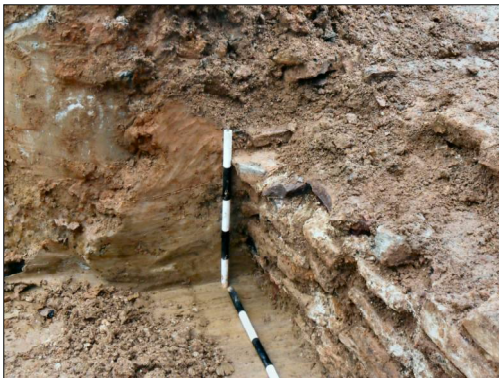
k) North-west-facing view of Wall 601, Foundation Cut 604 and Contexts 603 and 605. Scales: 500mm.

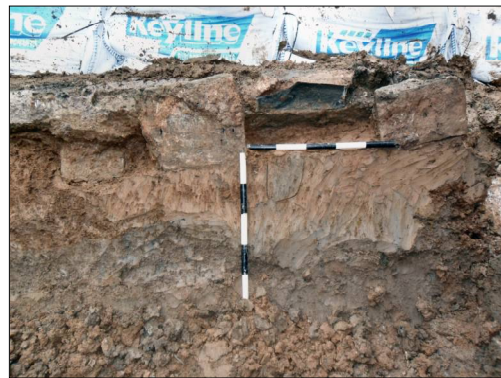
l) North-facing view of Post-hole 608, with concrete sill and remnants of Wall 602 to rear. Scales: 500mm.
