**Archaeological Survey and Recording
at
The Former Concorde Lodge, Kellaway Avenue,
Horfield, Bristol**

Bristol HER 24802
Centred on NGR ST 5904 7658

By
Kevin Potter
With contributions by
Dr Nick Corcos, Dr Alejandra Gutierrez,
Lorrain Higbee, Dr Harriet Foster
Matt Law and Sarah Newns

Avon Archaeological Unit Limited

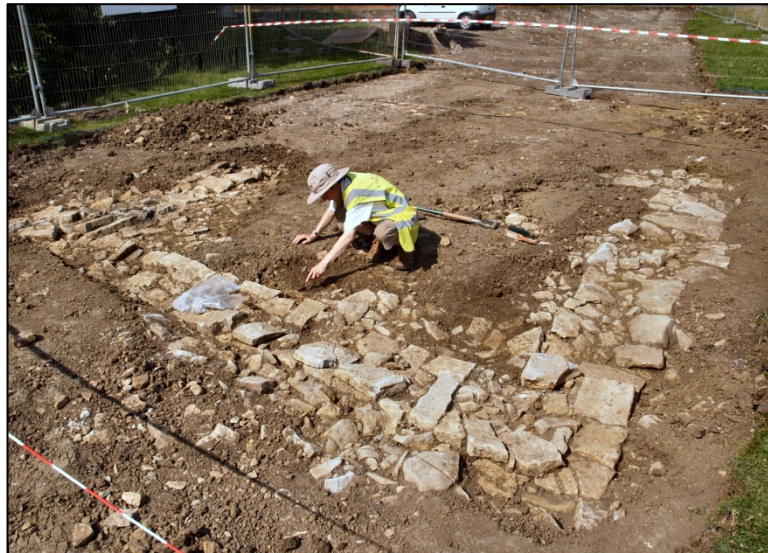
Plate 2. Structure 'A' looking northeast

During monitoring of topsoil stripping for the temporary access road, the remains of a masonry structure (*Structure A, Plate 2, Fig 8*) was located at the road entrance on the west side of Wellington Hill, roughly 137m north-east of the Concorde Lodge building. It comprised the remains of three walls (103, 105 & 106) that in plan formed a broken U-shape

orientated roughly east to west with the end wall (105) aligned north to south. The masonry was preserved to a maximum of two courses although in the main only a single course remained. It was built from random coursed, roughly hewn, tabular rubble lining a smaller limestone rubble core measuring an average of 0.6m wide. The south eastern wall (103) was broken by a stepped opening (104), possibly

reflecting the position of a doorway. The north-western wall (106) ended abruptly after roughly 3m, although no obvious cut was identified. A small stub of lias limestone masonry (115) protruding from the north-eastern baulk, appeared to continue the trajectory of Wall 106 and perhaps reflected a later re-build or modification, which involved the partial demolition of Wall 106 and subsequent replacement by Wall 115. Surrounding the remains of the building was a spread of lias limestone rubble (107 & 113) which appeared to reflect collapsed masonry from the structure. However, the internal spread (107) had a more even surface and regular distribution, suggesting that it may have represented the remains of an internal stone surface. The structure almost certainly continued further east, beyond the limits of the area excavated, where it was not uncovered because excavation for the temporary access road was not required in that area and the structure could remain preserved in situ.

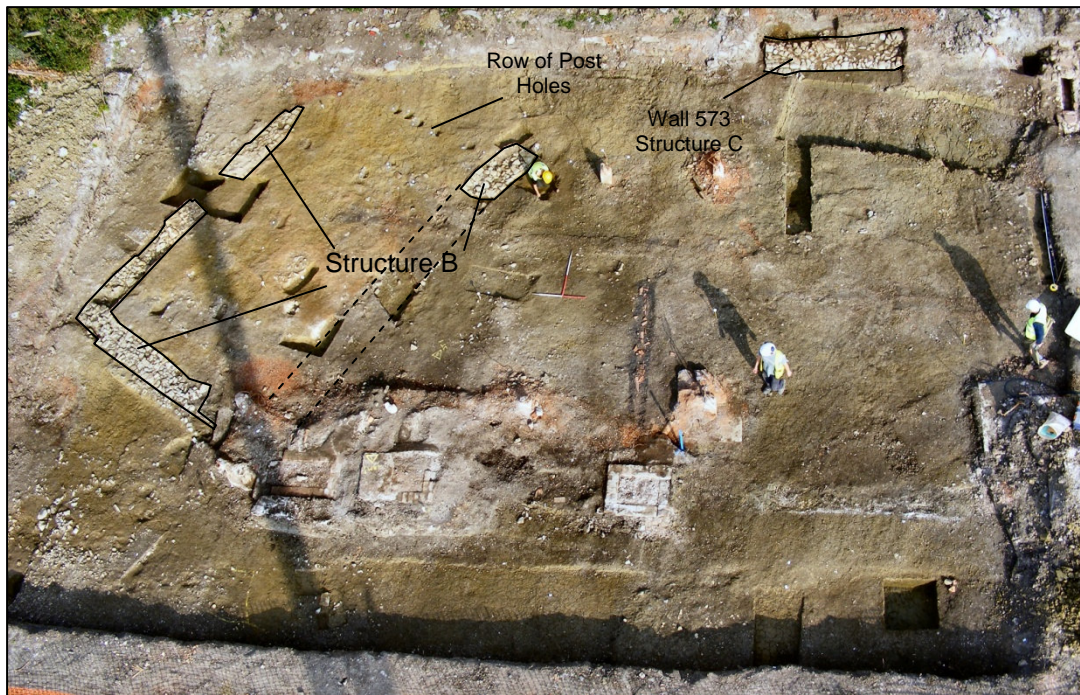
Plate 3. Excavation Area 1, viewed from crane looking north

Excavation Area 1 (**Plate 3, Figs 9 and 13**) revealed partial remains of two distinct limestone masonry structures. The largest (Structure B) comprised three walls (Walls

501, 502 & 507) forming the south-western end of a large rectangular building, whose shallow foundations were cut directly into the underlying natural clay. The long axis of the building was orientated north-east to south-west to 8.7m long, as preserved. It was built from limestone rubble, bonded in a matrix of olive brown (natural) clay, forming walls of roughly 0.65m width. The upper masonry, which was preserved in patches to a maximum of three courses, had roughly hewn facing blocks laid in a random coursed pattern surrounding a rubble core. Occasional patches of a sandy red brown clay mortar were visible in the uppermost courses.

The position of an internal division was indicated by a line of postholes (543, 545, 547 & 570, **Plate 3, Figs 9 and 14.2 - 14.5**). They formed a straight line spanning the north-east end of the building at a right angle to the walls. The interior of the building had been reduced to the level of the natural clay, which had a slightly different colour to that on the exterior, possibly due to different environmental conditions within the building. Patches of a thin, slightly sandy red-brown clay layer (563), were preserved over the natural clay and possibly reflected the remnants of a rammed clay floor. A further five postholes were cut through the natural clay within the building, although their distribution was not so obviously indicative of any structural feature. Four of them, 514, 516, 558 & 612 (**Fig 13**), could be argued to form the corners of a rectangle parallel with the walls of the building. Two spreads of collapsed masonry from the medieval walls (552 and 554, **Fig 9**) were located on the western side of Wall 501 and the eastern side of Wall 507. Excavation of these deposits produced sherds of c16th century pottery alongside residual medieval sherds and a single, probably intrusive, sherd of c18th century North Devon ware.

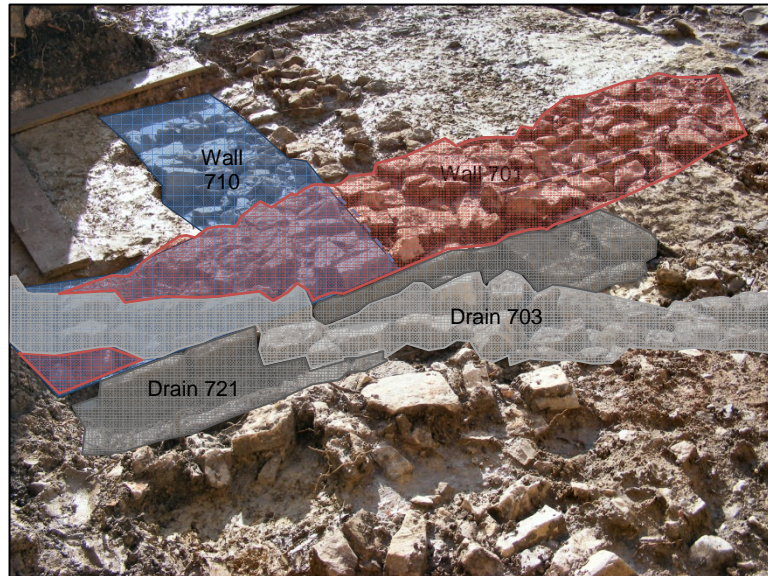
Plate 4. Excavation Area 2. Walls 701 and 710 and drains 703 and 721

Structure C as a whole (**Plate 3, Figs 9, 10 & 11**) comprised four walls (701, 702, 710 & 747) in Excavation Area 2 plus Wall 573 in Area 1, which appeared to reflect the western end of a rectilinear stone building. Excavation indicated that the building had two phases of construction. The earlier phase was represented by Walls 710 and 747 (**Plates 4 and 5, Figs 10 and 11**), which together formed the northwest corner of a building that underlay Wall 701. Wall 710 was 3.3 m long as exposed and wall 747 was 2.8m long as exposed. Both were c0.8m wide. Generally only a single course of either wall remained. In construction they resembled the medieval walls found in Excavation Area 1 and were built from limestone rubble, faced with roughly hewn blocks.

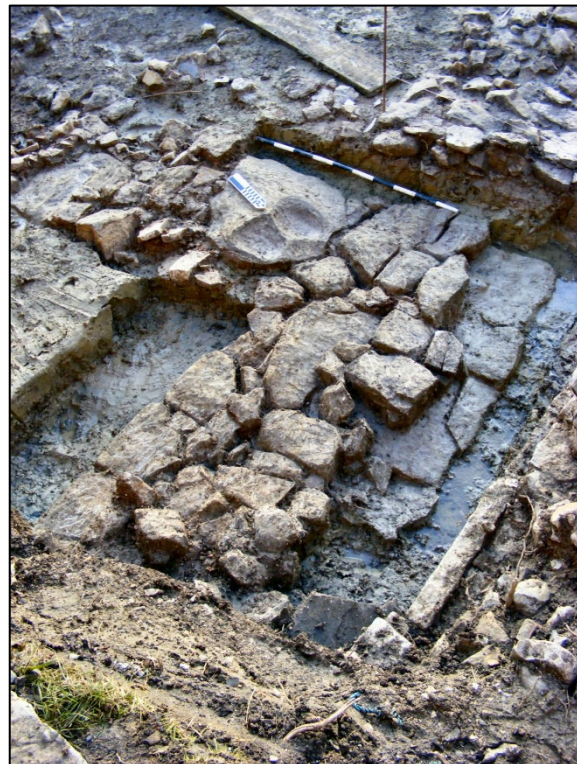
Plate 5. Excavation Area 2. Walls 710 and 747

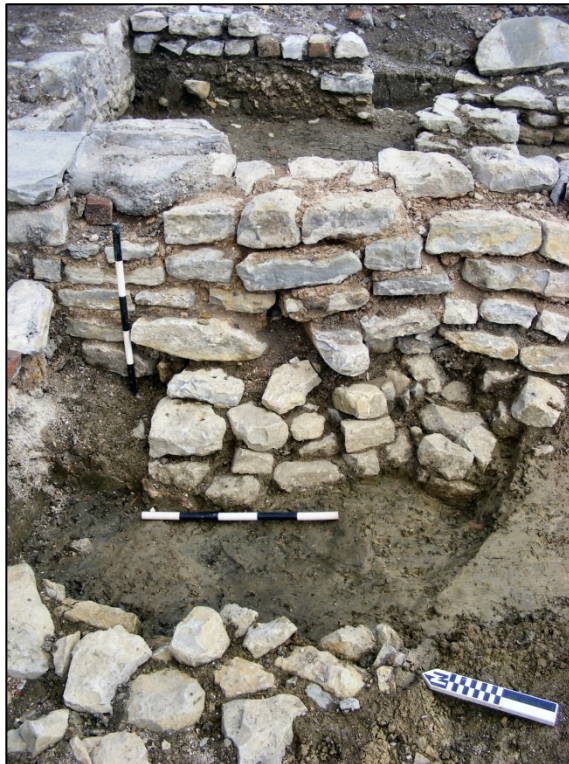
Plate 6. Excavation Area 3. Wall 1072 in section below wall 1007

Excavation Area 3 revealed the partial foundation of a single medieval limestone rubble wall (Wall 1072, **Plate 6, Fig 12**) orientated approximately south-east to north-west. It underlay Wall 1007, which itself formed part of 17th century Structure D (see below. **Figs 7 and 12**) The northern end of the wall was truncated by a 19th century wall (106), which formed part of Concorde Lodge. In construction the medieval masonry was similar to the medieval structures recorded in Excavation Areas 1 and 2 comprising limestone rubble in a matrix of re-deposited natural clay, forming a wall c 0.7m wide. It was truncated at both ends leaving only a 3.6m length exposed.

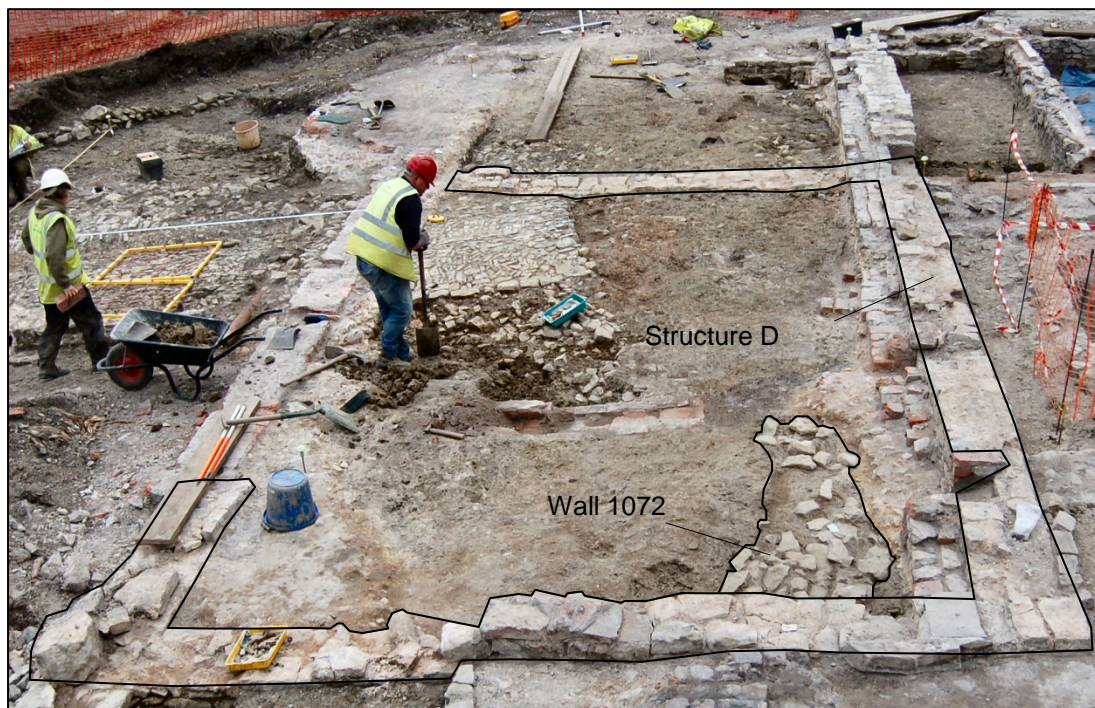
Plate 7. Excavation Area 3. Structure D looking west.

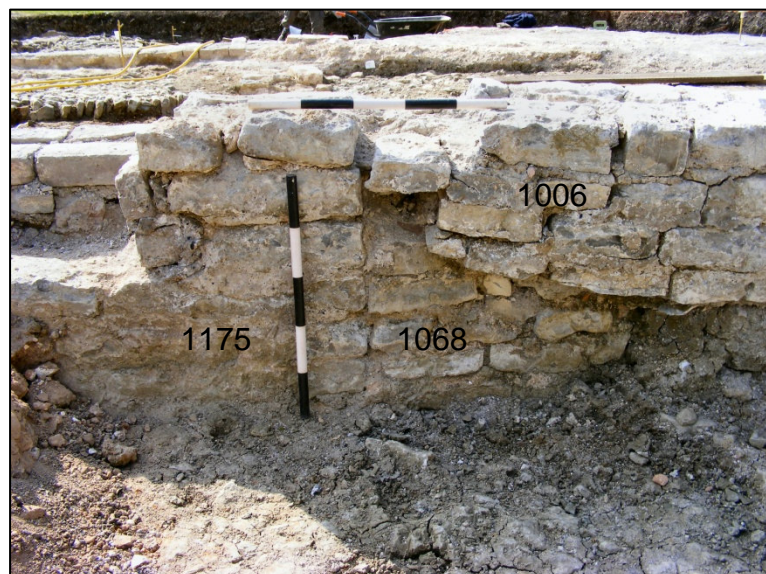
Plate 8. Excavation Area 3. Detail of Relationships Between 1006, 1068 and 1076

Wall 1006 spanned the width of the Lodge at its southern end,

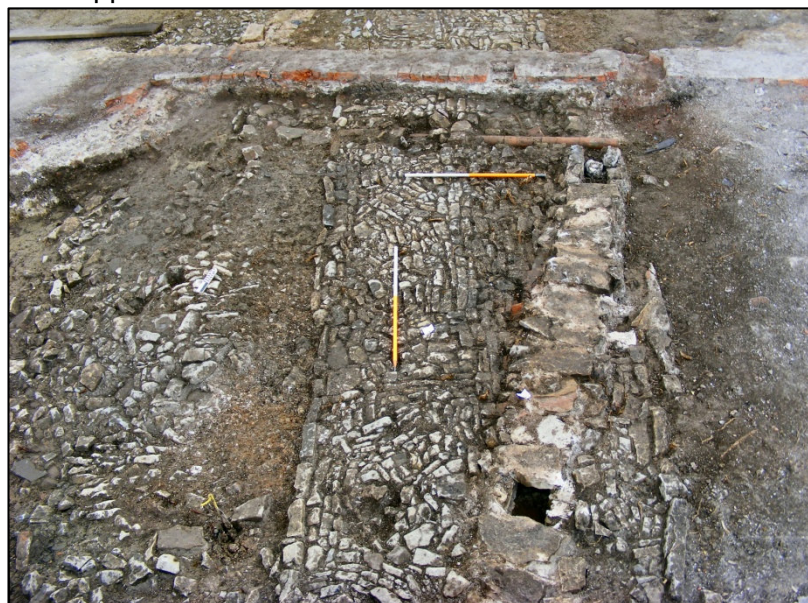
Plate 9. Excavation Area 3. Cobbled Pathway 1015. Looking North

On the southern side of Concorde Lodge, within Excavation Area 3, and below its southern extent, a number of 19th century garden features were located. The best preserved and most extensive was a cobbled path (1015, **Plate 9, Figs 12 and 16.1**), which ran roughly north to south from the rear of the

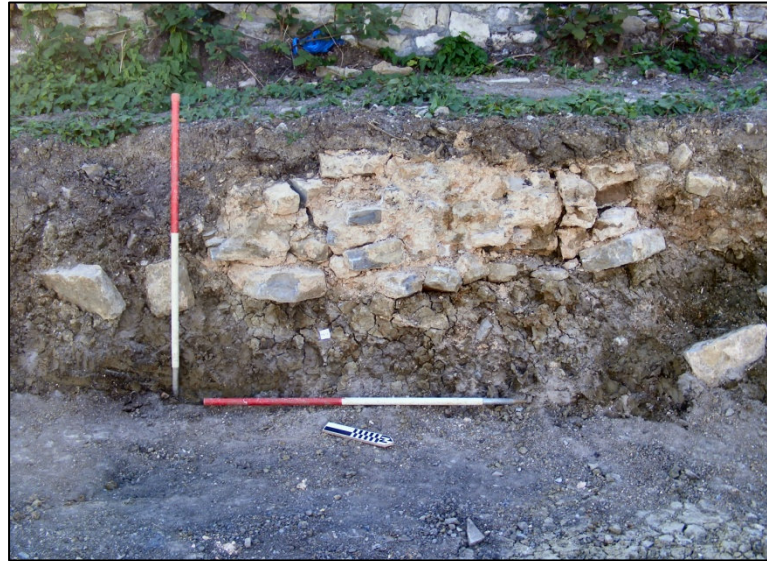
Plate 10. Wall 310 looking west

In addition to Structure A the watching brief monitoring identified a number of post medieval features. Two walls were recorded just beyond the southern limits of Excavation Area 1. The earliest was part of a north to south aligned wall (310, **Plate 10, Fig 9**) comprising partial remains of four courses of random coursed limestone rubble bonded with pink-brown lime mortar. It was

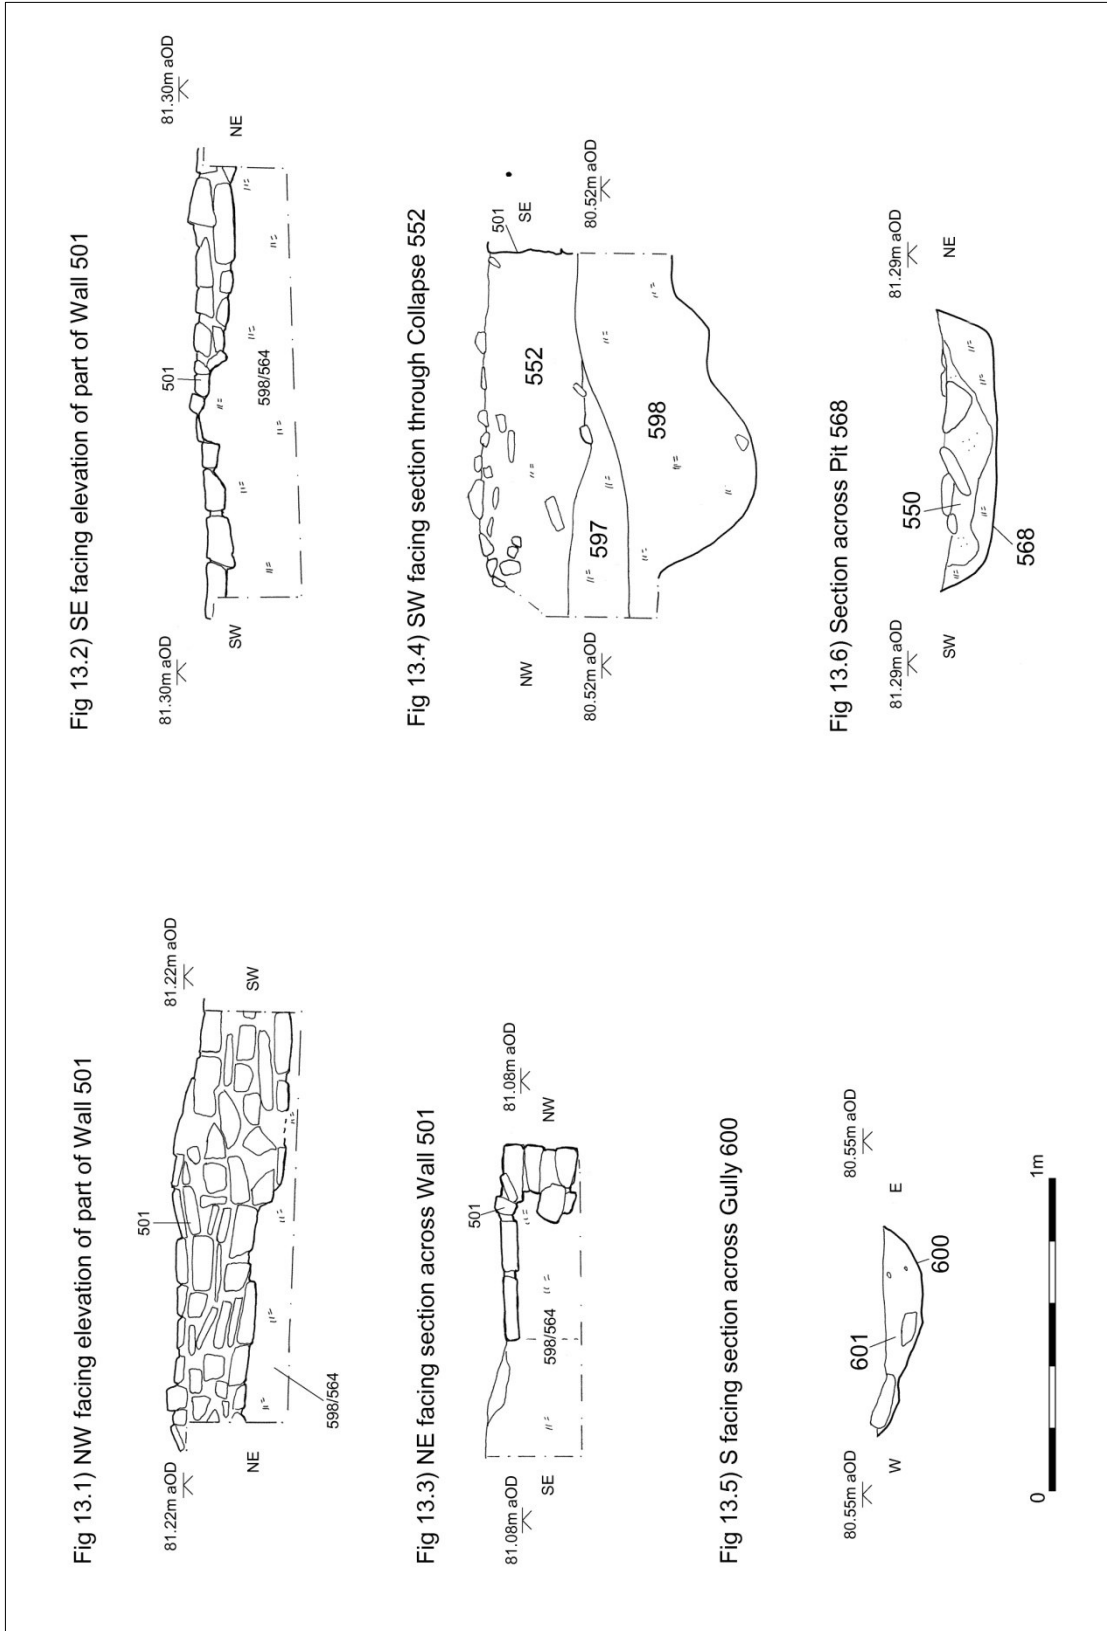
Fig 13.2) SE facing elevation of part of Wall 501

Fig 13. Section from Excavation Area 1

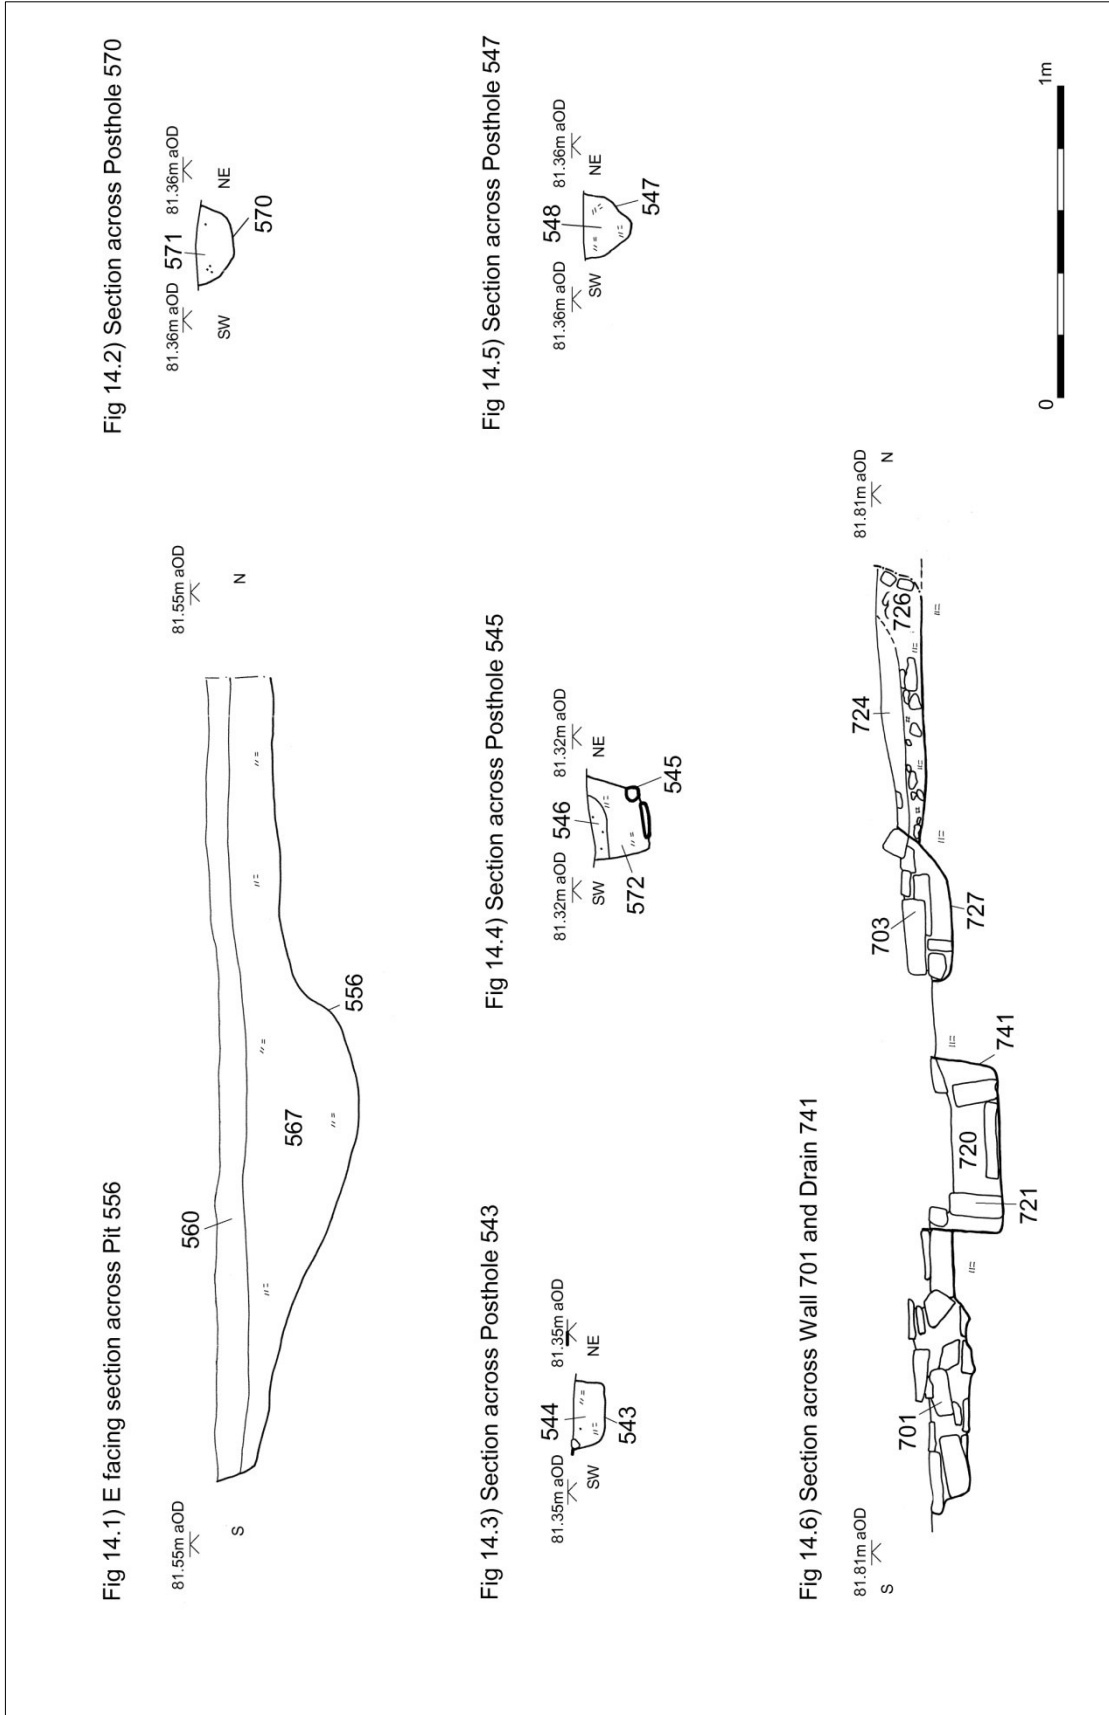
Fig 14. Sections from Excavation Areas 1 and 2

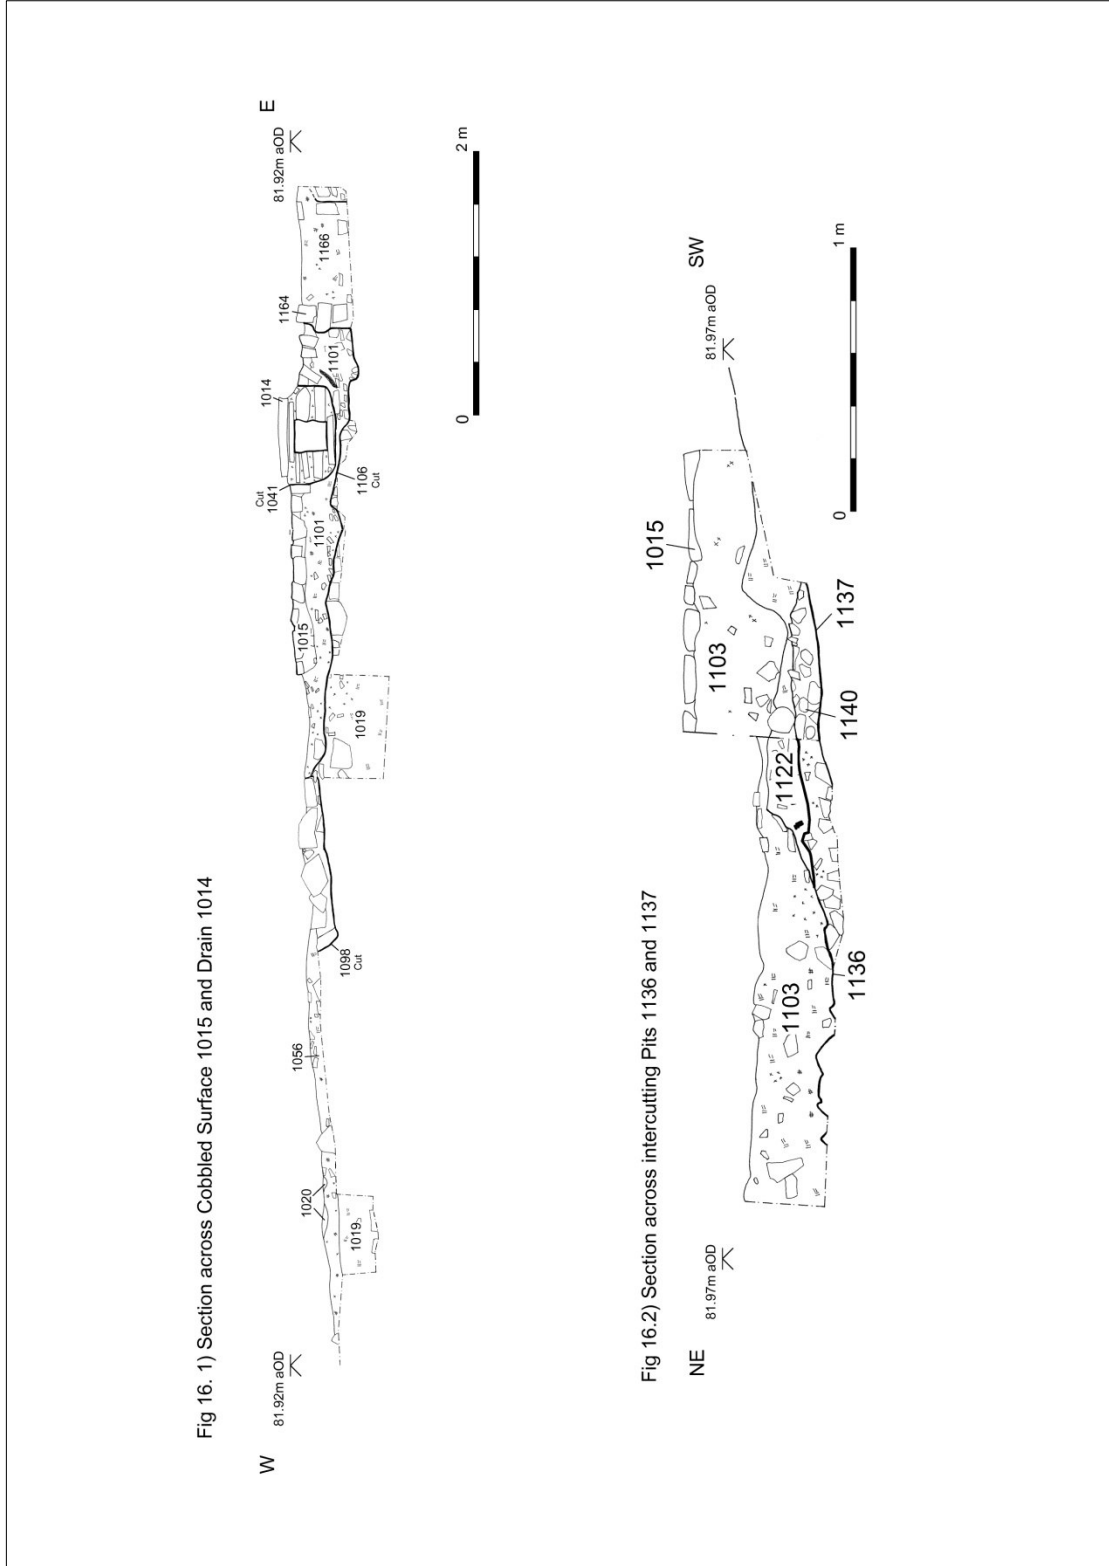
Fig 16. 1) Section across Cobbled Surface 1015 and Drain 1014

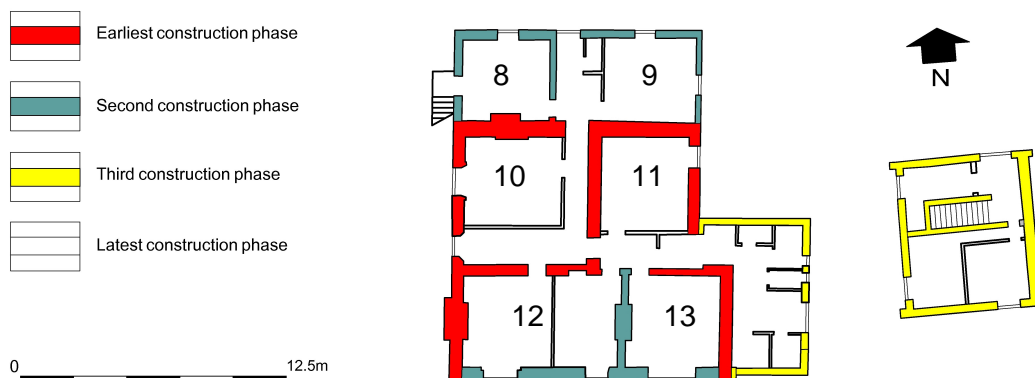
Fig. 18 Concorde Lodge, Phased First Floor Plan

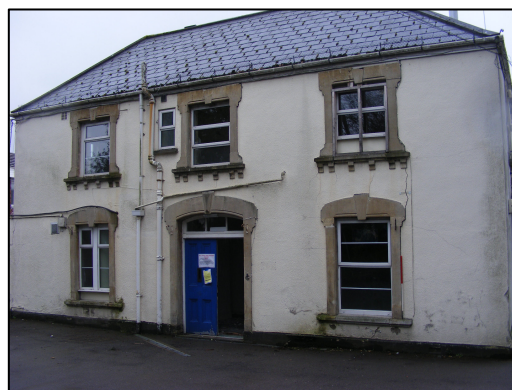
Plate 11. Building A. The north facing facade

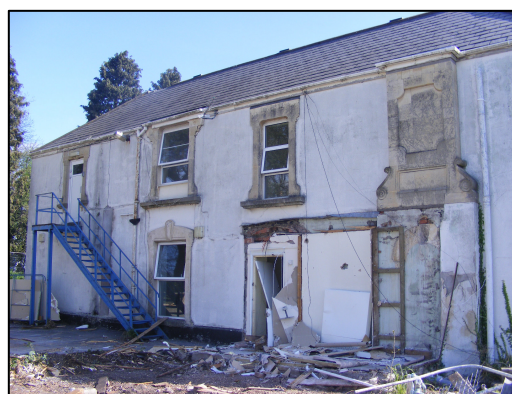
Plate 12. Building A. The west facing elevation

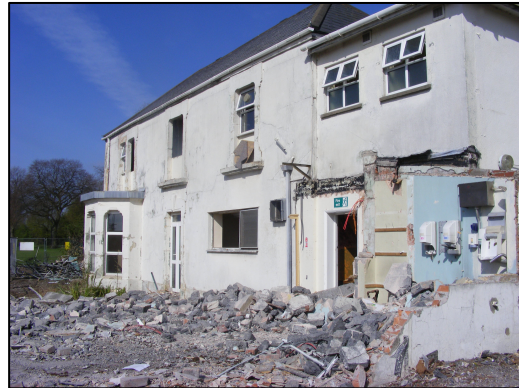
Plate 13. Building A. The south facing elevation

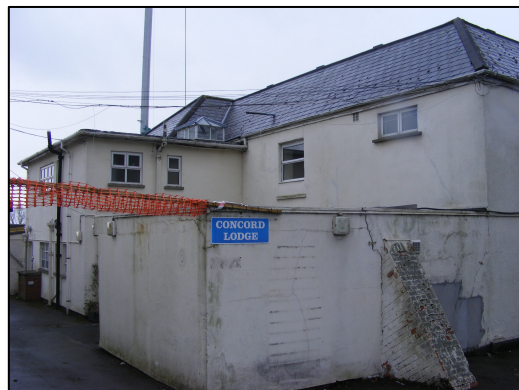
Plate 14. Building A. The east facing elevation

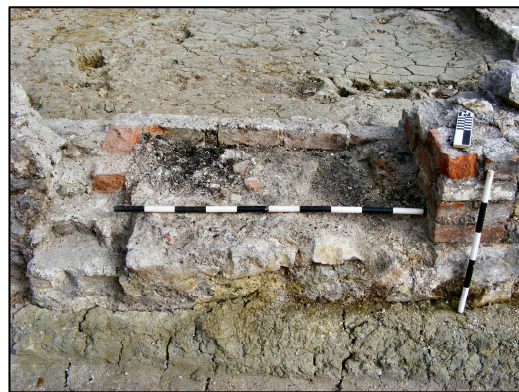
Plate 17. Detail of fireplace in room 4 uncovered during the Area 3 excavations

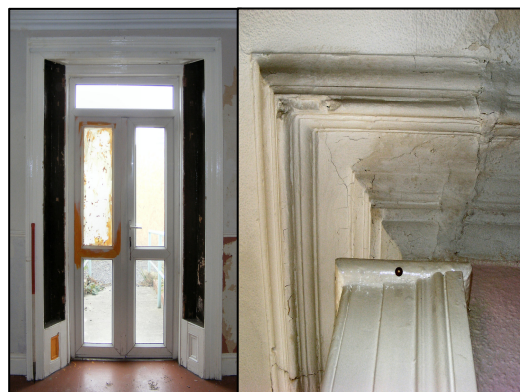
Plate 18. Details of wooden boxing and corning in room 6

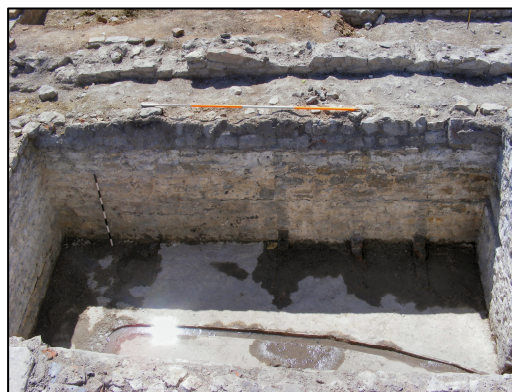
Fig 19. View of the cellar recorded in Excavation Area 3. Looking east
