Nos. 5 & 6 Kingsdown Parade  
&  
15 Marlborough Hill, Kingsdown, Bristol

Archaeological Evaluation & Recording Project  
(NGR ST 518 736)

ARCHAEOLOGICAL EVALUATION & RECORDING PROJECT

Report Prepared by:  
Kevin Potter BA (Hons)  
Avon Archaeological Unit Limited  
Bristol  
April 2010

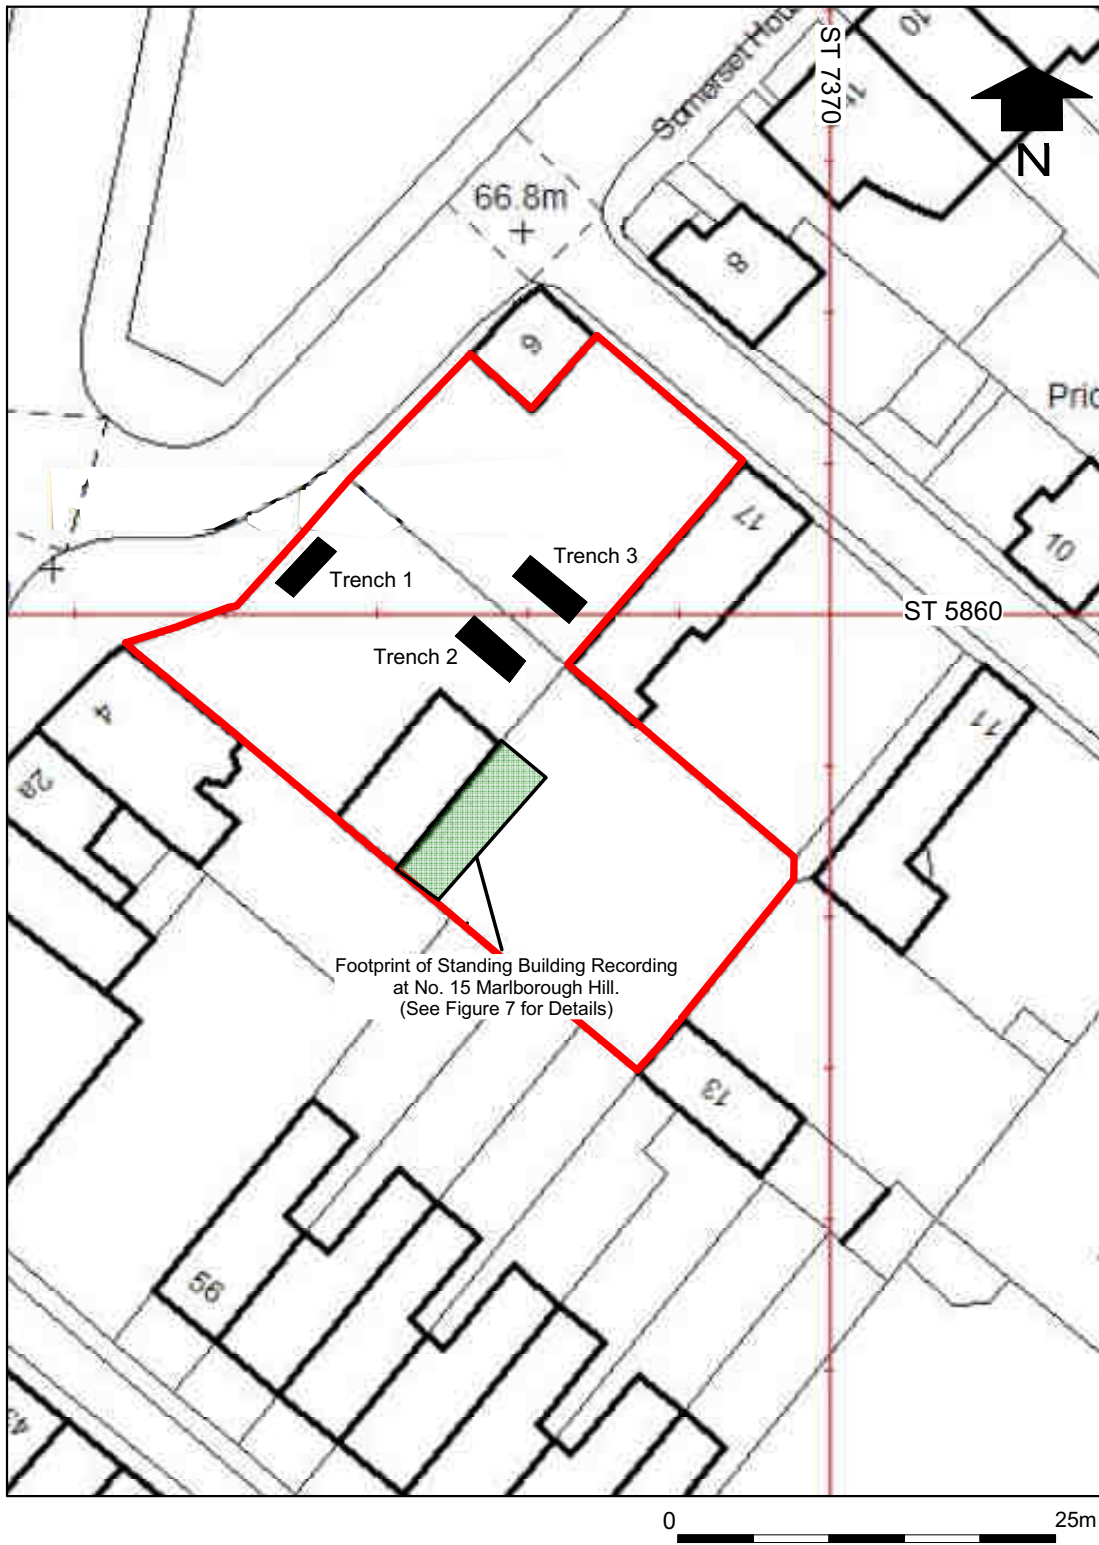
Figure 2

Boundary of the study area with Location of the Building recording at 15 Marlborough Hill & the Evaluation Trench Locations

- 4.1 Three trenches (**Figure 2**) were excavated and a fourth is programmed for excavation at a later date. Trenches 1 and 2 were located in the former garage forecourt of No. 5: Trench 1 was at the front of the site, aligned NE - SW, parallel with the street; Trench 2 was aligned NW - SE located towards the rear of the site and Trench 3 was located in the rear garden of No. 6, aligned NW - SE, alongside the boundary wall between Nos. 5 and 6. Each trench measured approximately 5 m by 2 m.

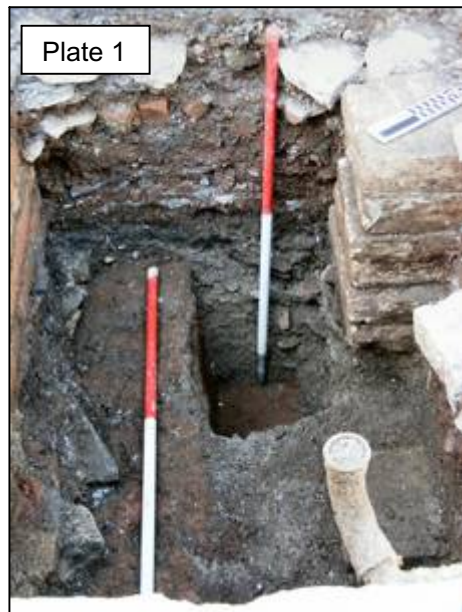
- 4.3 The natural was cut (**Figure 5**) by a linear feature (**124**) running SE-NW across the trench. Excavation of feature **124** showed that it had a vertical edge on its south western side and was roughly 0.44m deep, though its complete width could not be excavated as it was truncated by modern concrete tank 105. The fill (**123**) was a mid grey ash rich deposit containing occasional angular stones, up to 0.1 m diameter, frequent charcoal flecks and pieces of light coloured mortar. Unfortunately no dating evidence was recovered from the deposit though its composition and stratigraphic position suggest it was likely to be of 18<sup>th</sup>-19<sup>th</sup> century date.

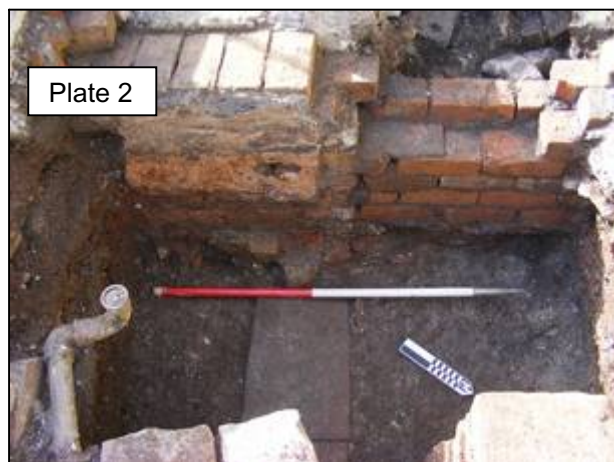
- 4.4 Running parallel with Cut **124**, on its SW side, were the lower courses of a red brick wall, (**115, Plate 2**) with mid grey ash mortar and clad with a grey ash render. The bonding material and render, suggest that the original parts of the wall (it had been partially re-built) were of c.19th century origin. A small section of embossed wallpaper (**Plate 3**) was visible, attached to the render. Its presence indicates that the rendered, NE facing, side of the wall was an internal elevation and that the building was likely to have been a dwelling. There is a strong correlation between the location of wall 115 and

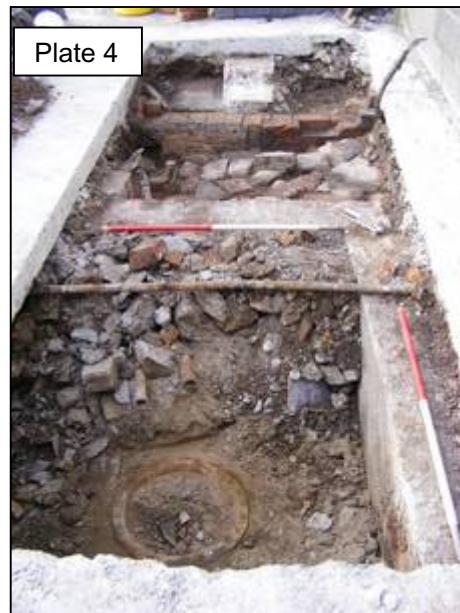
- 4.6 Most of the trench was occupied by 20<sup>th</sup> century structures and deposits (**Figures 5 & 6**) related to the former petrol garage which occupied the site. Most significantly the NW half of the trench was taken up entirely by a concrete tank (**105**, **Plate 4**) containing a metal petrol tank (**103**) filled with modern rubble (**102**). The SE end of the trench, abutting the SE facing side of **115**, was also occupied by a modern concrete structure (**117**) and a modern deposit of heavy rubble (**116**). It is worth noting that within the structure of concrete tank **105** was a stack of carefully cut and finished rectangular bath stone blocks (**110**, **Figure 5**). Whilst obviously re-used it would be fair to speculate that they were taken from a nearby structure, and could relate to a building that had previously stood on the site.

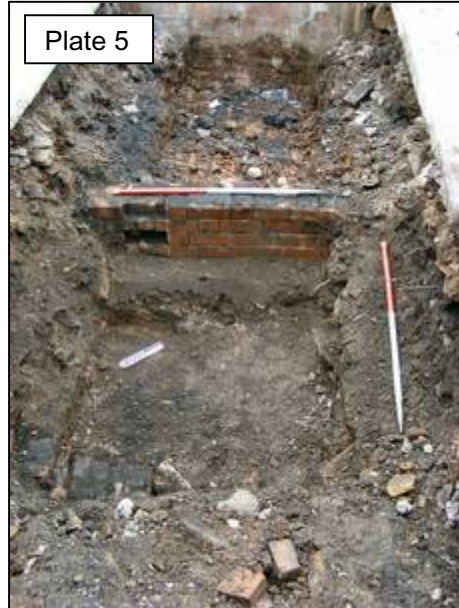
The structure comprised two parallel walls **205**, which, as indicated above, ran across the centre of the trench and a second (**206**) crossing the NE end of the trench. Both walls were bonded with black ash mortar and were not constructed with much care. It is possible that they are the remains of an air raid shelter, indicated by the presence of corrugated metal roofing, which had been reinforced with thick concrete, within the backfill surrounding the walls.

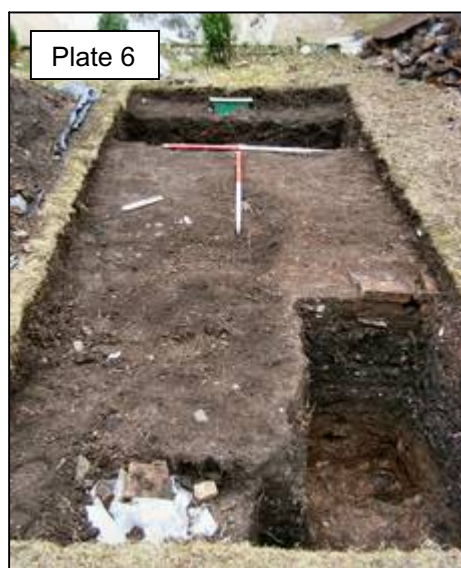
- 4.12 Natural **309** was sealed by a 0.2m thick deposit (**308**) of re-deposited natural mudstone, containing occasional small angular stones, charcoal flecks and pieces of red brick. This deposit was, in turn, sealed by a layer (**307**) of very hard, compacted light brown gravel. Directly overlying the natural, within deposit **308**, was a thin lens of very light grey mortar which may possibly have been evidence of a former surface, however there was insufficient evidence to determine.

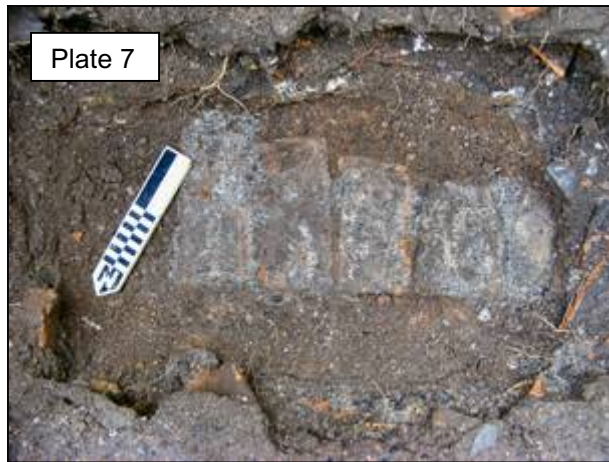
- 4.15 A large deposit (**304**) of silt mixed with rubble including red brick, ceramic roof tile, stone and 19<sup>th</sup>-20<sup>th</sup> century pot, formed the bulk of the material excavated in sondage B (**Figure 5**). Sealed by deposit **304**, which was roughly 1.6m thick, were the remains of a possible structure (**311**), in the form of a line of three red bricks and 2 pieces of roughly hewn stone. They were orientated NE-SW and were very loosely bonded with a light grey ashy mortar. Structure **311** sat atop a buried soil layer (**313**) which was a red-brown silt with some mortar content. Unfortunately the depth of the sondage made it impractical, and unsafe to excavate further and no dating evidence was retrieved from the deposit.

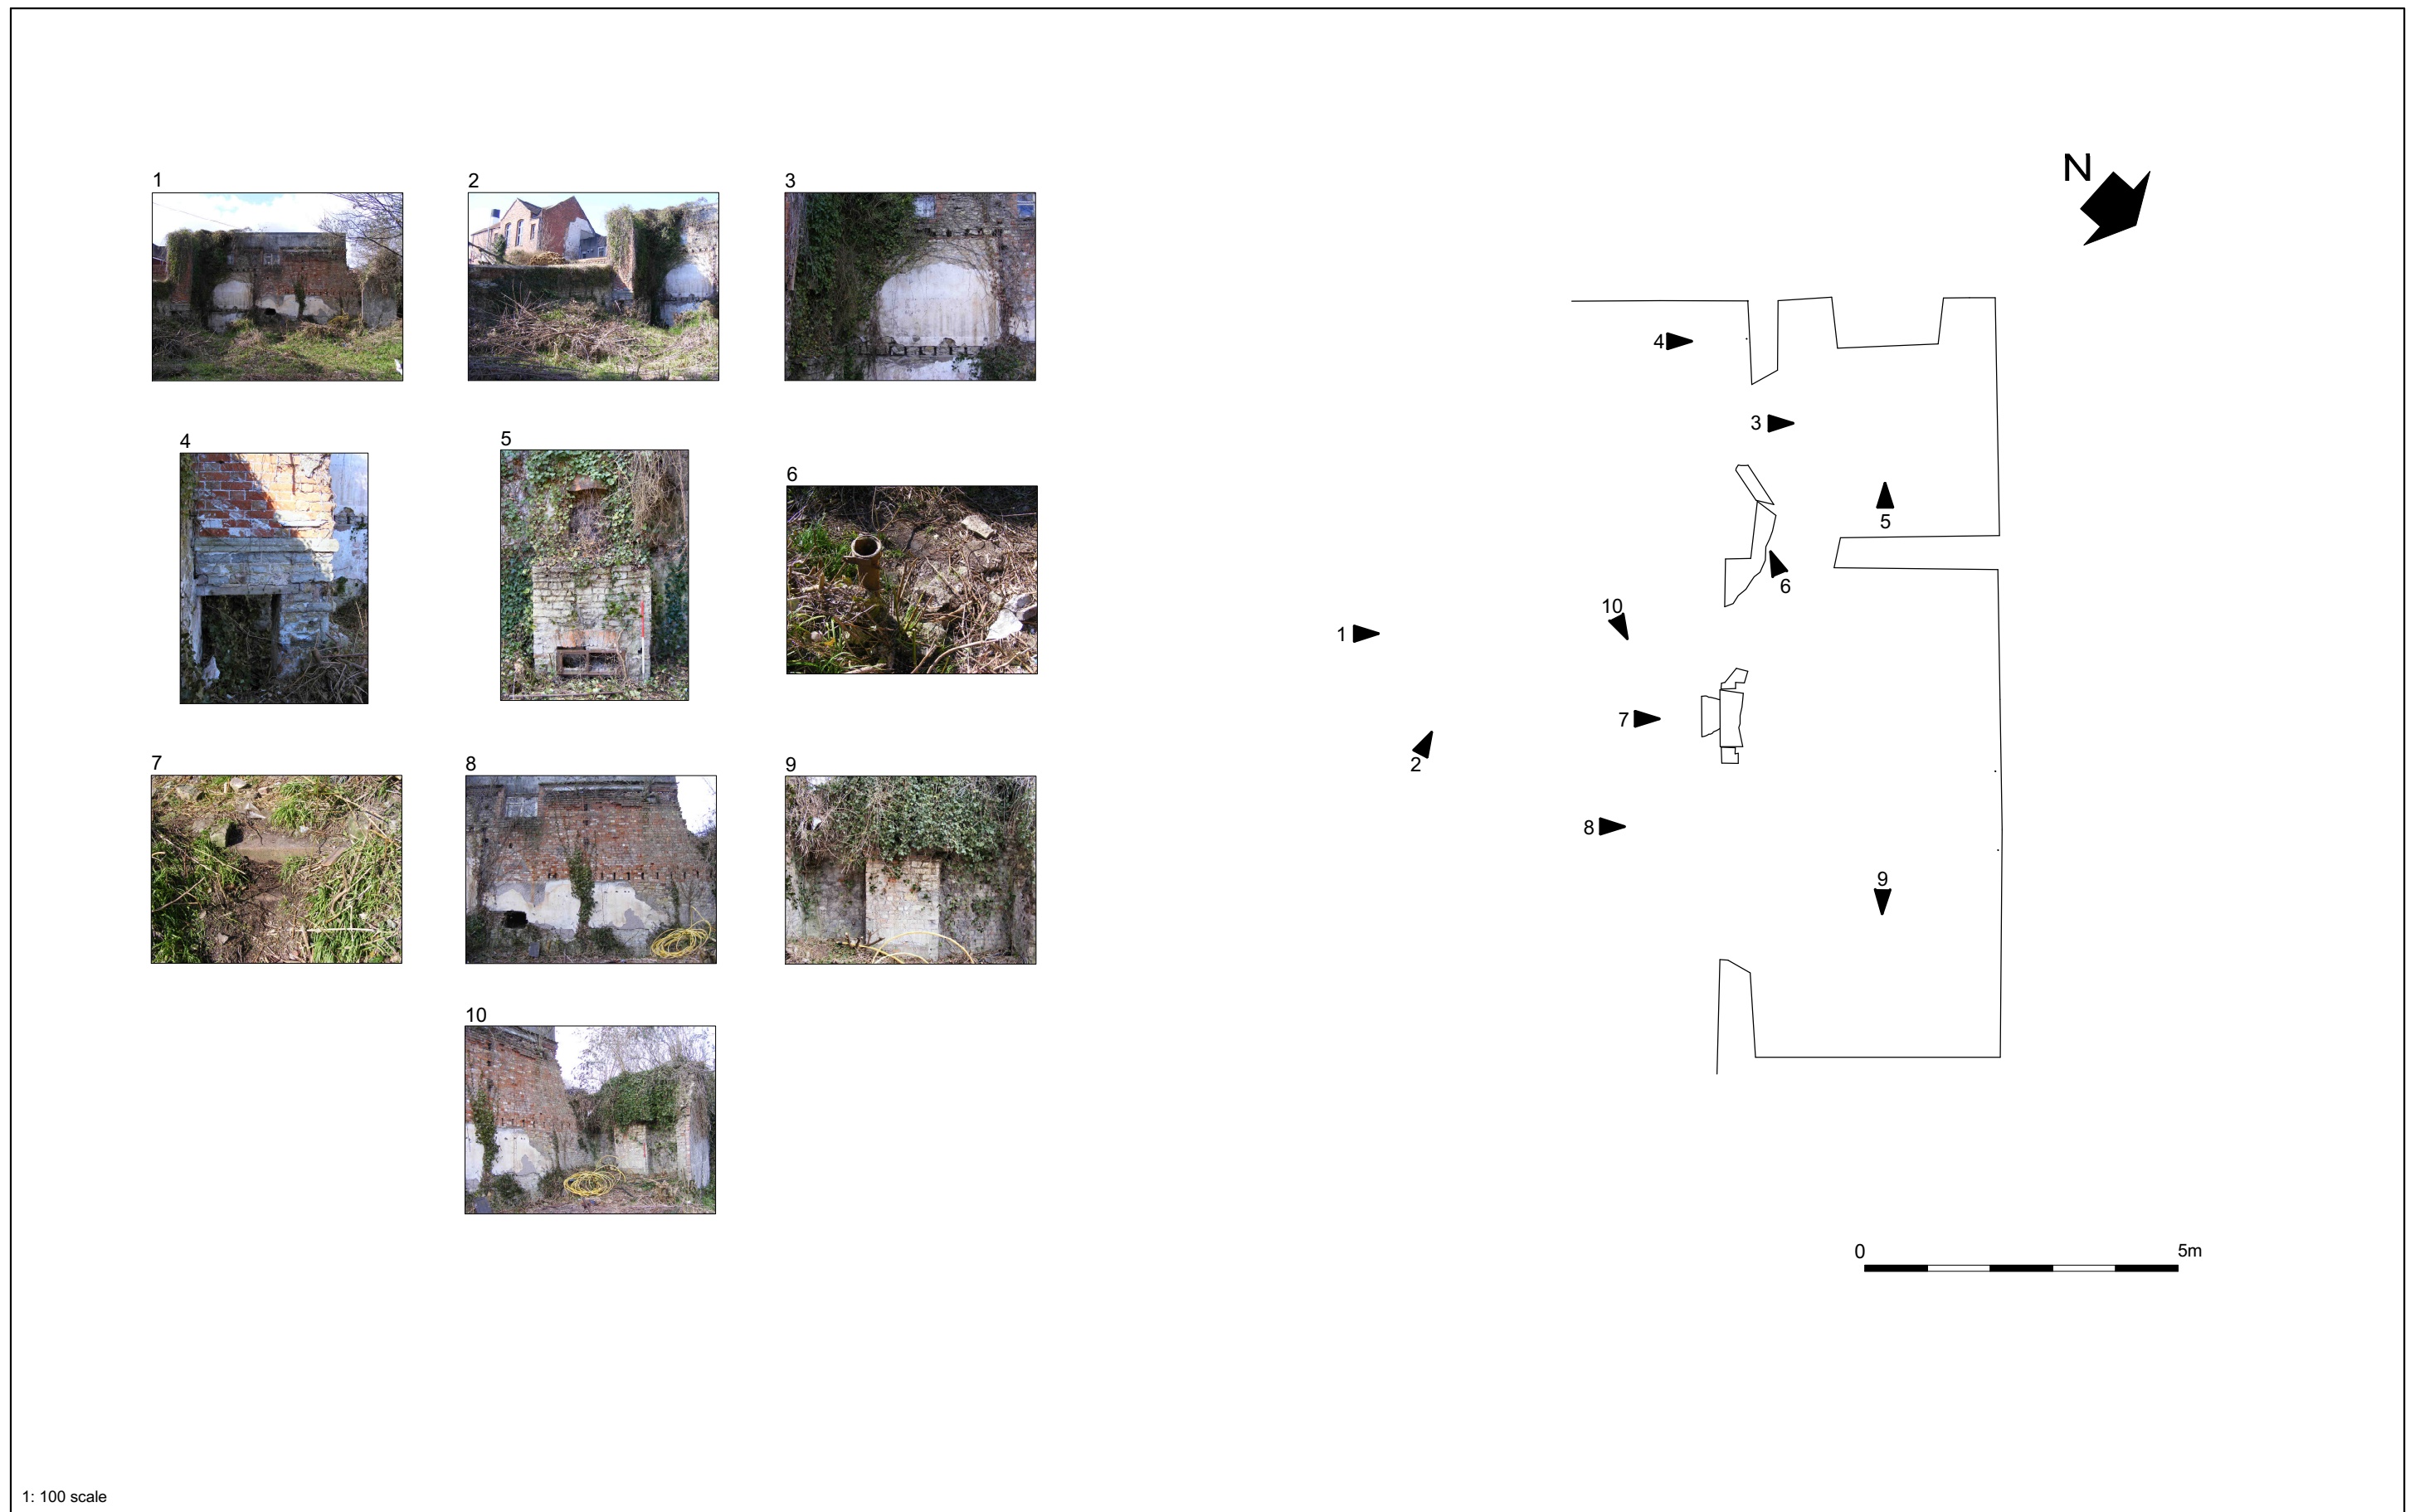
Figure 7

Ground Plan of No. 15 Marlborough Hill with Selected Views

- 5.1 The survey recorded all of the above ground remains of No. 15 Marlborough Hill. Dimensions can be taken from the scale plans and elevations at the back of the report. (**Figures 7-10**)

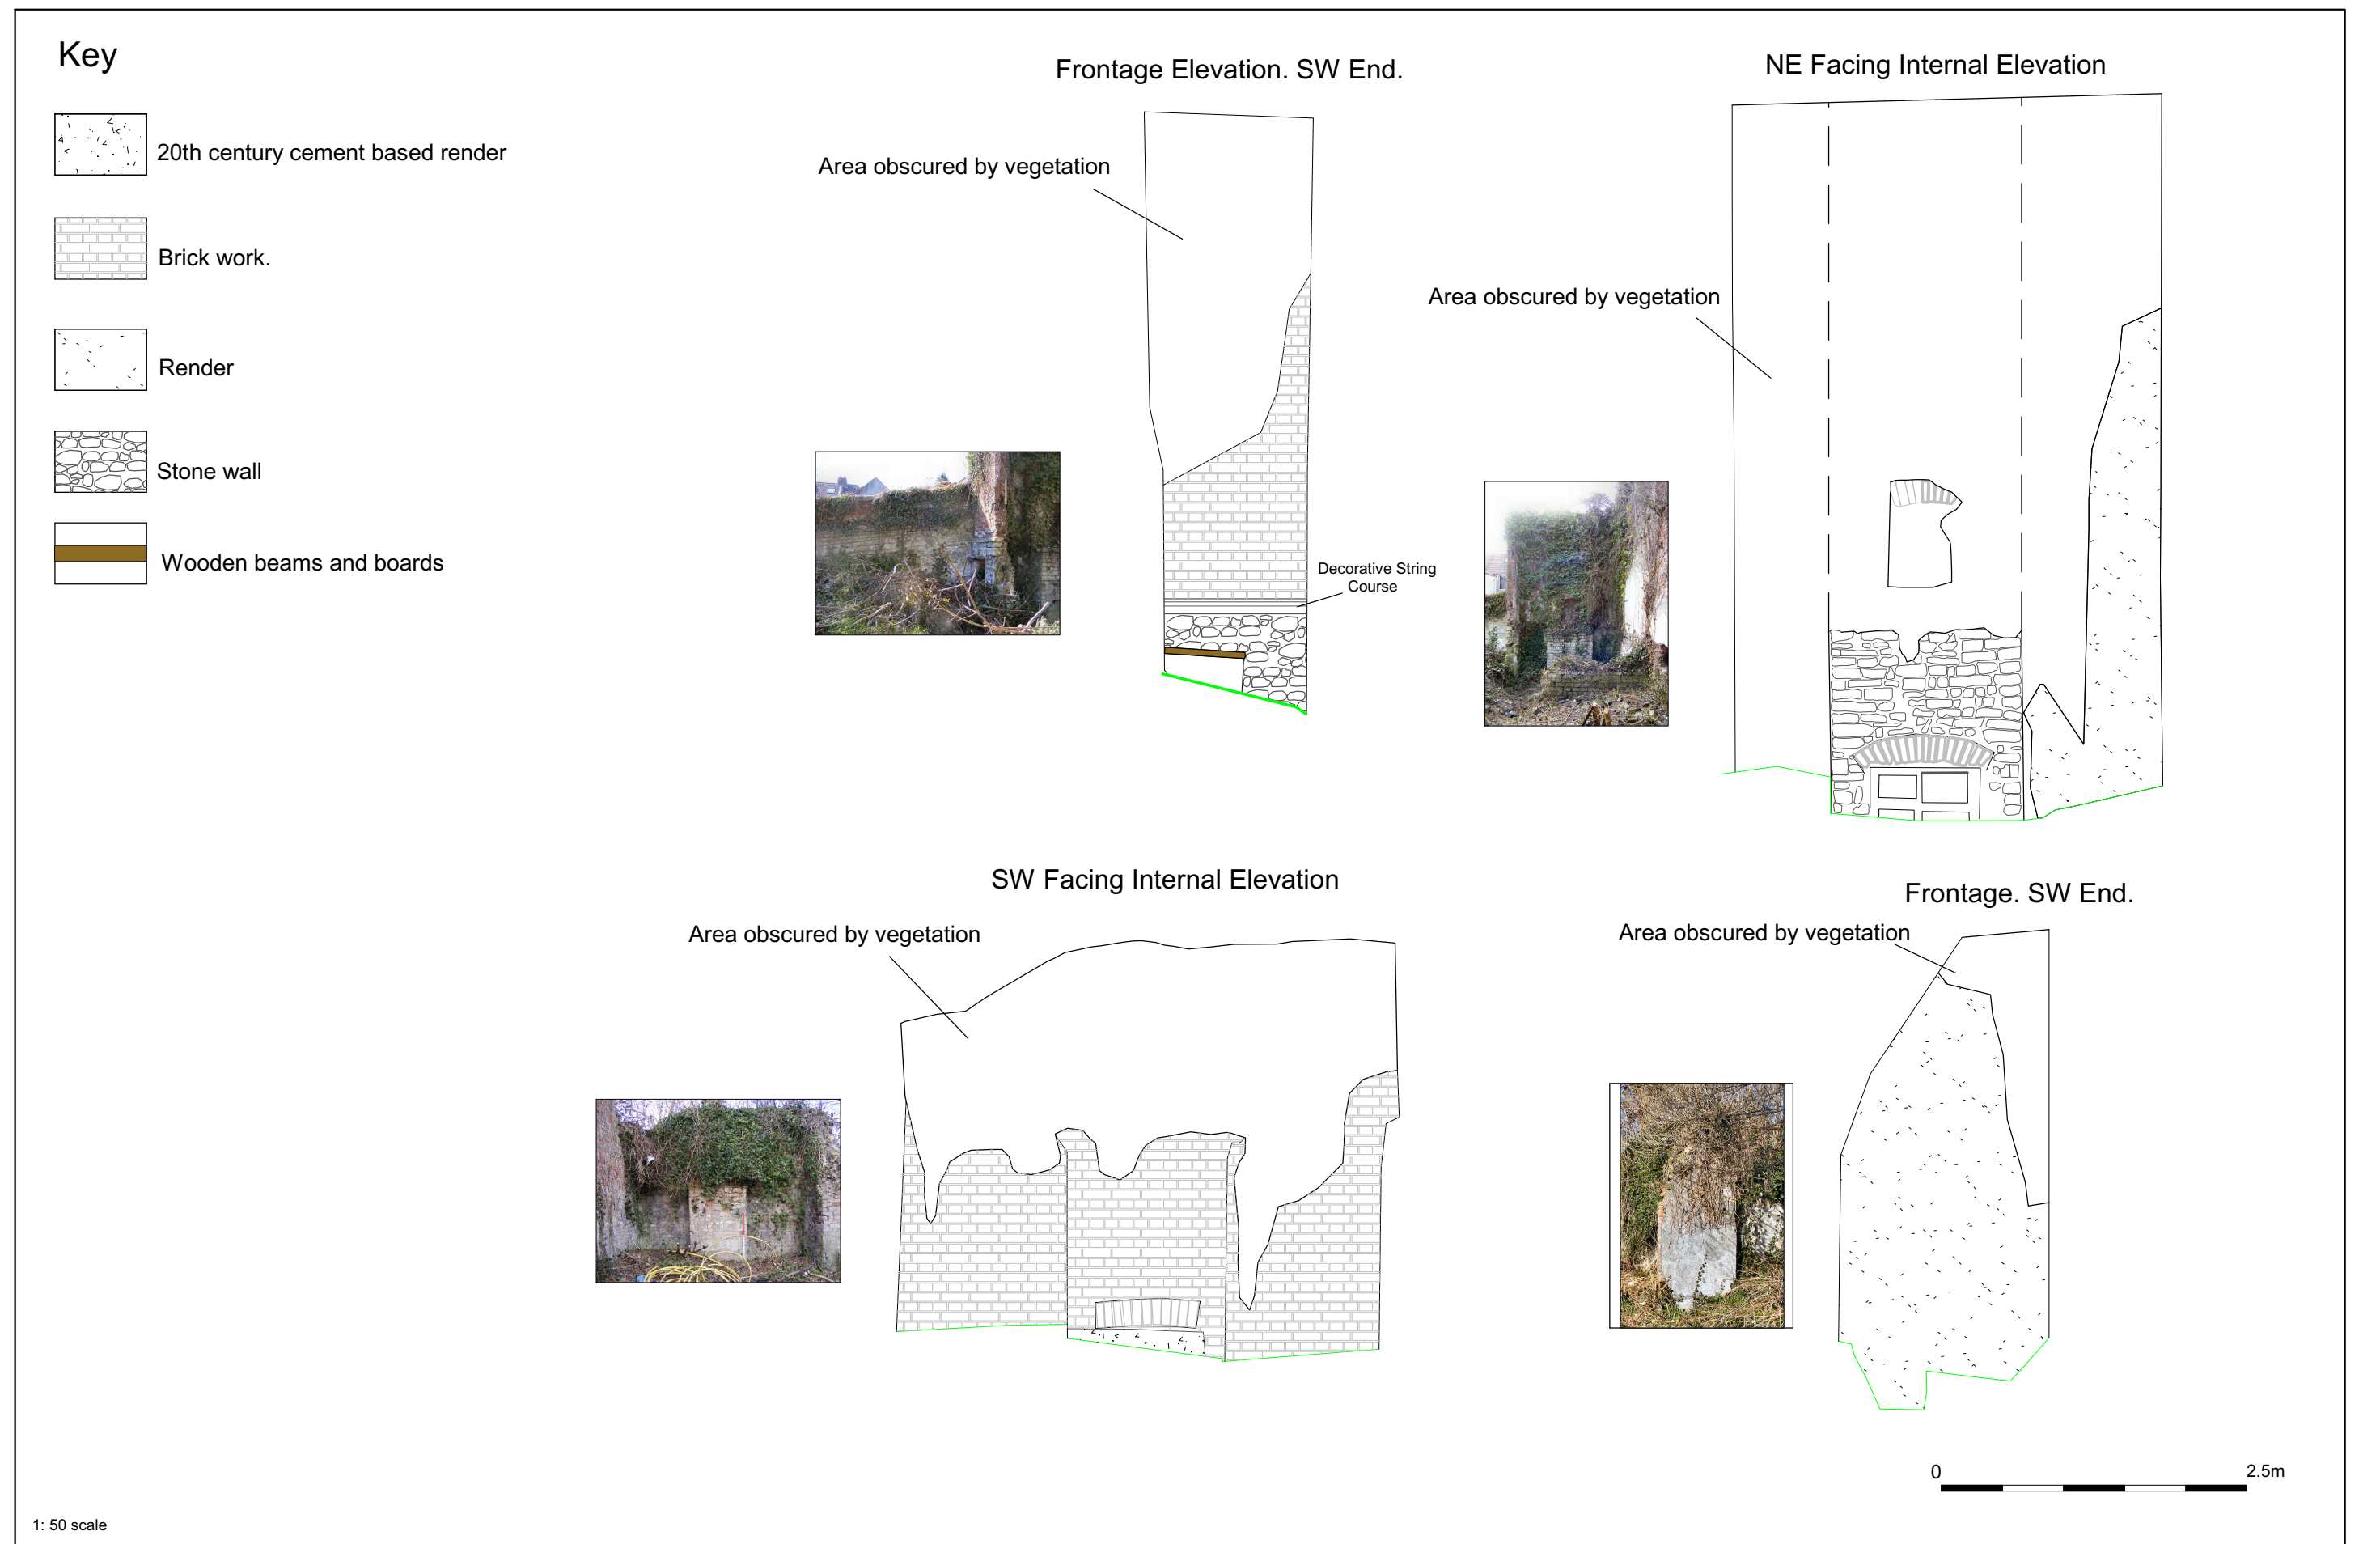
Figure 9

Side and Frontage Elevations of No. 15 Marlborough Hill. 1:50 scale

- 5.9 In accordance with the criteria of a level 2 building survey, detailed descriptions of features within the building have been kept to a minimum. However a small number of features are worth highlighting.
- 5.10 The north-east facing elevation (**Figure 10**) had a central flu housing a fireplace on both the first and second floors. A blocked fireplace was also visible at the ground floor of the south-east facing elevation (**Figure 10**). One side of a splayed window/opening was found within the above ground remains, of the frontage at both the SW and NE ends of the building respectively. Foundations and features were found, at ground level, along the route of the collapsed frontage (**Figure 7**) and comprised: remains of a red brick bay window at the south-west end of the building, stone steps in the centre of the frontage, and sections of stone foundations at various points.

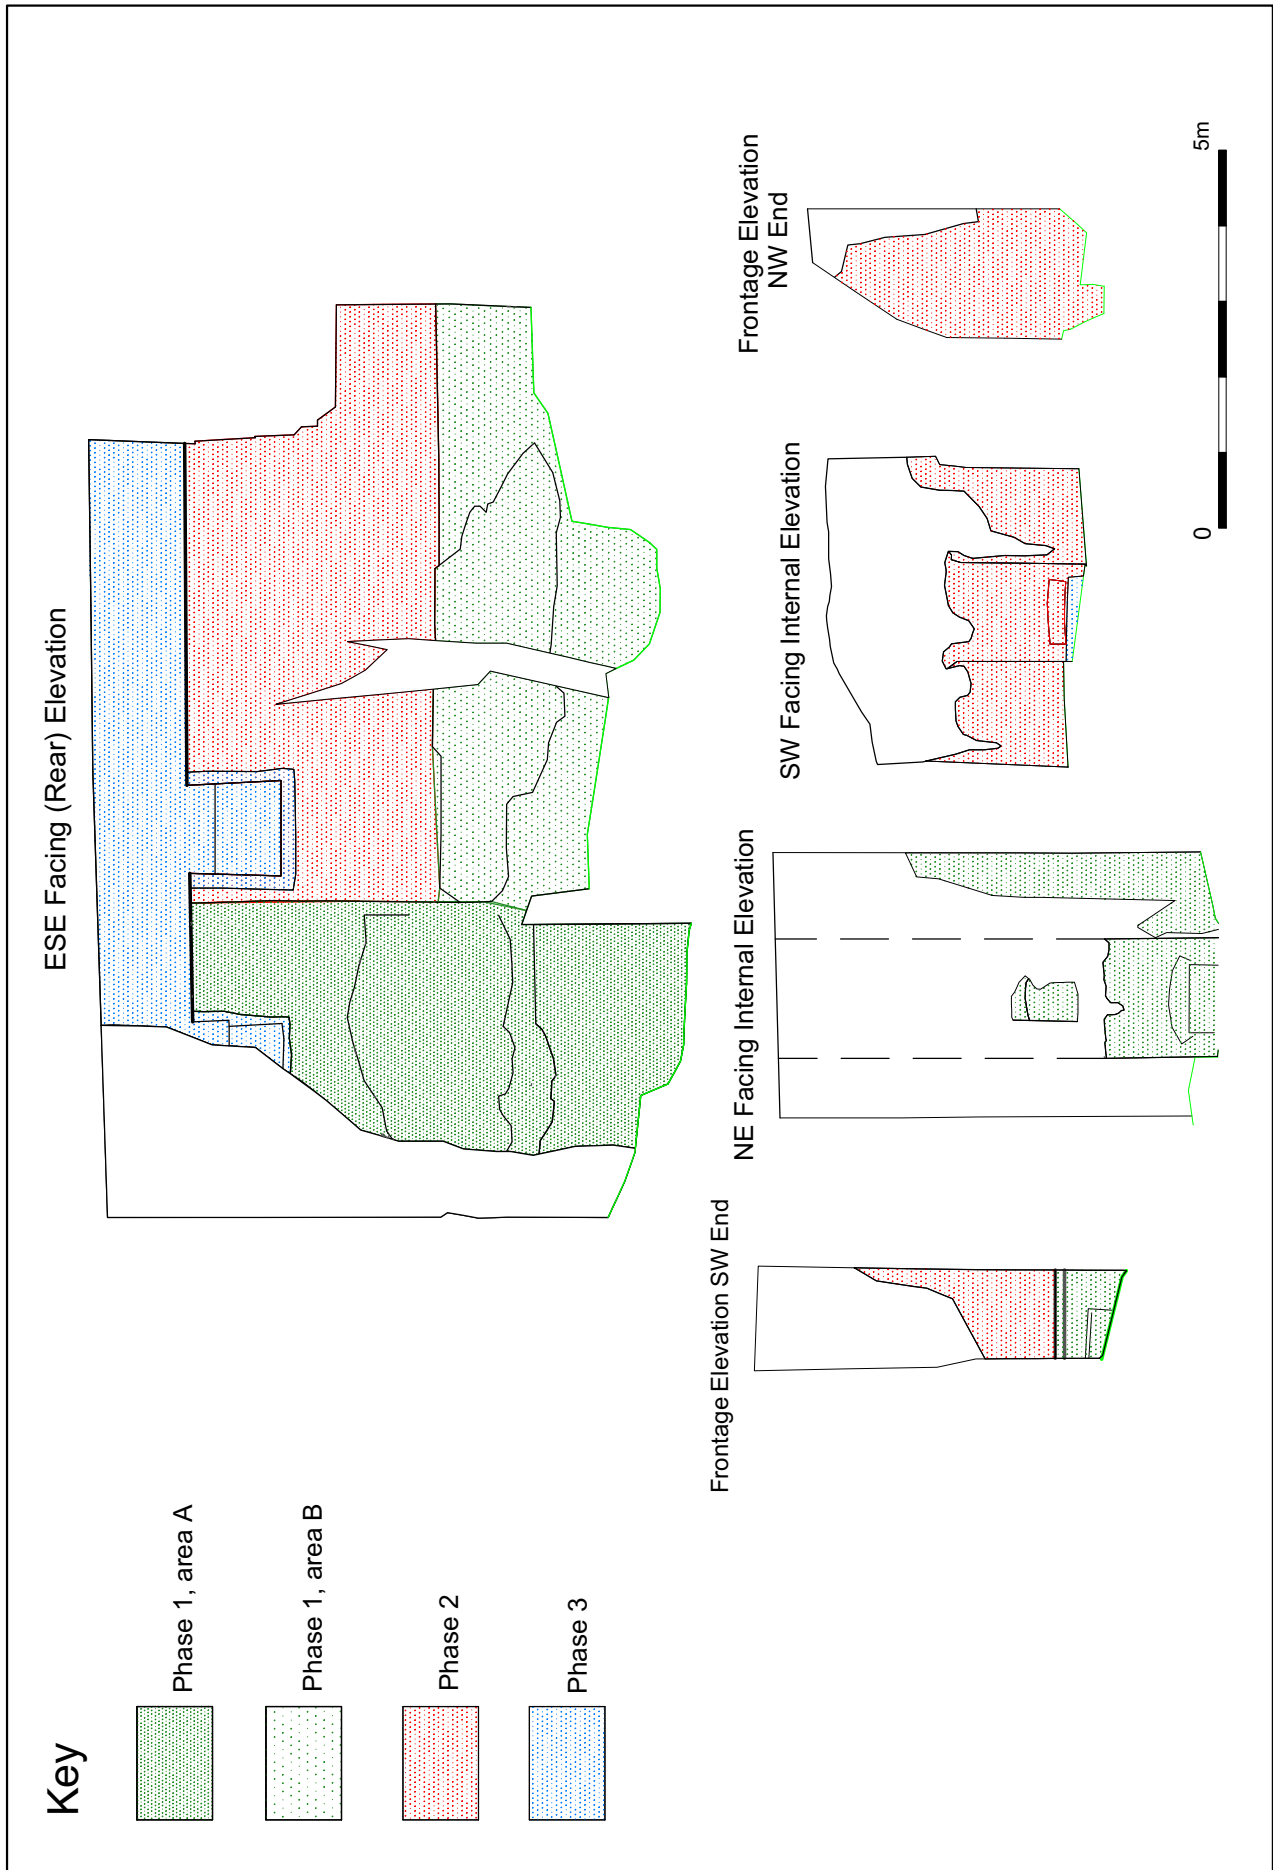
Figure 10

Elevations with Phasing. 1: 100 scale

### Phasing (Figure 10)

- 5.5 The earliest parts of the building are constructed from unevenly coursed sandstone blocks bonded in a pinkish grey lime and sand mortar. Sandstone block remains comprised not just the possible summerhouse at the south-east end of the building (Area A. **Figure 10**) but also the lower courses, up to the first floor, of the entire rear elevation (Area B. **Figure 10**). Given that the cartographic evidence, and surviving example visible in neighbouring Blenheim House, suggest the summerhouse would have been a small, roughly square shaped structure, it seems unlikely that Area B, would have been part of the original late 18<sup>th</sup> century summerhouse structure. However the only physical evidence to suggest that Areas A and B were not built at the same time is the render applied to their surfaces, which within Area A was a white, lime rich, render whilst Area B was clad in a mid grey ash and lime based render.

- 5.7 The documentary evidence suggests that in the late 19<sup>th</sup> century the summerhouse was extended to become the two storey house still partially extant. The extension was constructed from red brick and cream coloured sandy mortar, in a slightly irregular bond that most closely resembles English
