Numbers 670 to 686 Fishponds Road and 4 to 18
Hockeys Lane, Fishponds, Bristol

Archaeological Watching Brief and Standing
Building Recording

Bristol HER 24945 & 24947
NGR ST 6305 7560

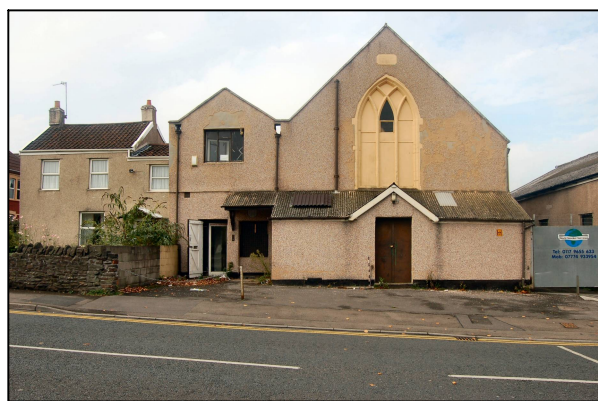
Plate 1

In its original form the chapel was a simple rectangular gable ended building built from random coursed red pennant sandstone blocks bonded with a mid-grey, friable ash mortar. The gable ends of the building were both clad in pebble dash render (**Plate 1**). The original façade, which fronted Hockeys Lane, was partially concealed behind a one storey lean to porch, beyond which was a central pointed arch entrance (**Plate 2**).

Above the entrance was a large perpendicular style pointed arch window which had been carefully blocked in concrete so that the freestone masonry of the frame was still visible.

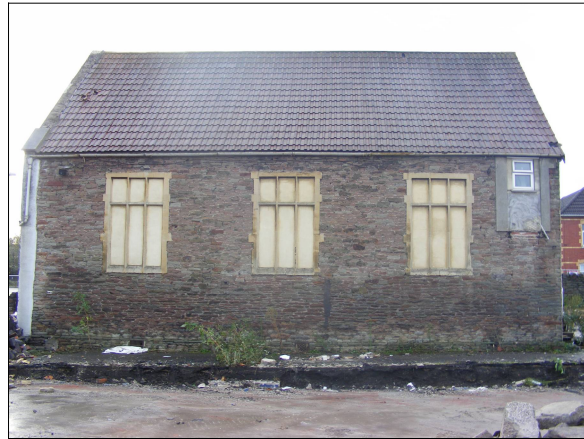
Plate 3

Only the north facing elevation of the chapel was fully exposed, the south facing side being butted by the later Sunday school extension. It contained three equally spaced rectangular windows in similar freestone masonry to that of the one in the façade (**Plate 3**). There was also a small window in the top west corner of the façade but this was a later addition and will be discussed in the Phase 3 section. The three original windows were blocked with concrete, which again, as in the façade window, respected the stone frames.

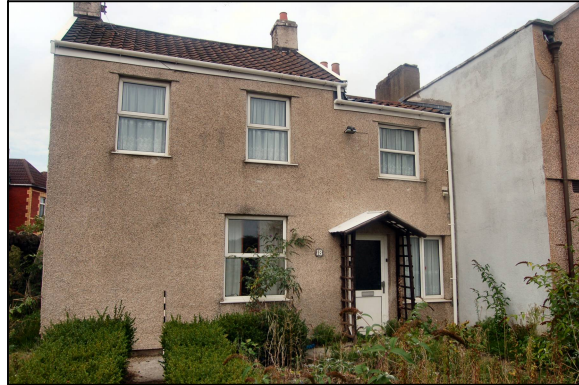
Plate 5

Though not explicitly required in the project brief a rapid survey of No. 18 Hockeys Lane (**Plate 5**) was deemed to be of significant enough value in understanding the development of the Methodist chapel, to which it was attached that it was undertaken as an additional exercise. A brief description is contained below.

No. 18 Hockeys Lane was a detached house, which had later been extended to abut the southern façade of the Methodist chapel Sunday school extension. It was a two storey rectangular house with a salt-box roof. The frontal facade faced east, fronting Hockeys Lane. Access was via a single door set to the northern side of the façade or via two doors in the rear elevation, though it was evident that the main entrance was formerly on the southern side of the original part of the house. There were four windows in the façade and one in the rear, west facing, elevation. Internally the layout was a simple two up two down with additional rooms, comprising a kitchen entrance area and third bedroom, contained within the extension which abutted the chapel.

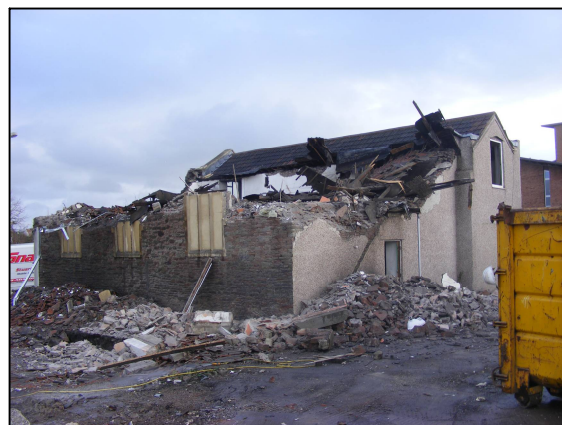
Plate 6

The initial demolition stage provided an opportunity to observe the fabric of the walls of the Methodist Chapel (**Plate 6**). The observations confirmed the fabric recorded during the building survey, which were pennant sandstone blocks bonded with a mid grey ash mortar.

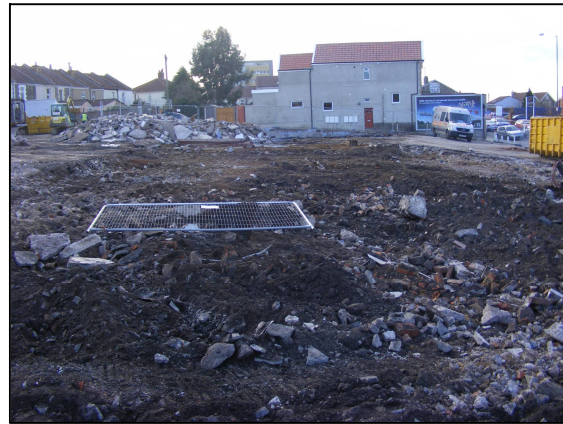
Plate 7

The excavation of the hard-standing surfaces had minimal intrusive impact on the underlying deposits. It revealed that across most of the site there is an undefined depth of modern made ground comprising earlier demolition rubble, containing stone, brick, concrete, stone chippings and clay (**Plate 7**).

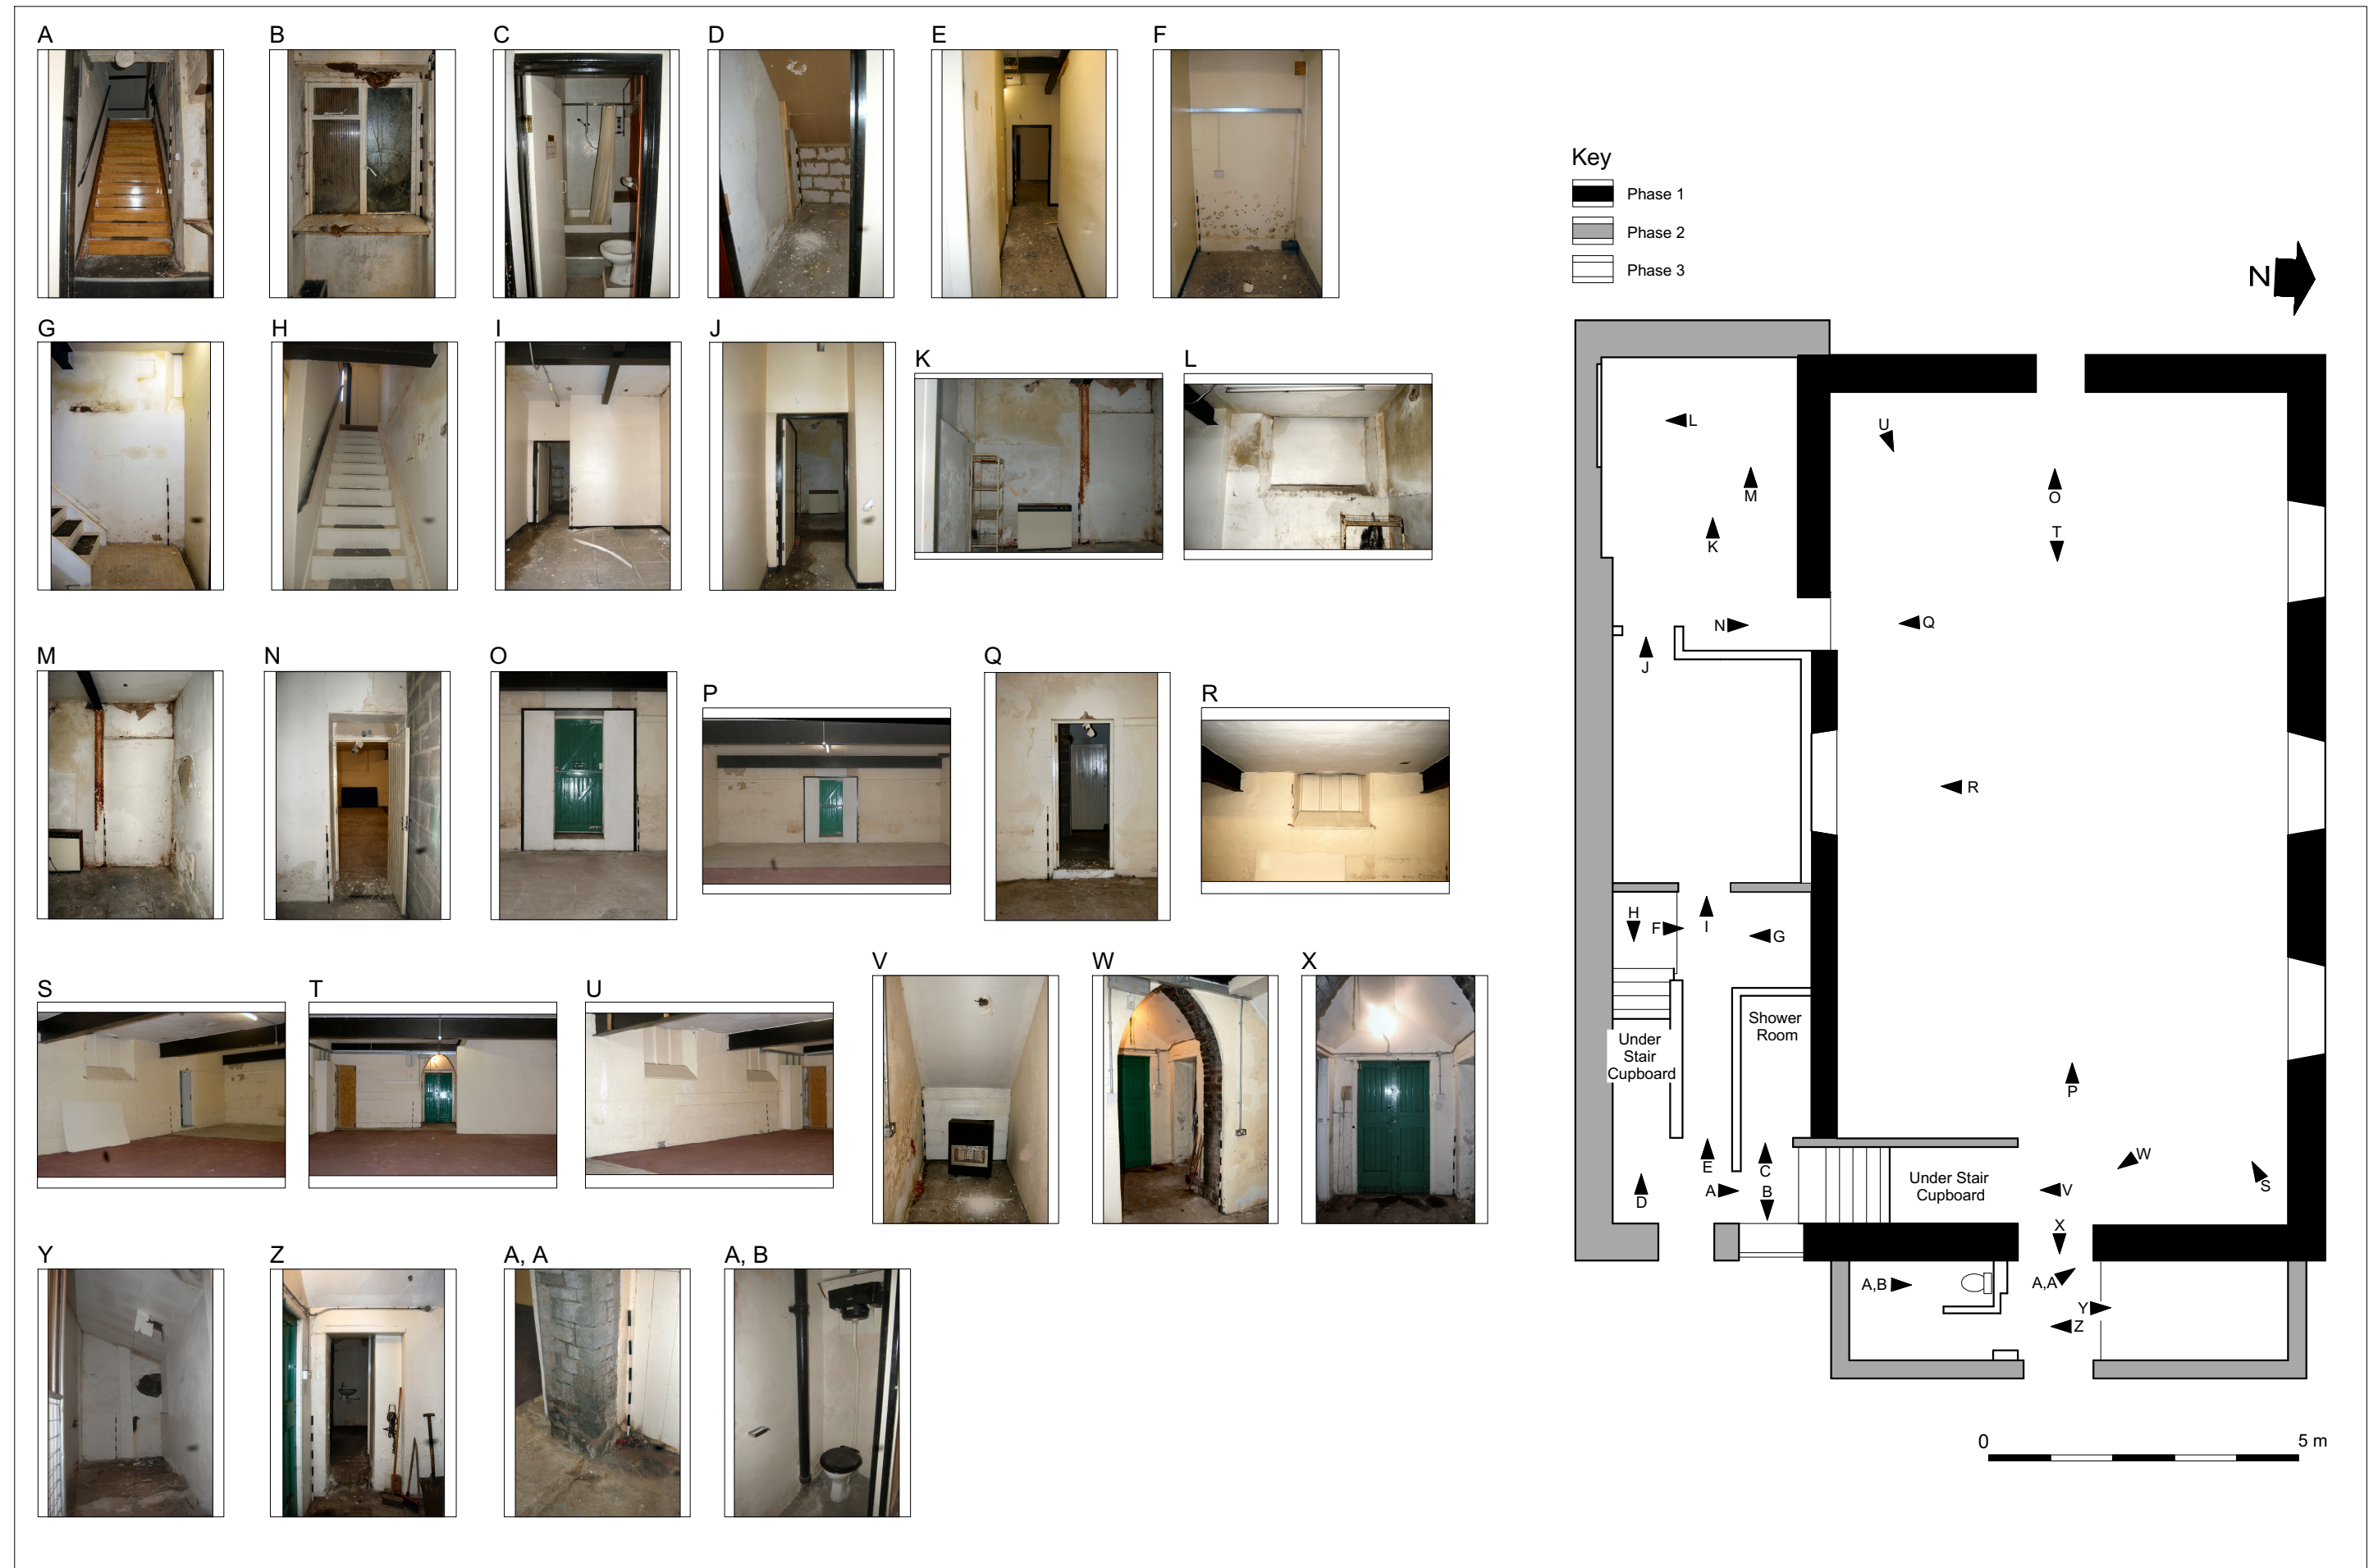
Ground Floor of the Chapel with Views 1:100 scale

The survey identified three broad construction phases the earliest being the construction of the Methodist Chapel (Phase 1) in the earlier 19th century. This was followed by alterations made when the building was extended to include the Sunday School (Phase 2) during later 19th century. Phase 3 represents modern alterations evident throughout the building. An exact date for the original construction of the chapel has not been found but it is depicted on the 1882 Ordnance Survey so was extant by that time, also a figure 18 was just visible in the worn date stone at the top of the façade, indicating that it was built within the 19th century. In its latest manifestation the building was a twin gable ended structure, the chapel being a larger gable on the north side of a narrow gable ended extension.

It appeared likely that the Sunday school extension was originally divided into only two ground floor spaces. Access to the newly created first floor was via two staircases, the largest inserted through the south-eastern corner of the southern wall of the original chapel, the second, which was a later addition, was on the southern side of the Sunday school extension towards its eastern end.

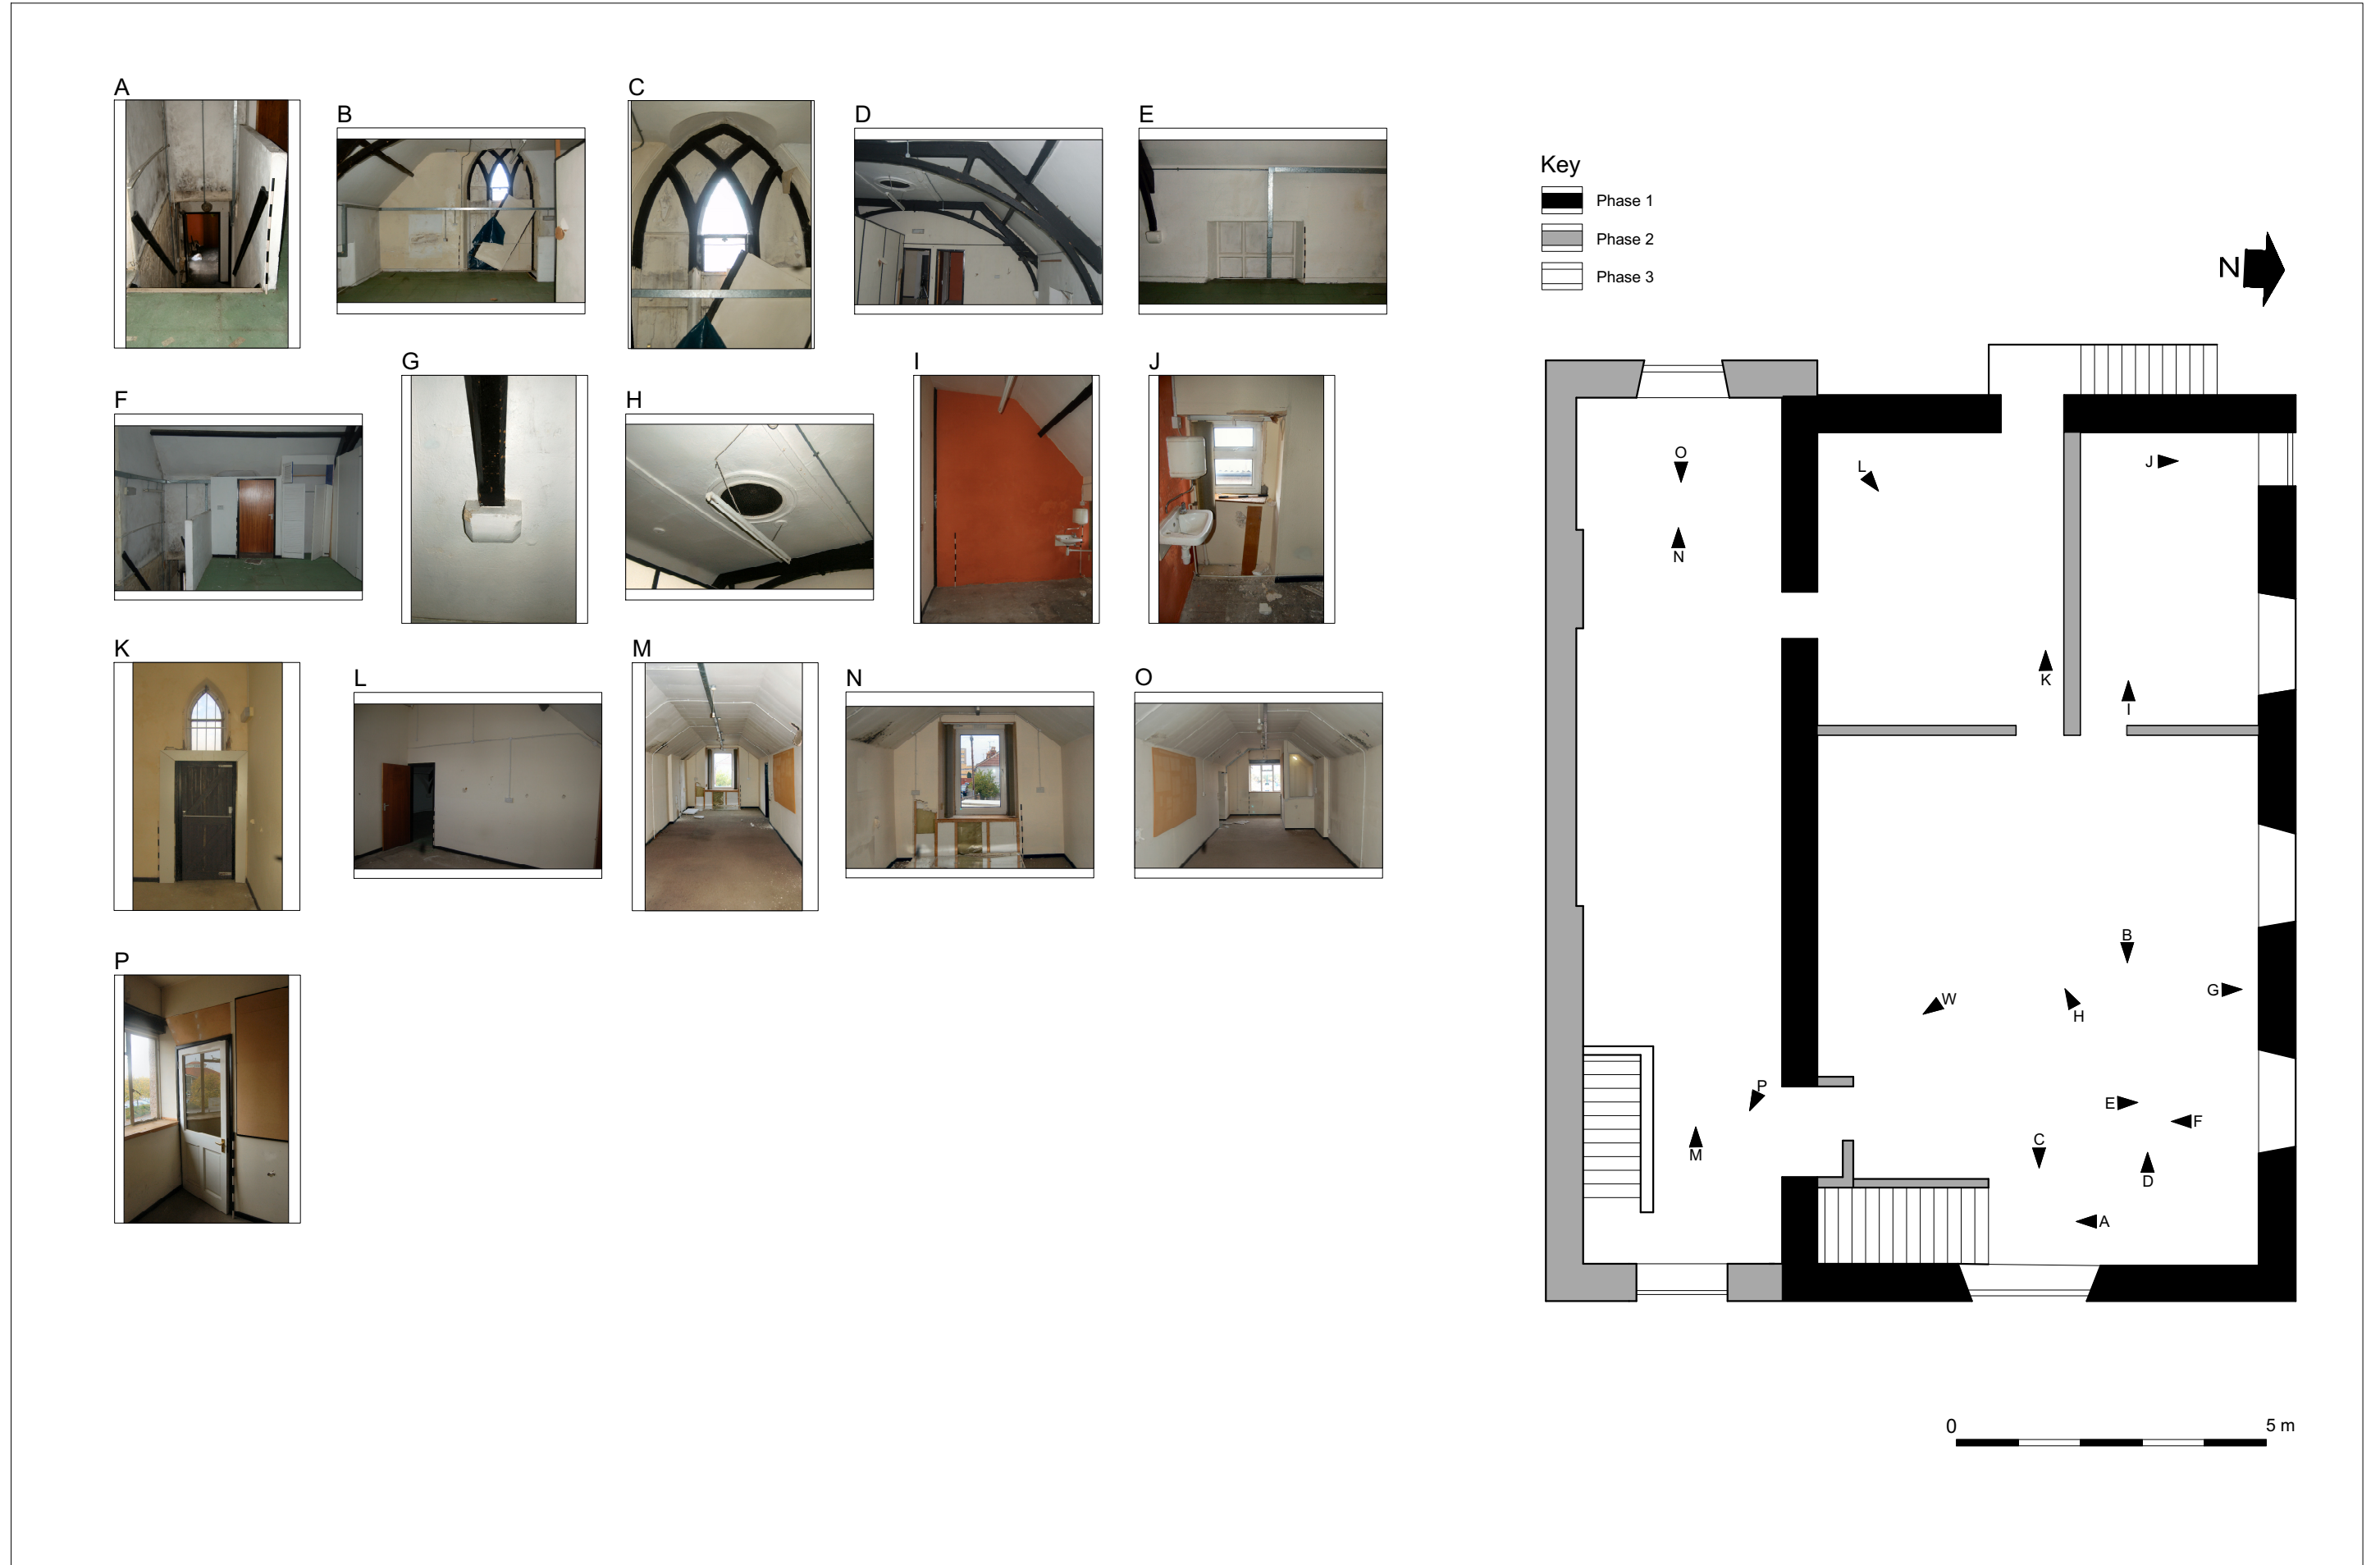
Figure 4

The first floor comprised four spaces with the Sunday school forming a single concourse while the existing chapel had been divided into three rooms, though it seems likely that the divisions may have been later (see Phase 3).

Above the rear fire escape on the ground floor, was a second, first floor, fire door leading to a flight of metal steps on the outside of the building. The layout of the first floor appeared to have remained largely as it had after its creation, when the Sunday school extension works were undertaken. A small window had been cut through the top west corner of the northern wall of the chapel, possibly replacing an earlier blocked window, and the frames of the two windows at either end of the first floor of the Sunday school building had been replaced with modern ones.

First Floor of the Chapel with Views 1:100 scale
