1 The Manor House, Chapel Street, Holsworthy, Devon.

An archaeological desk-based appraisal and field evaluation.

COAS Project Reference: C1/EVA/11/MCH

Torridge District Council Planning Application ref.: 1/1271/2008/FUL

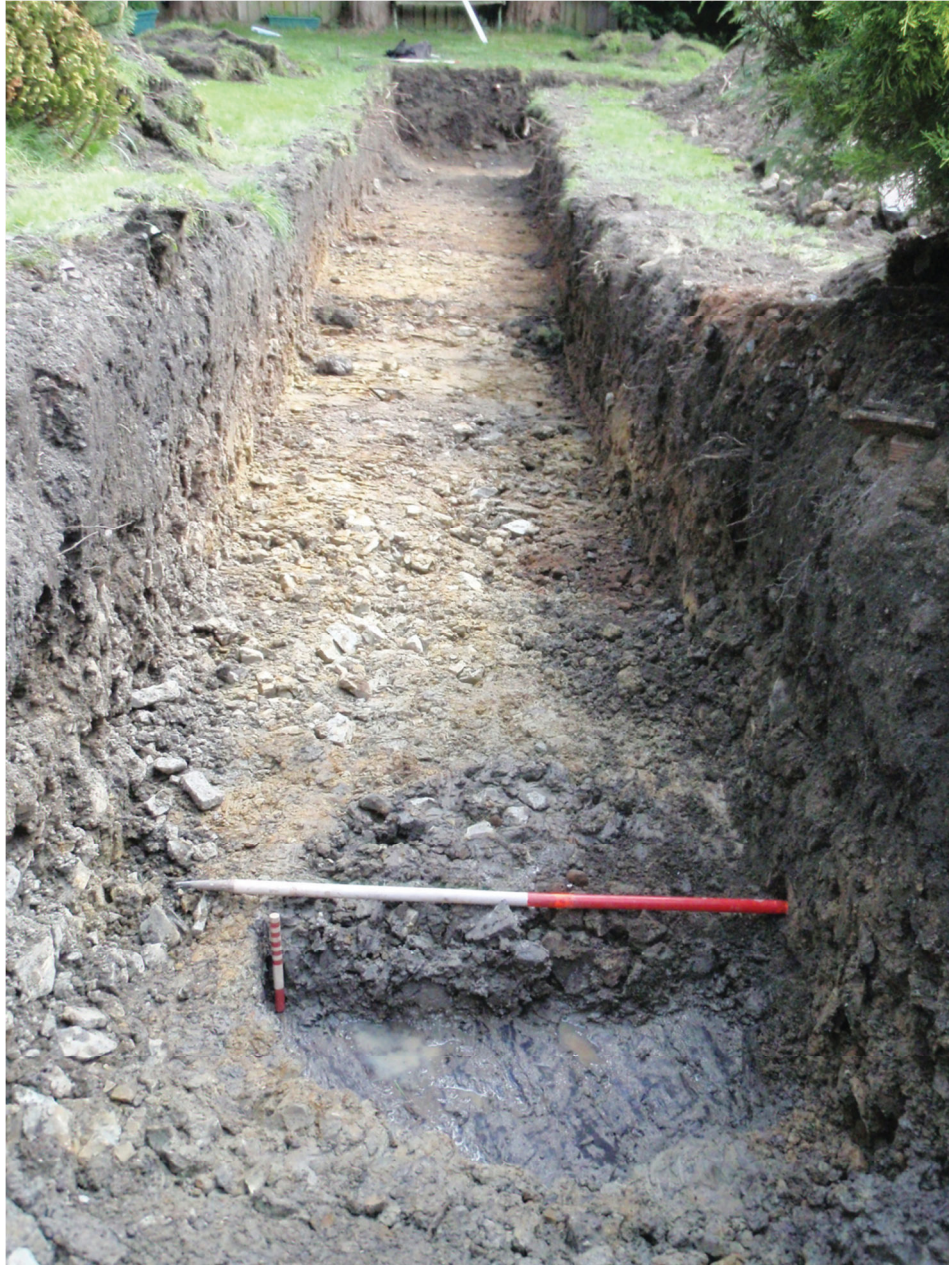
Front cover image: Trench 2 from the west after excavation of feature [205]. © Context One Archaeological Services 2011

- 5.3 Two archaeological 'features' were recorded. This included the base of a modern wooden barrel or cask ([205]/(203)/(204)) that was once set into the ground as deep as the natural geology, and the modern remains of a single width stone wall (202) that probably served as a flower bed border. Both were encountered in Trench 2.

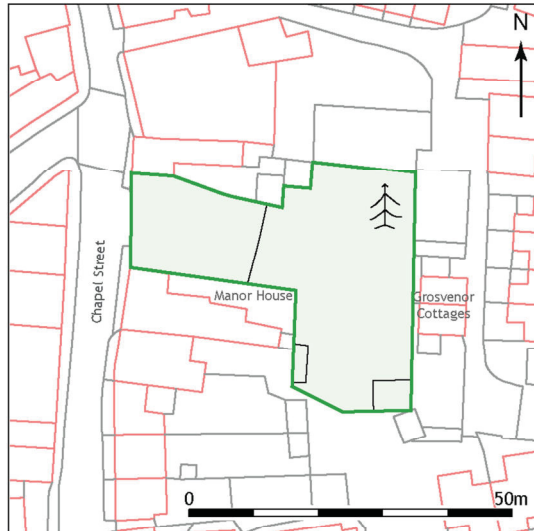
Transcription of 1843 Tithe Map

Ordnance Survey 25" map transcription, 1885

Ordnance Survey 25" map transcription, 1906

Ordnance Survey 1:2500 map transcription, 1954

Ordnance Survey 1:2500 map transcription, 1966 - 1985

- 3.3 Map regression of historic maps shows that the Site boundaries have remained largely static since the first half of the 19th century (**Figure 2**). The 1843 Tithe Map shows the Site as being largely unoccupied with a rectangular structure set on the road frontage. The apportionment accompanying the Tithe describes this as 'houses', presumably a small terrace, amongst 'waste' ground. The Site was owned by 'John Wood' and tenanted by 'Thomas Tull'. The structure is not evident on maps after 1885. Maps from the late 19th and early 20th centuries show a boundary bisecting the Site. Aligned roughly north to south, the boundary appears in a slightly different position in the 1885 and 1906 maps but may well represent the same feature. A small outbuilding, which is still extant, was first represented on the 1885 map. A further structure, perhaps an additional outbuilding, is only evident on the 1885 map.

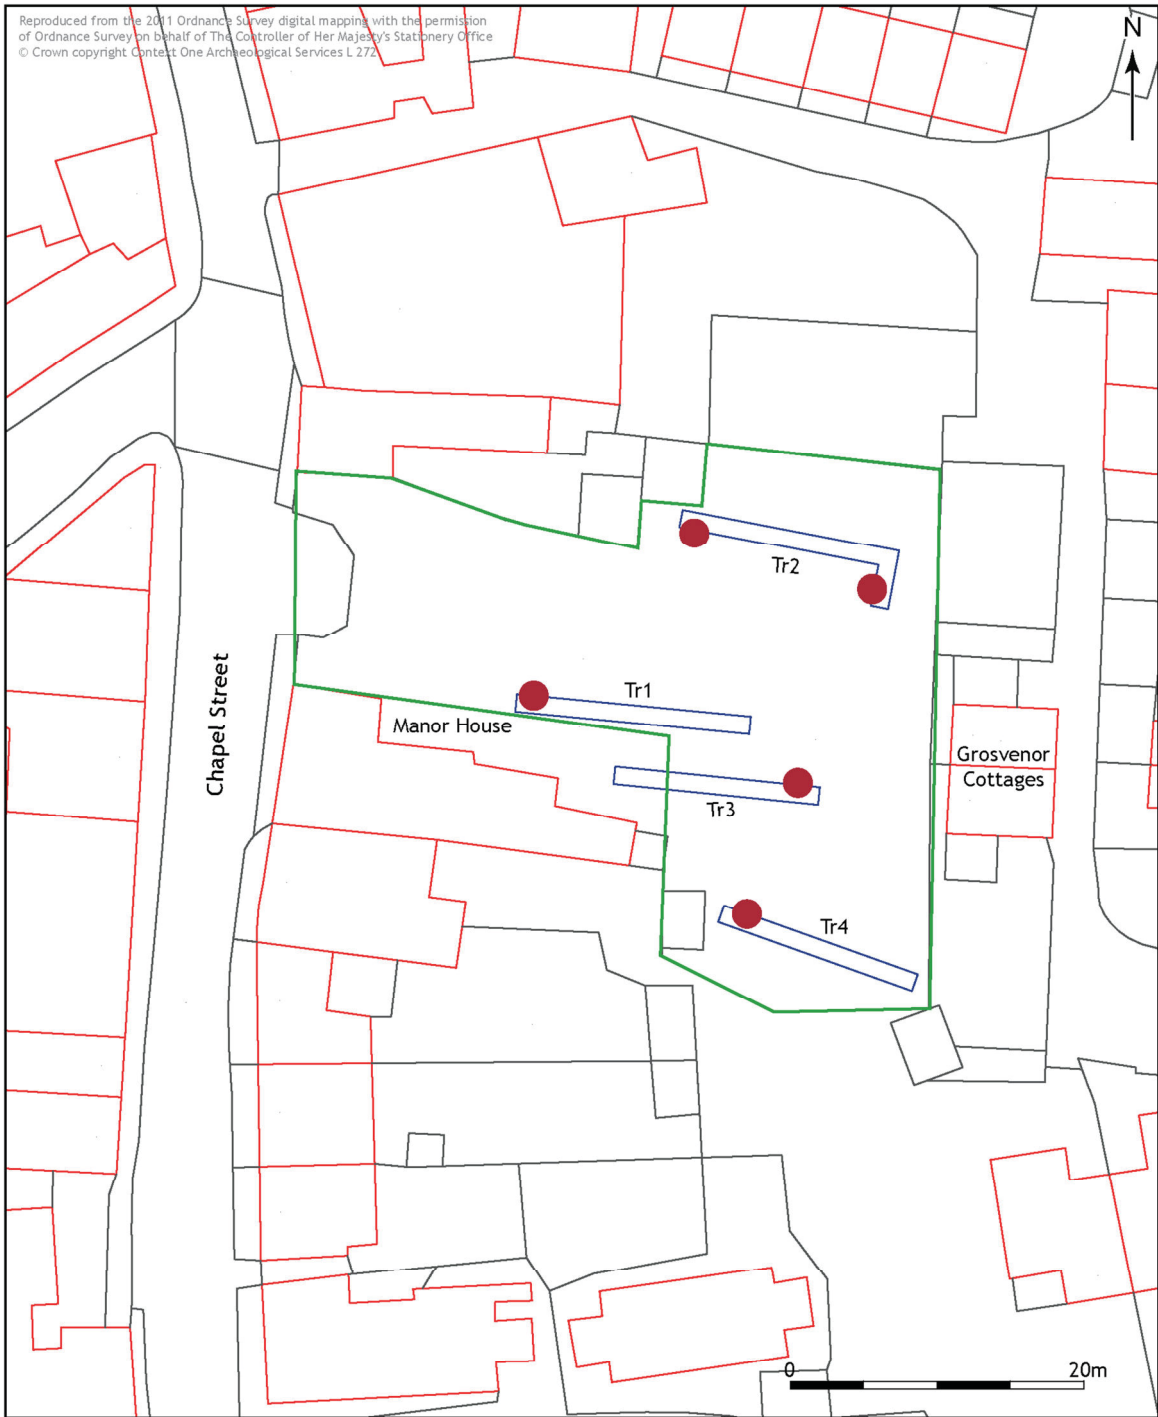
profile locations </p>	<p>PROJECT TITLE 1 The Manor House, Chapel Street, Holsworthy, Torridge, Devon</p>		
	<p>FIGURE TITLE Detailed site setting showing trench and profile locations</p>		
	<p>SCALE as shown</p>	<p>PROJECT CODE C1/EVA/11/MCH</p>	<p>FIGURE NO. 2</p>

site boundary

Tr X trench locations and numbers

The field evaluation was carried out over two days between 18 and 19 April 2011 and consisted of 4 machine and hand excavated trenches: trench 1 measured 16m x 1.2m; trench 2 was 'L'-shaped and measured 15m x 1.6m and 4m x 1.6m; trench 3 measured 14m x 1.2m; and trench 4 measured 14m x 1.2m. Combined, the trenches represented a 7.23% sample of the development area (0.115 hectares). The size and layout of the trenches varied from the Written Scheme of Investigation due to on-site obstacles such as garden features (a disused concrete pond) and mature trees/vegetation. The original plan was to excavate 4 no. 20m x 1.6m trenches representing an 11% sample of the proposal area.

- 5.1 In the text below, context numbers appear in standard brackets, e.g. (102) and cut numbers in square brackets, e.g. [205].
- 5.2 Excavation revealed a similar sequence of horizontal deposits in all four trenches. These comprised topsoil ((100), (200), (300),(400)) above subsoil ((101), (201), (301), (401)) which in turn lay directly on natural geology ((102), (206), (302), (402)). Topsoil varied between 0.20m-0.40m thick; the subsoil between 0.26m-0.80m; and natural geology was reached between 0.50m and 1.00m below the ground surface. The variation between the thickness of deposits was a direct result of modern episodes of garden landscaping. This had also resulted in a variation of the deposit matrix of the topsoil and subsoil. The natural geology was recorded as a generally dark yellowish brown (10YR 5/6) deposit with frequent, loose 'squared' sandstone fragments (no dimension greater than 0.20m). Both the topsoil and subsoil deposits incorporated varying scatters of natural sandstone fragments testifying to repeated episodes of modern intervention.
