B0421: Castle Green/Castle Bow, Taunton, Somerset.

A programme of Archaeological Monitoring and Recording

Wessex Water plc

September 2014

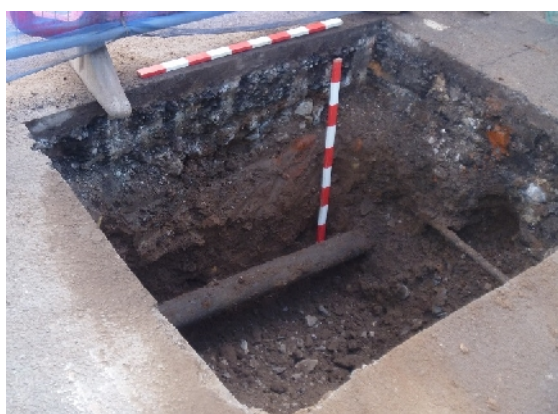
Plate 1. Profile 7 (from N; 2 x 1m scales)

- 4.1 Variable deposit sequences were encountered during the monitoring programme, sealed beneath the modern surfaces and underlying make-up layers.
- 4.2 Along Castle Green, pit 1 and pit 3 did not penetrate beneath the modern deposits, which extended to a depth of 0.9m deep. Further west along Castle Green, in Pit 7 a reddish brown (5Y 3/2) redeposited clay (702) was encountered at a depth of 0.4m below the modern paving, containing occasional charcoal and chips of white stone measuring <0.02m diameter (**Plate 1**). Nearby, in pit 10 the heavily mixed and compacted redeposited clay (1002) was recorded as very dark grey brown (10YR 3/2) containing angular stones measuring <0.03m diameter and CBM fragments measuring <0.15m diameter. This overlay the natural comprising dark brown (10YR 3/3) clay (1003) with rare stones measuring <0.03m diameter. Near the centre of Castle Green, in pits 4, 5, 6 and 9, and at the junction with Castle Green and North Street, in pit 8, the same redeposited clay ((402) (502) (602) (802) & (902)) as in pit 7 was recorded at a depth of 0.7m below the modern paving. In the same area, within pit 11 was a redeposited clay (1103) with gravel above modern pipes and overlying the natural clay (1104) at a depth of 0.7m below the modern paving. In the proximity of the medieval Great Hall, pit 2 recorded modern backfill (201) of the pre-existing pipe trench below modern paving (200) (**Plate 2**).

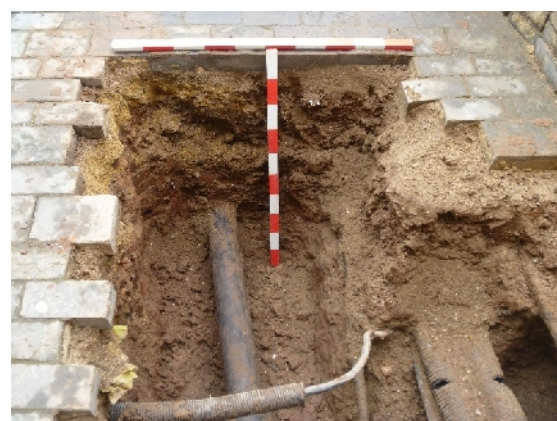
Plate 2. Profile 2 (from N; 2 x 1m scales)

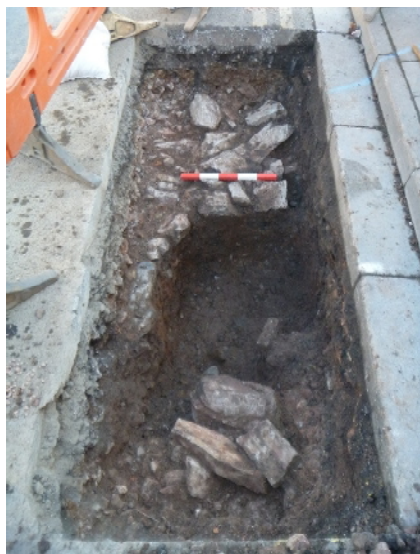
- 4.3 In Corporation Street, pit 34 exposed an earlier road surface (3400) beneath the modern tarmac and overlying a water main assumed to be c. 100 years old (**Plate 3**). The undisturbed surface comprised roughly laid lias stones each measuring between 0.05m square and 0.3m wide by 0.4m long by 0.2m deep bonded with red clay (see **Plan 1**; **Figure 2**).

Plate 3. Pit 34 showing old road surface (3400) (from N; 0.5m scales)

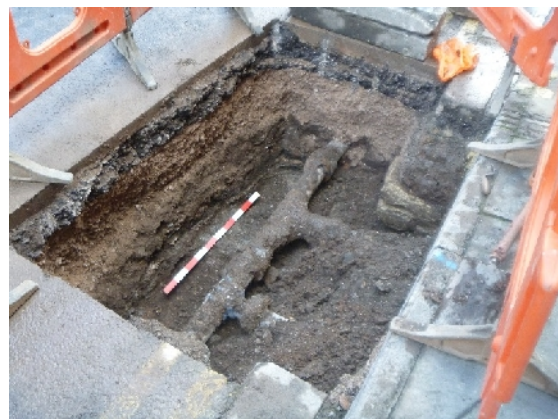
- 4.4 Immediately to the east, pit 31 revealed several post-medieval deposits beneath the modern tarmac and underlying modern layer (3101), all of which had been disturbed by the modern 1998 water main (**Plate 4**). At a depth of 0.6m below the tarmac, a dark brown soft to friable silt layer (3102) measuring 0.4m deep, overlay a band of slate (3103), which in turn covered a deposit (3104) which was the same as the uppermost silt deposit (3102) (**Plate 5**). Animal bone, glass and clay pipe was observed throughout all three deposits but not collected, with 17th century clay pipe observed at the lowest point. In the south-east corner of the pit was a poorly constructed wall foundation (3106) constructed above the post-medieval deposit (3104) (**Plates 6 & 7**). This comprised three squared random courses of Hamstone blocks measuring between 0.08m wide by 0.25m long and 0.25m wide by 0.38m long and 0.15m deep, with mortar joints measuring 0.01m wide filled with a soft bonding material. The foundation was visible for a width of 0.49m and a height of 0.29m within the pit. Redeposited red clay (3105) was exposed in the north-west corner of the pit.

Plate 4. Pit 31 (from SW; 1m scales)

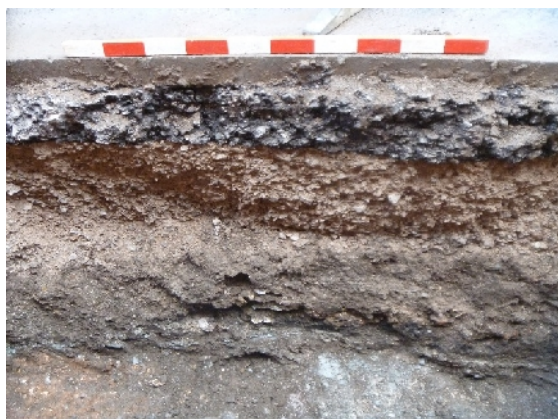
Plate 5. Profile 31 showing post-medieval layers (from S; 1m scales)

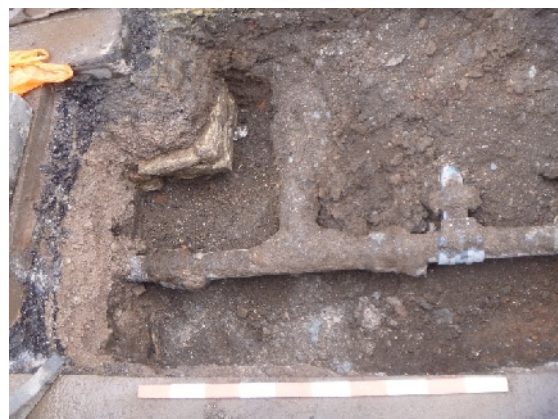
Plate 6. Pit 31 showing foundation (3106) (from N)

3105 (TP31)	NAT	Layer	Re-deposited natural clay. Exposed at NW corner of TP	3104	-	-	-	-	-
3106 (TP31)	MOD	Structure	Foundation. Poorly constructed of random coursed rubble. Exposed 3 courses of ?Hamstone, each block measuring between 0.08m x 0.25m and 0.25m x 0.38m x 0.15m. Soft bonding material, mortar joints measuring 0.02m	3101	-	3104	-	0.49m	0.29m

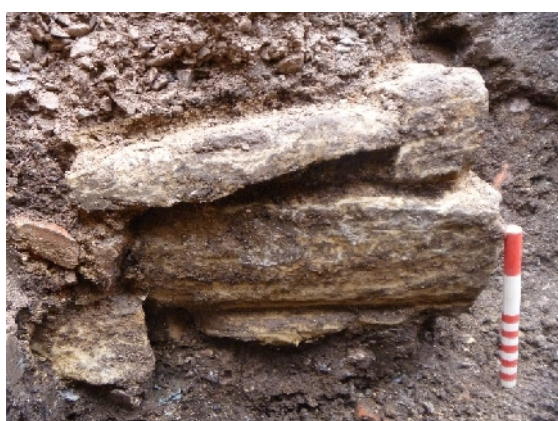
Plate 7. Pit 31 showing foundation (3106) (from NW; 0.2m scales)
