B0401: Ditchampton to Bulbridge, Wiltshire: Elimination of standalone source

An Archaeological Watching Brief

COAS Project Reference: C1/WBF/12/DBW

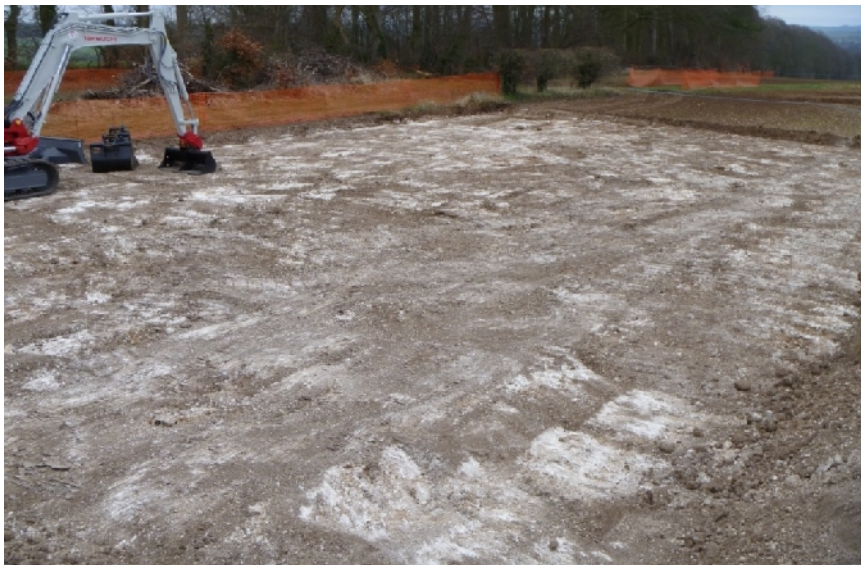
Plate 1. Compound 2 (from W)

5.3 The simple and shallow soil sequence on the valley sides reflected episodes of aggressive ploughing which had cut into the natural as exemplified in compounds 1 and 2 and along the easement (**Plates 1 to 3**).

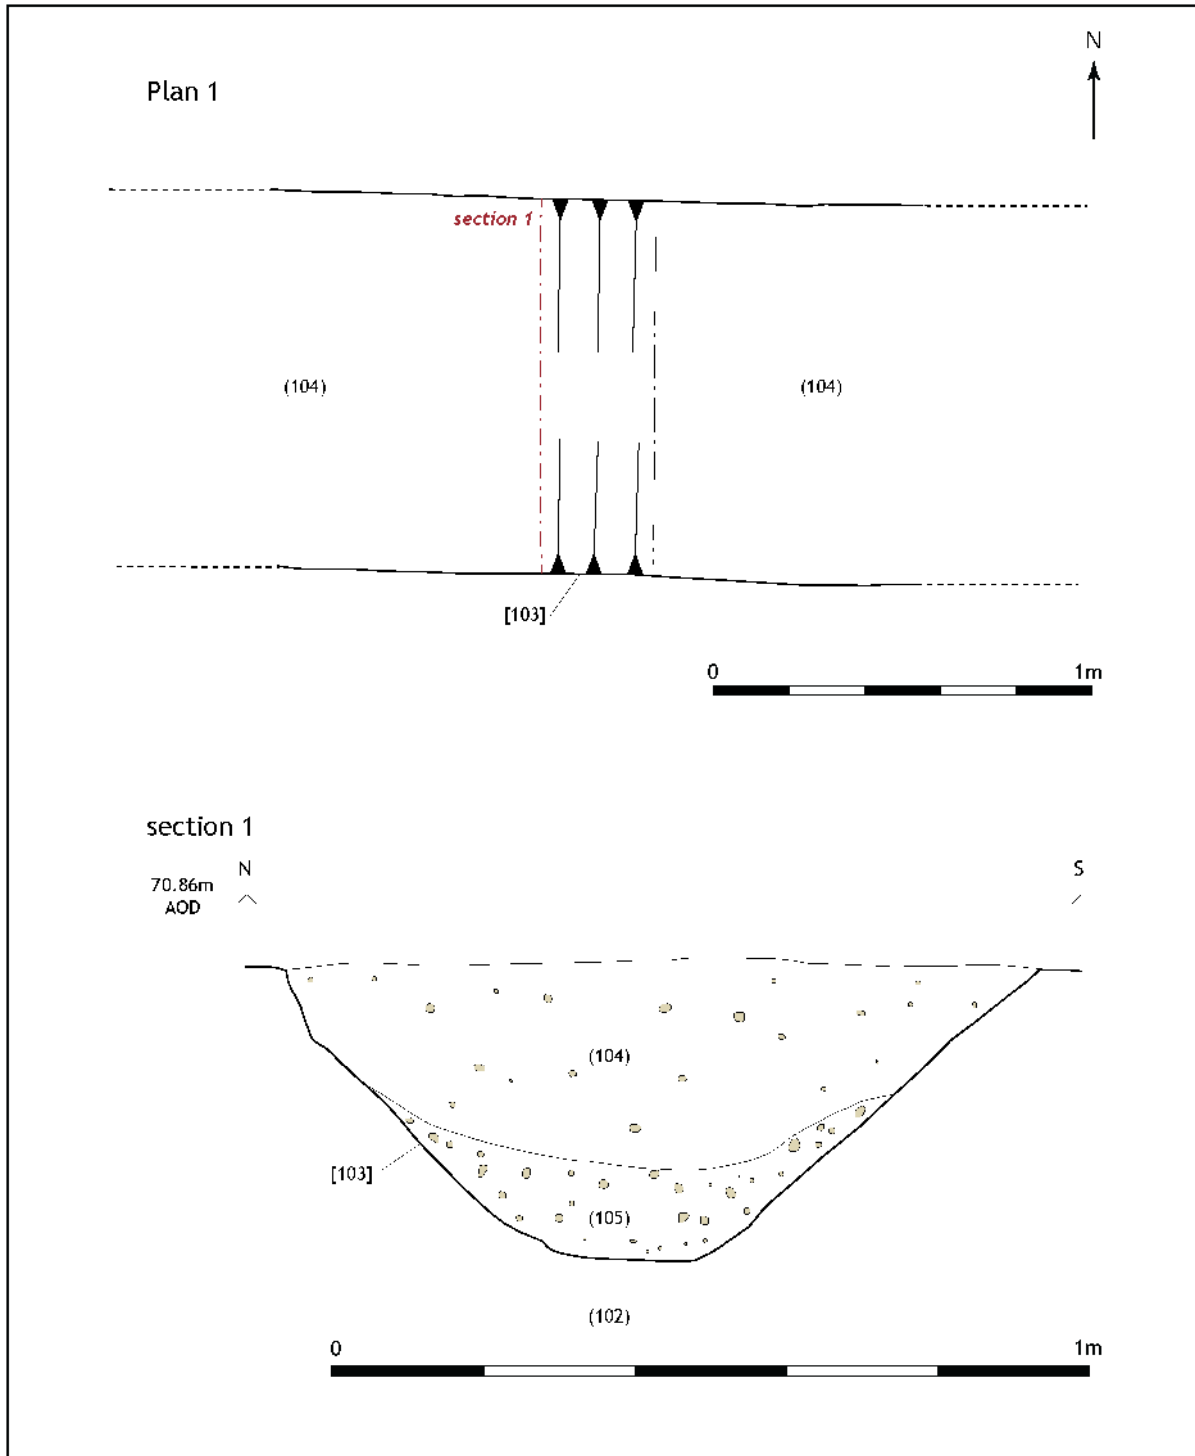
chalk fragments</p>	<p>PROJECT TITLE</p> <p>Ditchampton to Bulbridge, Wiltshire: Elimination of standalone source</p>		
	<p>FIGURE TITLE</p> <p>Plan 1 and section 1</p>		
	<p>SCALE</p> <p>as shown</p>	<p>PROJECT CODE</p> <p>C1/WBF/12/DBW</p>	<p>FIGURE NO.</p> <p>2</p>

5.6 A second truncated 'V' profiled linear feature [103] was identified and sampled in field 8. Two phases of filling appeared to have been gradual and incidental or natural (**Figure 2; Plate 7**), although it clearly had been cut as a ditch. Finds which are probably of Post-medieval date were recovered from the upper fill (104) only.

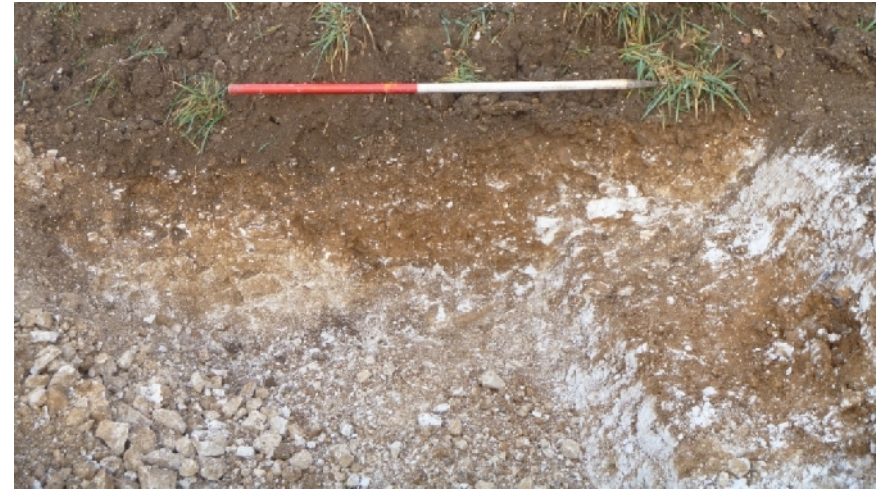
Plate 6. Linears [109] and [111] (from E; 1m scale)

5.5 Two smaller, similarly oriented linear cuts, between the broad linears may also have formed naturally, although the truncated 'V' profile of [109] was suggestive of a ditch. It was clearly later than the fill (110) of [111] which was 'U' profiled (**Plate 6**).

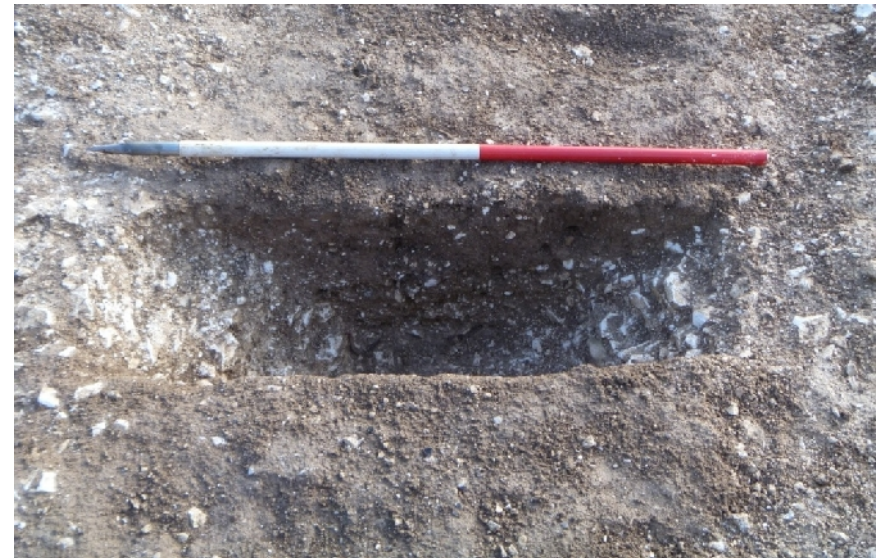
Plate 7. Ditch [103] (from E; 1m scale)

6.4 All of the Fabric 2 and six of the Fabric 1 finds were unstratified within field 8. Three small sherds in Fabric 1 were recovered from the upper fill (104) of ditch [103] in the same field.

6.5 One handmade iron nail (43g), 108mm long, tapering from a rectangular head of 15mm by 10mm to a point of 3mm by 1.5mm, was recovered from the upper fill (104) of ditch [103]. Undated.
