Rooms below the Nisi Prius Court, Shire Hall, Dorchester, Dorset

An Archaeological Field Evaluation

COAS Project Reference: COAS/EVA/12/SHD

National Grid Reference: centred on SY 69099 90734

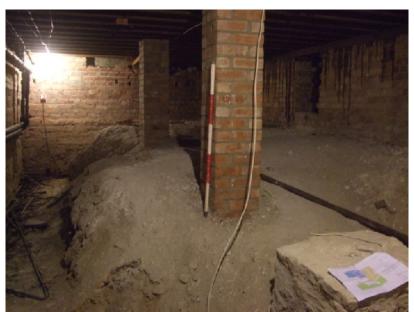
Plate 1. Room B6 showing rubble (104) (from S; 1m scale)

- 6.2 The most recent deposit (**Plate 1**) in both rooms was of rubbly material (104), mainly chalk, which covered almost the entire surfaces of rooms B6 and B7 (**Figure 2**) and butted against modern brick pillars (**Plates 1 3**), a stone plinth (203) (**Figure 3**, plan 1; **Plate 2**) and the external and internal walls, original and later (**Plate 3**), of the building. Underneath was a natural chalk surface (103). The fills of two cuts were sealed between the rubble (104) and natural (103). The two rooms were divided by a modern brick partition.

- 5.2 The evaluation comprised the machine excavation of two *ca*. 1m X 1m test pits (TP) in room B6 (Figure 2). It had been intended to excavate a third TP in room B7 but due to the overburden of unstable rubbly material over the floor it was judged unsafe to proceed (Plate 1).

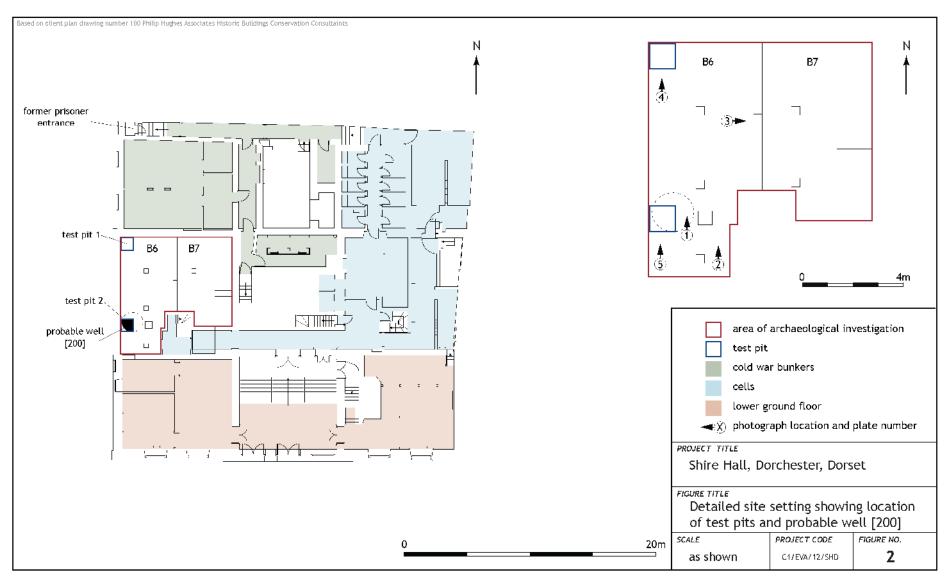
- 6.4 Following cleaning in TP2, the south half of a circular cut [200] was exposed in plan (**Figure 3**, plan 1). It was excavated to a depth of *ca*. 1.2m from the natural surface, below which it was judged to be unsafe to proceed. Two successive loose fills were identified, (201) distinguished from (202) by in the inclusion of larger fragments of brick (**Figure 3**, section 1). The cut was a well-defined cylinder and was probably for a well (**Plate 5**).
