Court Farm, Wookey, Somerset.

A programme of Archaeological Field Evaluation with Historic Building Recording and Archaeological Monitoring and Recording

January 2015 (version 2)

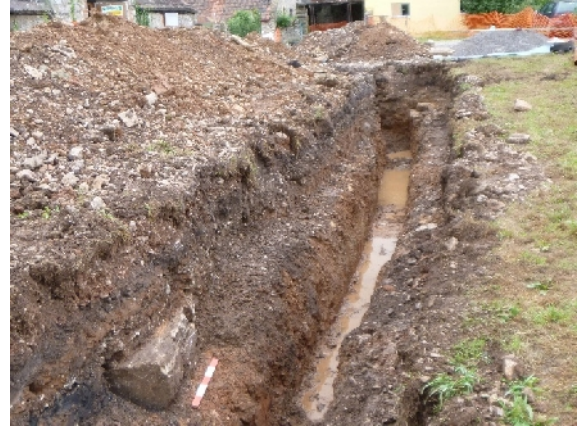
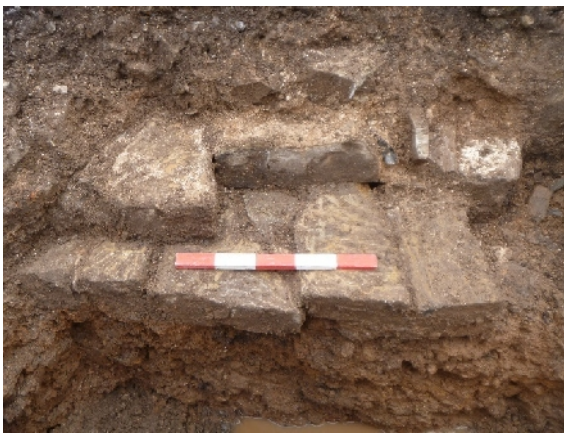
Plate 28. Tr10, wall (1020) on left & wall (1019) at far end (from S; 0.5m scales)

Plate 29. Tr10, wall (1020) (from E; 0.5m scales)

- 5.20 Further south the deviation encountered further structural remains. Directly beneath the modern deposits (1021) (1022) was part of a wall foundation (1019) constructed of uneven courses of yellow limestone aligned north to south, within the natural clay (Figure 5; Plate 27). Further south, a post-medieval occupation layer (1023) beneath the modern deposits (1021) (1022) covered another foundation (1020) constructed of uneven courses of yellow grey limestone, incorporating a door jamb segment (Figure 6; Plate 28 & 29).
