Teffont Evias Rising Main Replacement, Wiltshire

An Archaeological Watching Brief

Wessex water plc

COAS Project Reference: C1/WBF/11/TER

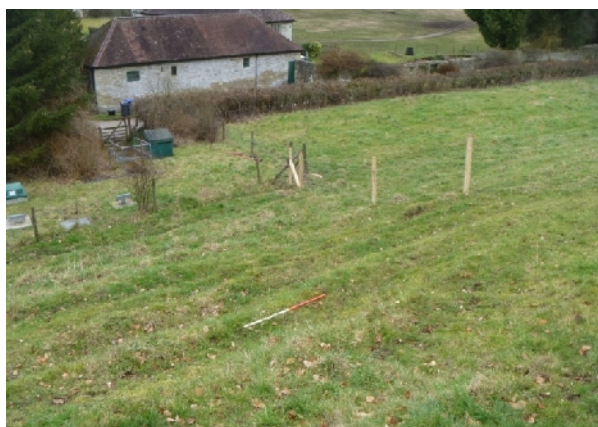
Plate 1. The Site before construction work (from W; 1m scale)

- 5.2 The topsoil (100) differed little throughout the length of the easement, comprising a mid brown soft silty clay including sparse small stones to a depth of up to 0.20m, overlying a darker, sandier, subsoil (101) (**Plate 2**) of up to 0.10m depth. This sealed a gravelly sandy clay with frequent small and some medium large limestones, some of which were rounded (102), probably constituting a disturbed bedrock (**Plate 2**). Stepping on the surface was due to well established farm animal contour tracks (**Plate 1**).

- 7.1 No archaeological deposits of finds were recovered, despite a record of earthworks in the field. However, there were very well established farm animal contour tracks which from the air, without a well-defined scale, might have appeared to be humanly engineered terracing.

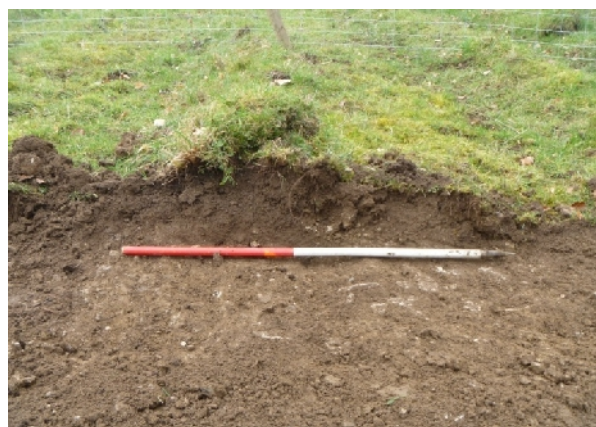
Plate 2. Profile 1 (from SE; 1m scale)
