B0375: Kingston Deverill Stream Support, Kingston Deverill, Wiltshire

An Archaeological Watching Brief

COAS Project Reference: C1/WBF/12/KDW

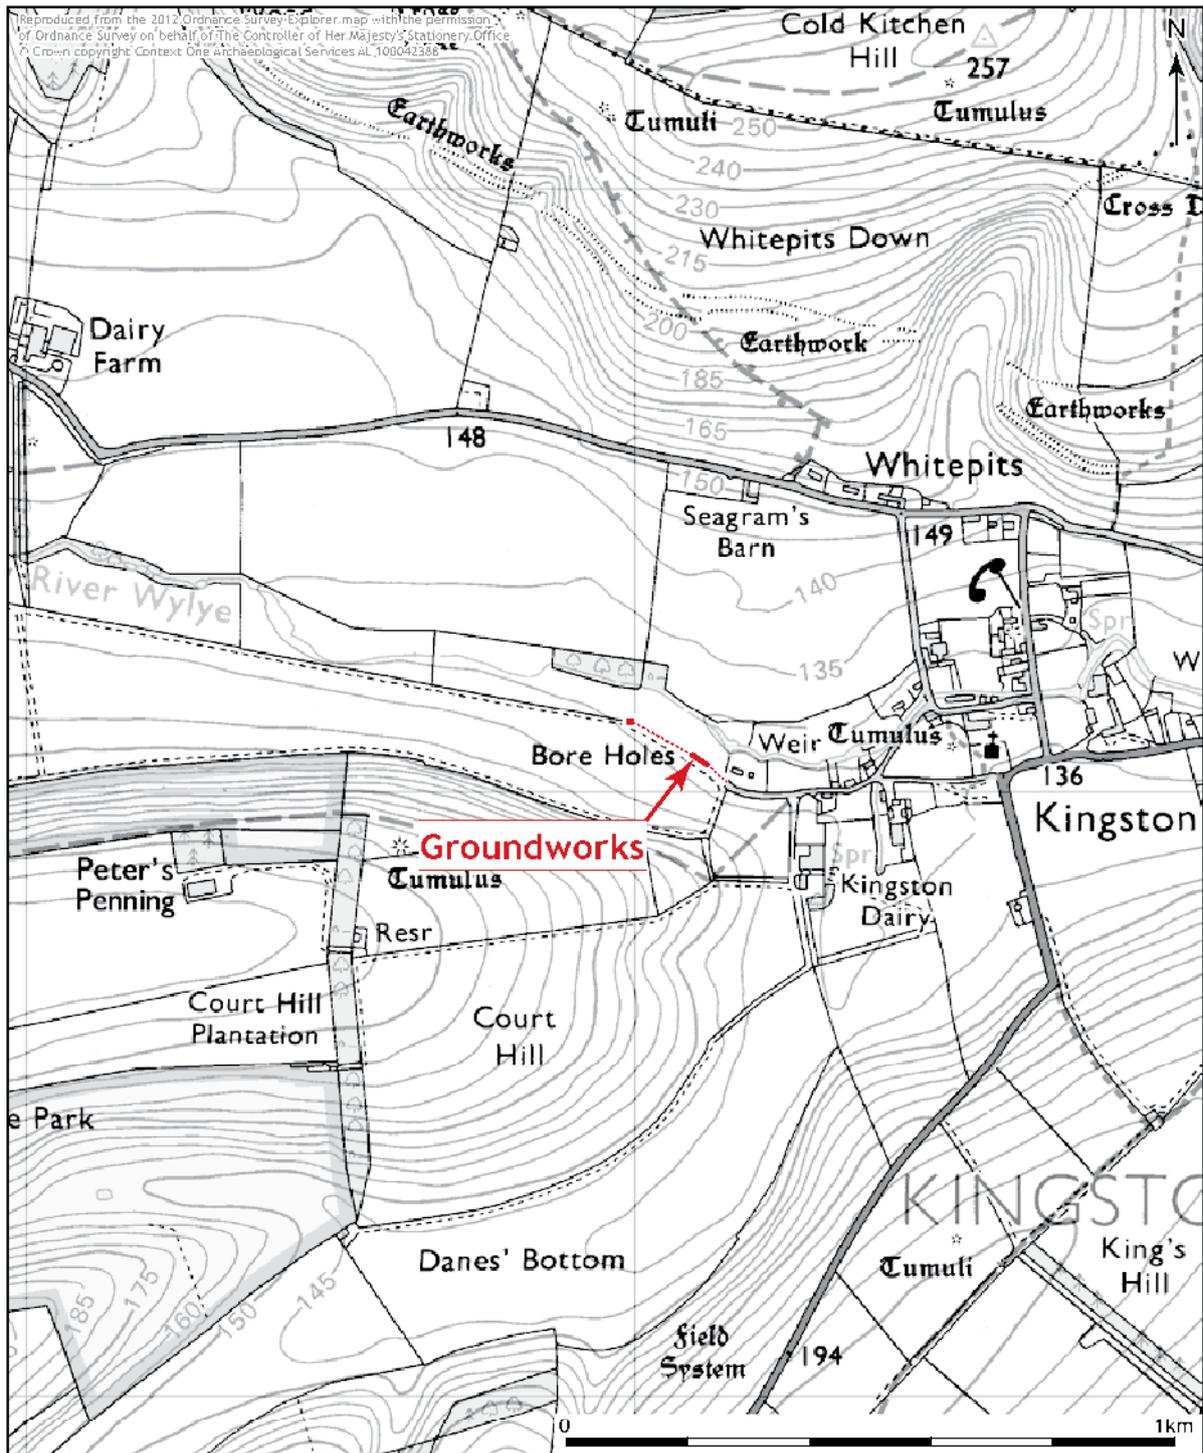
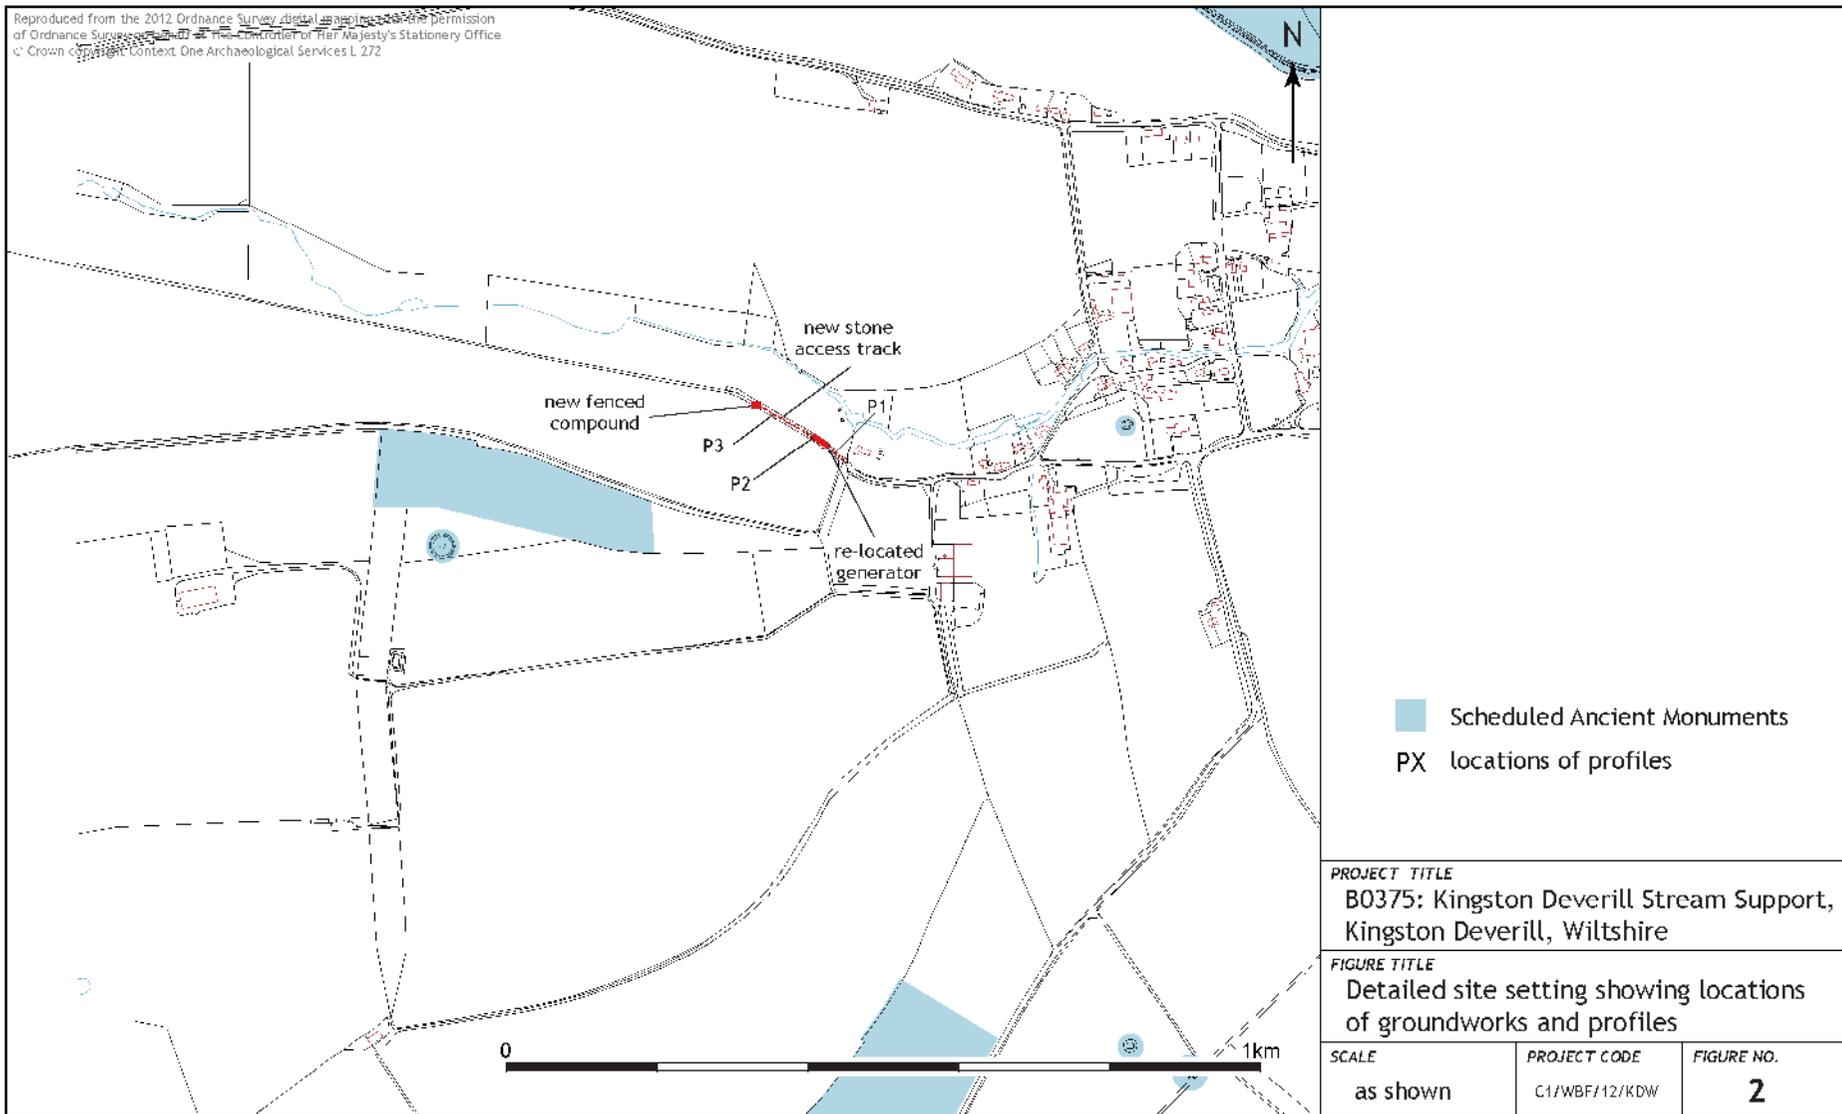
PROJECT TITLE B0375: Kingston Deverill Stream Support, Kingston Deverill, Wiltshire		
FIGURE TITLE Site setting showing groundworks		
SCALE as shown	PROJECT CODE C1/WBF/12/KDW	FIGURE NO. 1

- 3.1 The scheme comprised machine stripping of an area for the new ducting between two boreholes and an associated access track (**Figure 1**).
- 3.2 A 360 degree tracked machine fitted with a toothless grading bucket removed the overburden along the route of the proposed scheme under archaeological supervision. Machine excavation continued to the depth of formation, leaving a good surface on the subsoil to enable identification of any archaeological features.

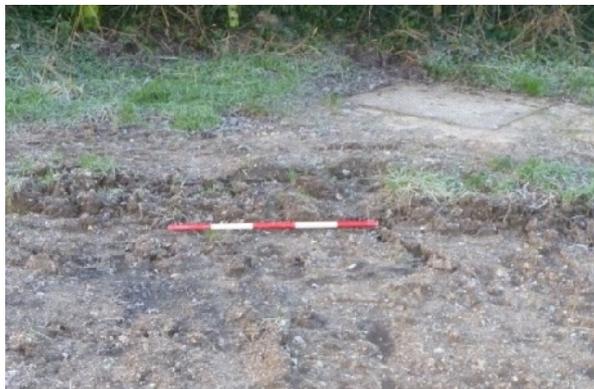
Plate 1. Profile 1 (from E; 1m scale)

- 4.2 The area observed comprised a strip of land along the north east side of a field boundary hedge and an area stripped within the compound of an old generator. The soil sequence varied according to recent land use. Along the south east approach to and beyond the old generator a topsoil (100) of mid brown silty clay included up to 20% small flint pebbles. To the east of the generator it was *ca.* 0.15m deep and covered a light brownish grey, gravelly subsoil (102) including up to 10% small flint pebbles (**Plate 1**; Profile 1). Beyond the old generator *ca.* 0.05m of topsoil barely covered a modern track made up of scalplings (101) (**Plate 2**; Profile 3).

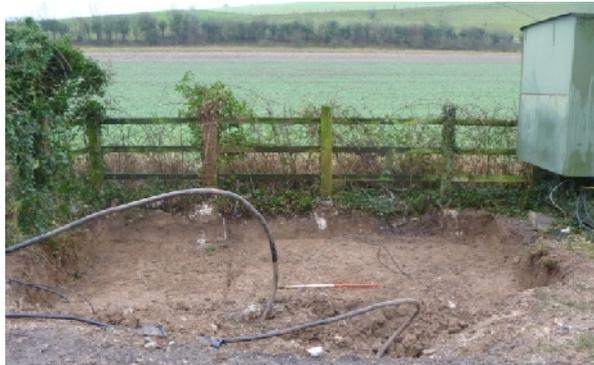
Plate 3. Generator compound (from NE; 1m scale)

- 4.3 The topsoil (200) within the old generator compound (**Plate 3**) was also shallow, with a depth of *ca.* 0.15m, but was of a mid-yellow brown colour and texture of soft sandy clay including moderate subangular and subrounded stones with route mass (**Plate 4**; Profile 2) which contrasted with the darker, heavier, soil in the field. It covered a light brown yellow sandy clay subsoil (201) with sparse inclusions of subangular and subrounded stones. The subsoil was disturbed by services to the generator and pieces of modern brick were also observed but not collected.
