BV161: Fields adjacent to the B3069, Kingston Road, Worth Matravers, Dorset

An Archaeological Watching Brief

Wessex Water plc

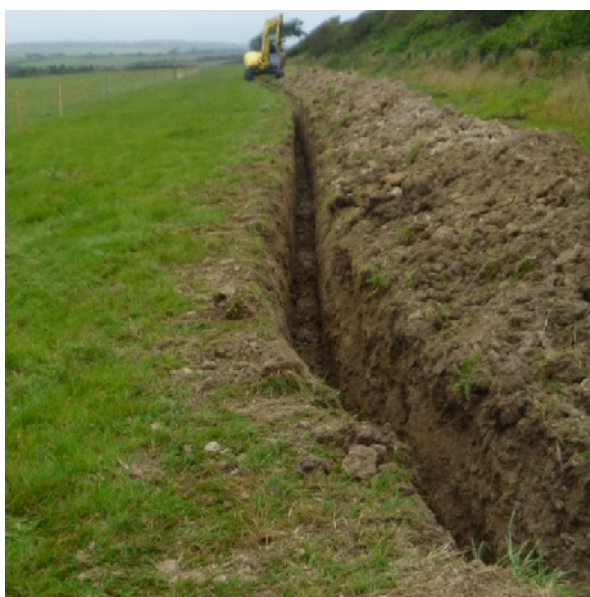
Plate 3. North pipe trench (from E; no scale)

- 4.4 The soil sequence of the north branch of the pipe trench comprised consistently of c. 0.15m deep mid grey brown firm, silty, clay topsoil (200), including sparse fragments of stone, overlying c. 0.70m of homogenous light yellowish grey compacted, very slightly silty, clay (201) including rare stones, interpreted as subsoil. The natural was mid yellow grey brown cemented clay with no visible inclusions (202) (**Plate 3**). The lie of the land implied that the soil sequence would not differ where only the easement was monitored (**Plate 4**).
