BW131: Land Adjacent to Park Cottages, Winterborne Tomson, Dorset

An Archaeological Watching Brief

Wessex Water Plc scheme reference: BW131

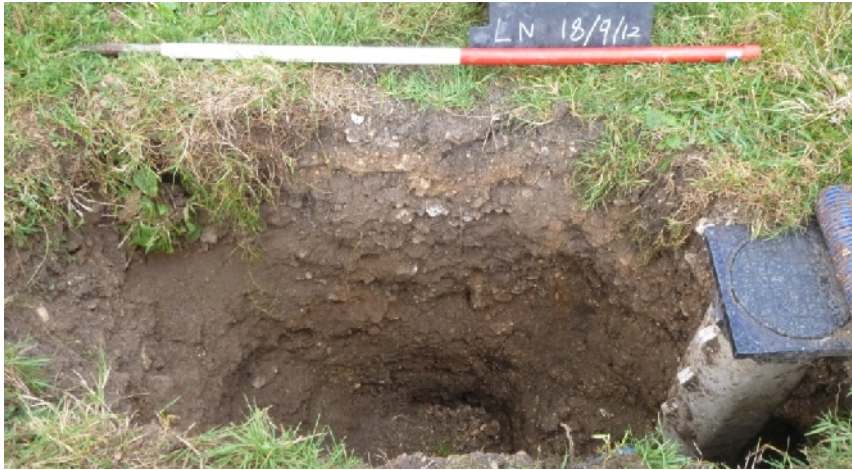
Plate 1. Reception pit 2 (from E; 1m scale)

- 4.3 At the west end of the pipeline route two of the reception pits (RP) entirely comprised backfill (100) and (200) (**Plate 1**) over which turf had formed. At the extreme west end a true sandy loam with rare subrounded gravel inclusions topsoil (900) had formed to a depth of c. 0.20m directly over river terrace gravel set in sand (901).

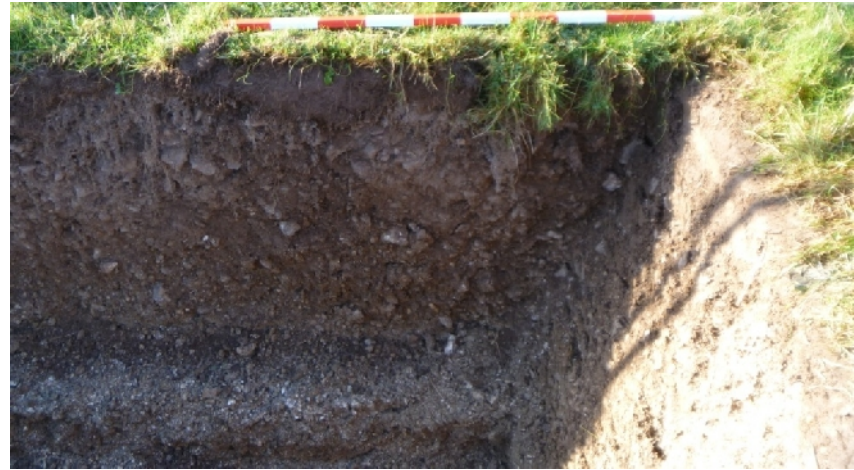
Plate 2. Reception pit 5 (from NE; 1m scale)

- 4.4 In the central pipeline section, RP3 was also made up of backfill but in RPs 4 and 5 the true soil sequence of c. 0.20m of topsoil (400) and (500) over Quaternary river terrace gravel deposits (401), (501) and (502) (**Plate 2**) were exposed. A similar sequence was exposed in RP8 at the extreme east end of the pipeline (**Plate 3**). Two pits in the middle section, RPs 6 and 7 were backfilled without observation but the level ground (**Plate 4**) where they were excavated suggested that the soil sequence would not have differed from that of RPs 4 and 5.

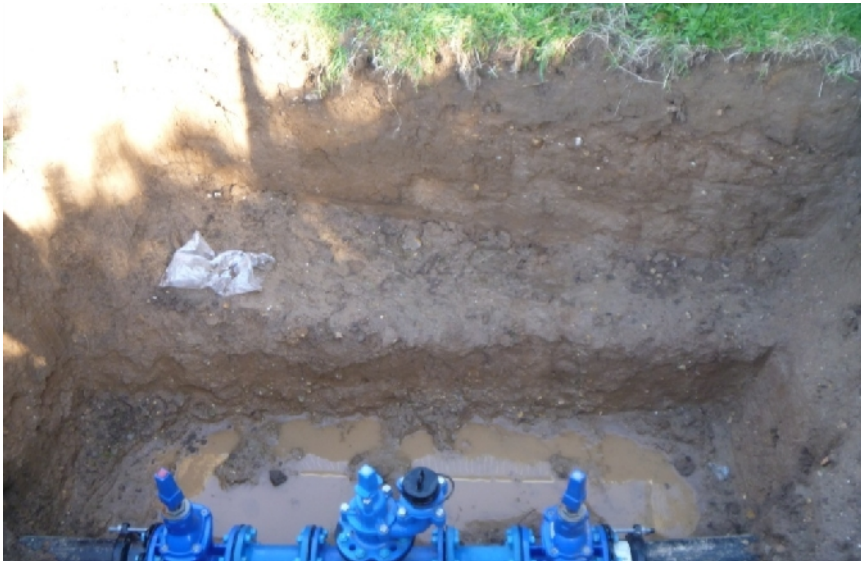
Plate 3. Reception pit 8 (from S; 1m scale)

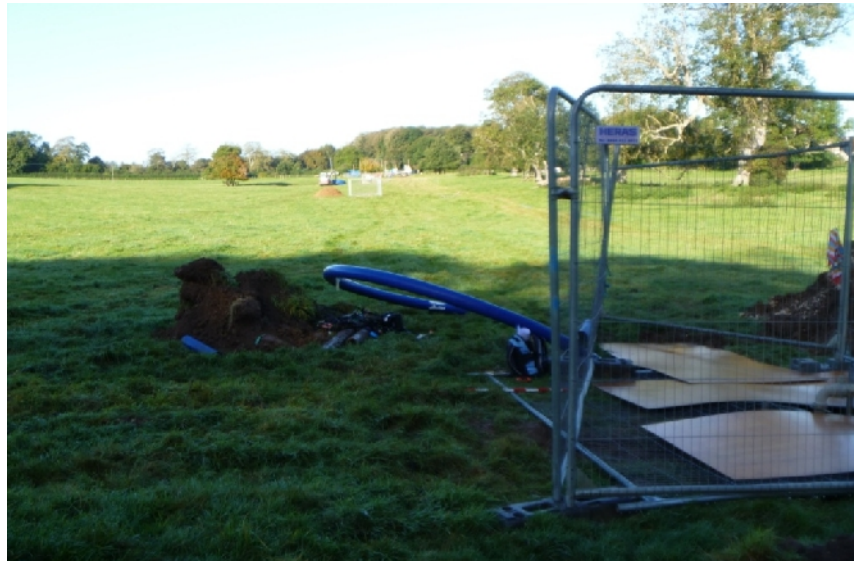
Plate 4. Reception pits 6 and 7 (from ESE; no scale)
