BW121: Yatesbury (Res) Distribution Site, Main Road, Cherhill, Calne, Wiltshire

A Programme of Archaeological Monitoring and Recording

COAS reference: C1/AMR/13/YCC

Wessex Water Plc scheme reference: BW121

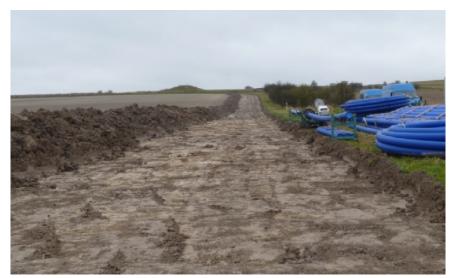
Plate 1. Looking along the easement approaching the barrow $\mbox{ (from N)}$

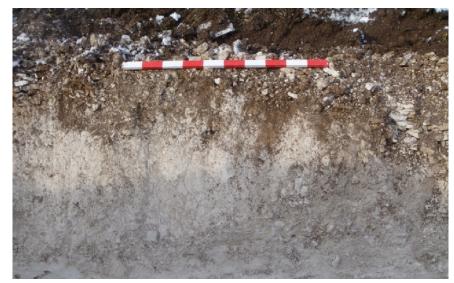
Plate 3. Profile 3 (from E; 1m scale)

- 5.3 The soil sequence was of two types, varying according to the topographical location. The topsoil was of a slightly reddish, darkish mid-brown silty loam throughout ((101), (201), (301), (401) and (501)), the depth varying from 0.20m to 0.25m. On the plateau and immediately below the head of the scarp it lay directly over periglacially fractured chalk ((102), (202), (302), (402)) (Plates 2 and 3) but further downslope a pale, brownish grey, soft, silty colluvium (402) (Plates 1 and 4) had formed over the chalk to a depth greater than that of the excavation of c. 1m.
- 5.4 Repeated parallel linears scored into the chalk were clearly the results of subsoil ploughing and were recorded in digital photographs (**Plate 2**). No archaeologically significant features were identified nor were any finds observed or recovered.

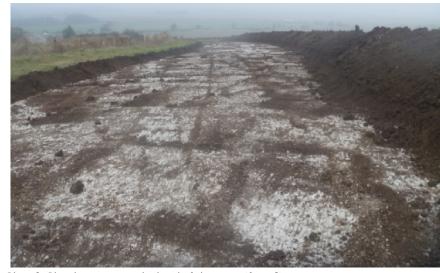
Plate 2. Plough-scarring at the head of the scarp (from S)

6.1 The archaeological work revealed that the plateau has been severely truncated by cultivation so that it is impossible to judge whether in the past there had been archaeological features or deposits associated with the barrow or other nearby earthworks. Conversely, the colluvial bi-product of intensive ploughing has formed a deep protective seal over the scarp, obscuring any deposits which may survive there.

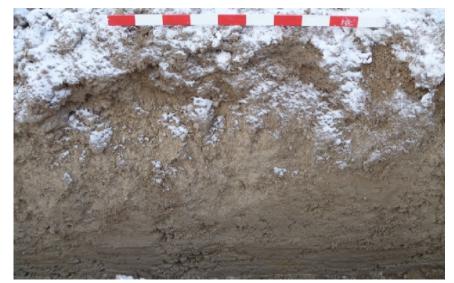
Plate 4. Profile 4 (from E; 1m scale)
