# Harper House, Hound Street, Sherborne, Dorset

## An Archaeological Watching Brief

**COAS Project Reference:** C1/WBF/11/HSD

September 2012

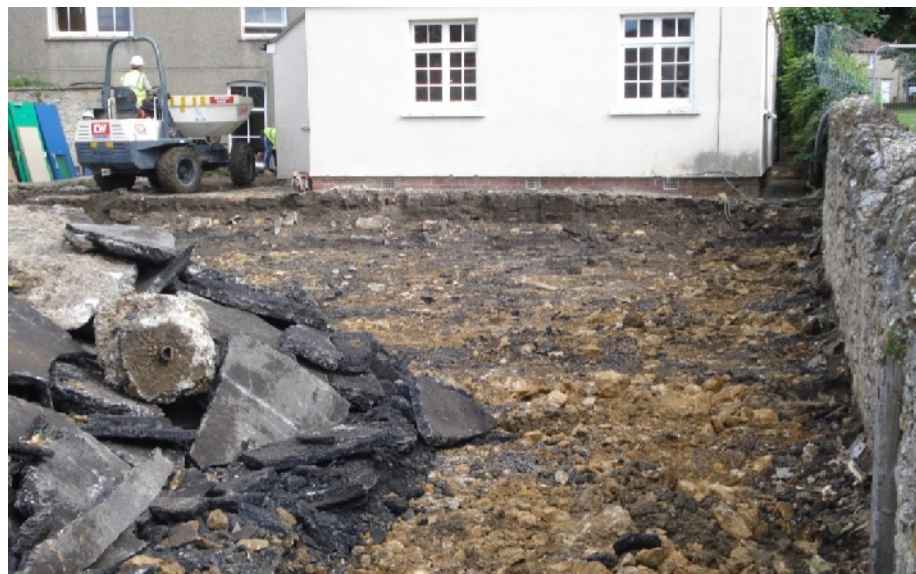
Plate 3. Area 1, general view (from SSE)

- 5.2 The area was situated on the east side of the Site, immediately south of Harper House. Prior to development it was under tarmac (**Plate 3**) set on a levelling deposit (100). The removal of the modern layers in preparation for the cutting of foundation trenches (**Plate 4**) suggested a grading in preparation for their laying as they were directly over natural (101) (**Figure 2**, profile 1; **Plate 5**).

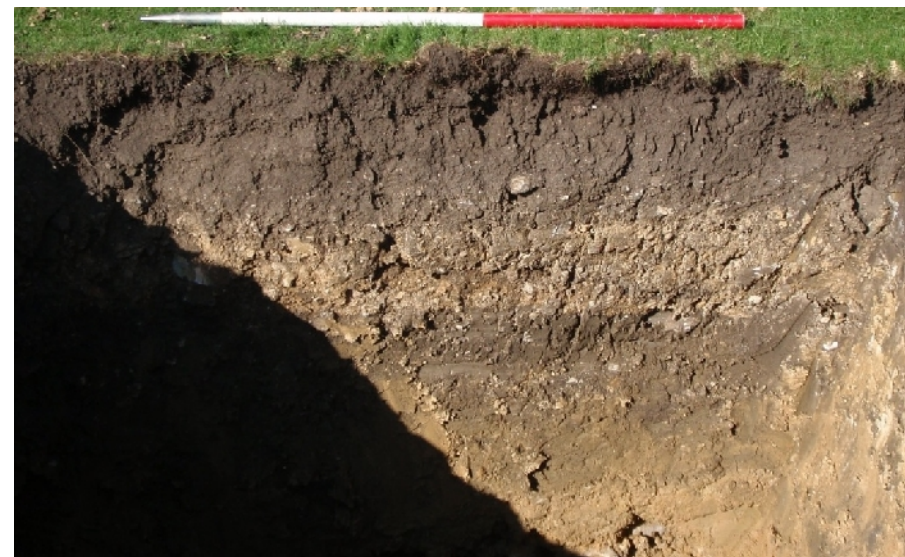
Plate 6. Area 2, profile 2 (from NE; 1m scale)

- 5.3 The area occupied land south of the centre and west of Harper House. Prior to the installation of service trenches and a soakaway it was under lawn, through the middle of which a test pit was excavated. This revealed a deep topsoil (102) sealing a possible make-up or garden drainage layer (103) over what was interpreted as an earlier garden soil (104) (**Figure 2**, profile 2; **Plate 6**).

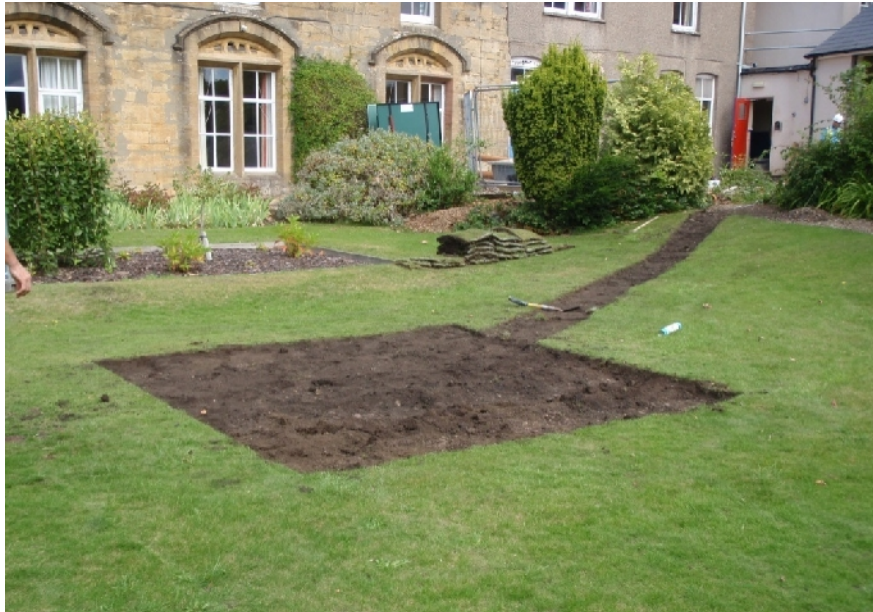
Plate 7. Area 2, soakaway (from SSW)

- 5.4 The soakaway was excavated midway between the test pit and the angle of the join between the central and east parts of Harper House (**Plate 7**). In part of the soakaway the topsoil lay directly over natural (101) (**Figure 2**, profile 3; **Plate 8**) but it also encroached on an area of presumed modern stone paving (110), also set on natural (**Plate 9**). In the service trench leading to the house courses of rough garden wall (105) (**Plate 10**) may have been broadly contemporary with the paving.

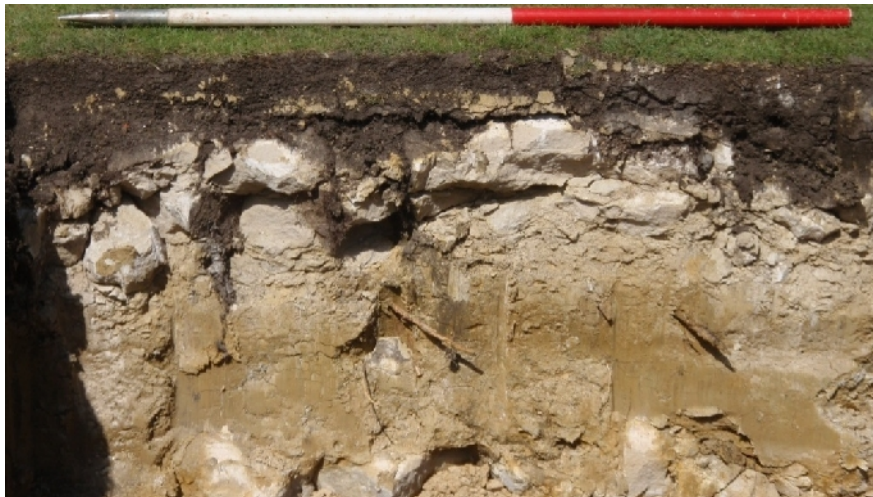
Plate 9. Area 2, limestone paving (110) (1m scale)

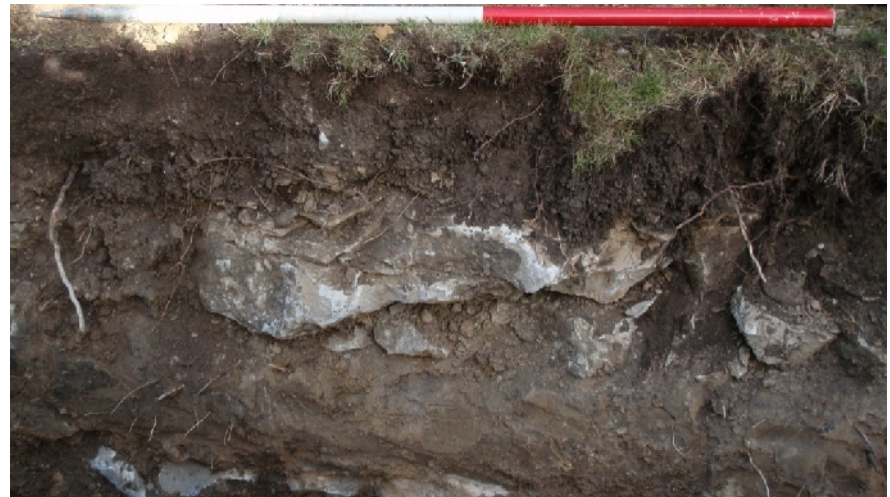
Plate 10. Area 2, garden wall (105) (from SE; 1m scale)

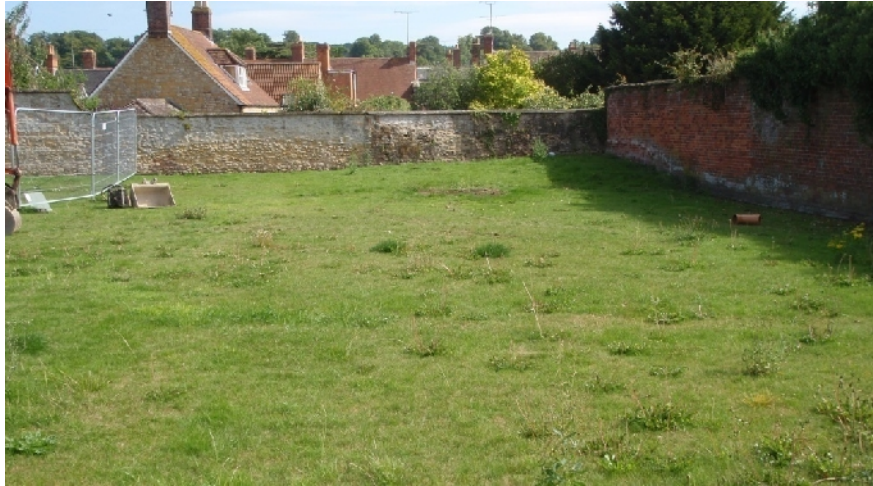
Plate 11. Area 3, profile 4 (from NNW; no scale)

- 5.5 The area in the south west part of the Site was lawned, enclosed on its south and west sides by old, high, stone and brick garden wall (**Plate 11**) with a potting shed at the north end. Services trenches revealed consistently deep, loam topsoil (**Plate 12**) exceeding 1m in depth, over natural sandy clay, a sequence identified in a test pit (**Figure 2**, profile 4; **Plate 13**).
- 5.6 No other features or archaeological deposits were found. The recovered artefacts are discussed in section 6.
