# Montgomery Primary School, Redvers Road, Exeter, Devon

An Historic Building Recording Survey

COAS reference: COAS/SBR/10/MRE

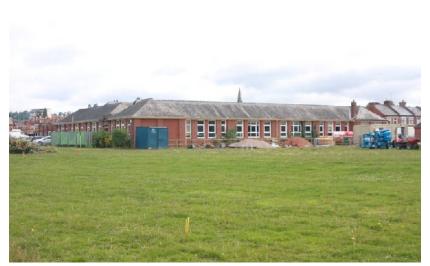
Plate 1. West and south ranges of main school building showing roof structure (from SW)

- 4.3 The main building is in the form of a quadrangle surrounded by a grassed play area. The slate-covered, hipped, roofs (Plate 1) are set over frogged brick, stretcher bonded walls (Plate 2), with breeze block architraves over the original entrances, the best example of which is one original designated for 'Girls' (Plate 3). The west and east ranges each comprise two north to south oriented units, the longer to the north, with converging hips concealed behind the breeze block architraves above the entrances. The longer section of the west range rises to two storey height. The north and south range roofs converge with the west and east at ridge height.

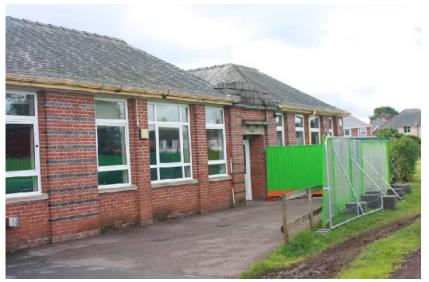
Plate 2. Overview of brickwork and western entrance, Scale 2m, Looking SE

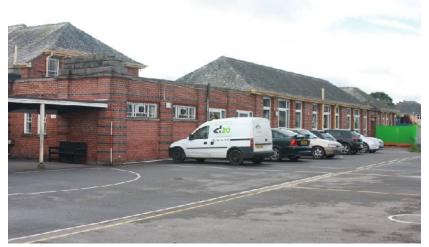
Plate 4. Main School, north west corner and west range exterior (scale 2m; from NNW)

- 4.4 A covered walkway (**Plates 4** and **5**) links the west of the north range to outbuilding B which combines a flat roofed element leading to a fully hipped slate roofed building (**Plate 6**), both single storey and facing south onto a play area put down to Tarmac and marked for sports.

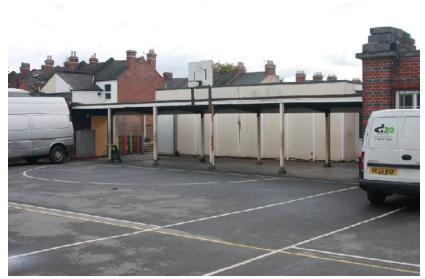
Plate 5. Covered walkway from north range (scale 2m; from SW)

- 4.5 East of the walkway a prefabricated structured has been annexed to the north range of the main building (Plates 5 and 8). On the east side it conceals the original 'Infants' entrance, the lintel for which can be seen above a modern two-leaved door (Plate 7). To the north east a covered play area (Figure 2, B; Plate 9), open on the south side, faces onto a second tarmac-covered play area. A bench along the north wall of the covered area is probably original. Above pupils have been allowed to create a colourful mural over all three walls, including a door through the east end (Plate 10).

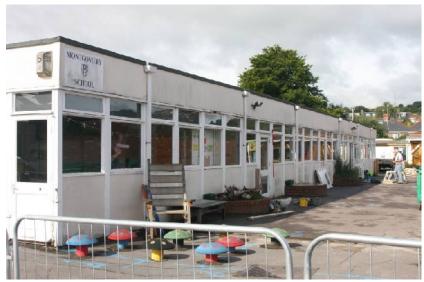
Plate 8. Modern extension to main school, scale 2m, Looking SW

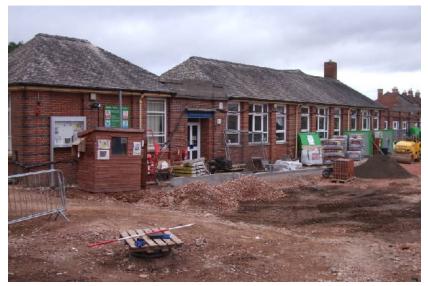
Plate 11. East range exterior (scale 2m; from SE)

- 4.6 As noted, the east range comprises two hipped units (**Plate 11**; the photograph was taken after building D had been levelled). Each bay of the north section is lit be large windows. The original lintel above the entrance, between the north and south sections, has been covered with a 'welcome' board (**Plate 12**). There is no entrance to south range, which is lit by long windows through each bay.

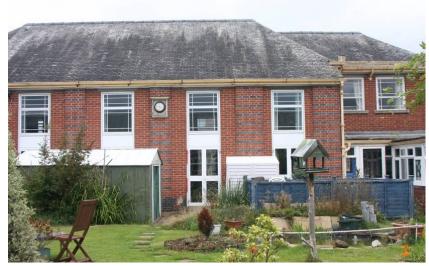
Plate 14. West range courtyard interior, across 'cloister' garden (scale 2m; from E)

- 4.7 The courtyard formed by the ranges is fringed by a single storey flat roof (**Plates 14** and **15**). This appears to have been part of the original scheme when it served as a covered walkway, open on the inside. Timber clad walls have since been added.

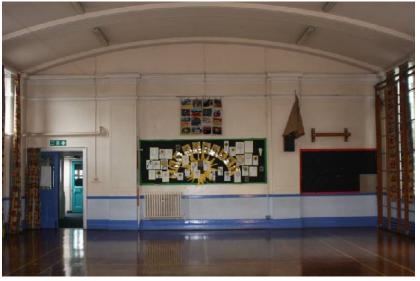
Plate 19. Assembly Hall, west end, showing sprung floor (scale 2m; from E)

- 5.3 The hall range has the principal facade of the school, facing north towards the gates of Manor Road. The facade has five tall windows lighting the volume of the hall, which is flanked by, and equal in height with, the only two storey elements of the structure (Parker 2008). Either side of the hall are two smaller rooms on two storeys lit by smaller windows. Flanking these are a pair of porches with adjoining bays that appear to have been flat-roofed cloakrooms, beyond which are covered walkways that run northwards towards the school gates. The elevation of the hall to the cloister and garden is similar in detail and appears to have originally had French windows opening directly into the central garden. The hall also houses the most highly finished and architectural interior, which is a wellproportioned room with segmental, barrel-vaulted ceiling. The walls are articulated by pilasters decorated with incised panels rising to moulded entablatures and cornices. There are broad, flat ribs crossing the segmental ceiling and a highly polished sprung floor (Parker 2008).

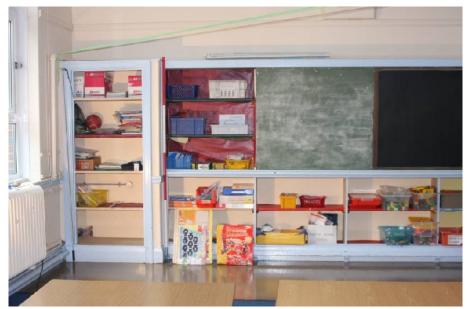
Plate 22. Typical Classroom teaching wall (scale 2m; from ENE)

- 4.10 Classrooms were accessed directly from the corridor by single a door in a corner. Typically they included built-in shelving set to one side of (**Plate 22**) and below a blackboard (**Plate 23**).

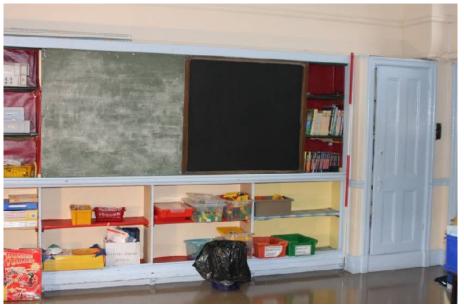
Plate 23. Typical Classroom teaching wall (scale 2m; from ESE)

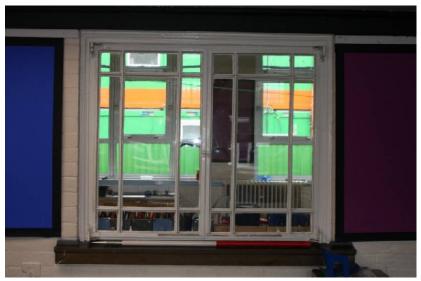
Plate 26. Original east range metal casement window (scale 1m; from W)

- 4.12 Metal casement windows were still *in situ* (Plates 26 and 30) and wooden framed windows with ringpull latches for upper sections were also still in place (Plate 31). Distinctive rectangular planned column bases and capitals are fully exposed along the east corridor (Plate 27). It is not clear whether or not a Belfast sink (Plate 28) in an art room is part of the original scheme but a gauzed vent in the same room (Plate 29) is of a style which suggests it might be, as is true of a built in cupboard in the first floor staff room (Plate 32). Elsewhere there are metal electric switches (Plate 33) and Bakelite door knobs (Plate 34) which may also date to the time when the school was built.

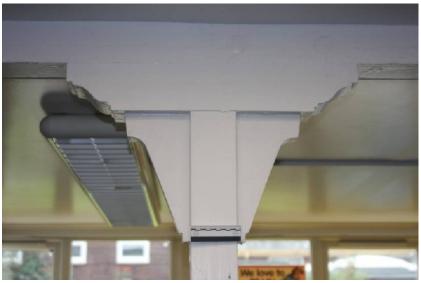
Plate 27. Detail of roof support, east corridor (no scale; from W)

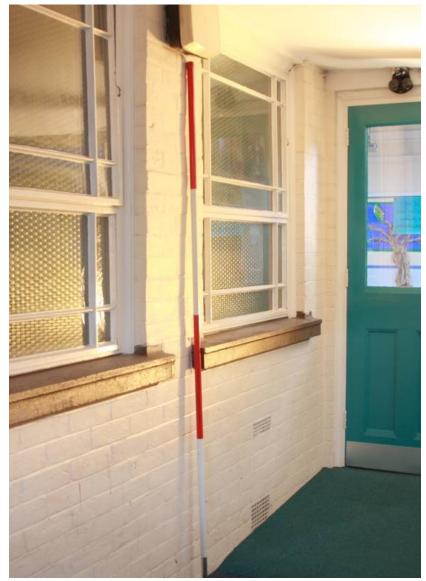
Plate 30. Original metal window, hall approach (scale 2m; from WSW)

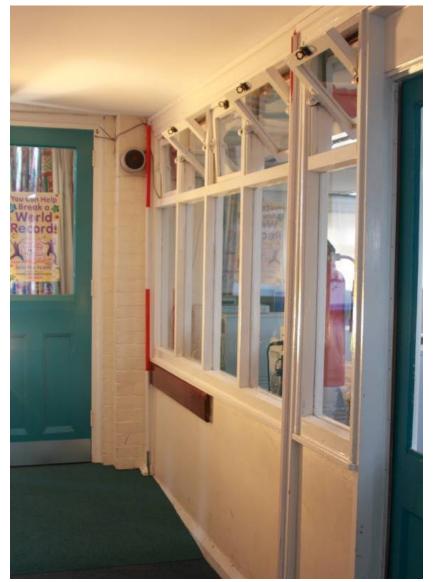
Plate 31. Original wooden window, hall approach (scale 2m; from WNW)

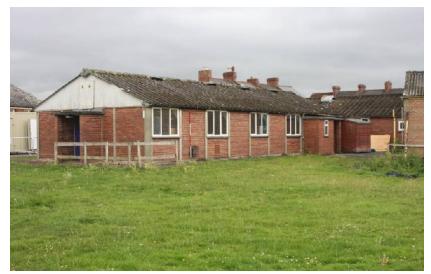
Plate 35. MOWP Hut (E) showing roof structure (scale 2m; from SW)

- 4.14 The gable roofs are covered with corrugated asbestos over walls of frogged brick in stretcher bond set between concrete uprights (Plates 35-38). A boiler house chimney stands at the south end of building D (Plate 39). Building E housed a school dining area (Plate 40), accessed by twin leaved wooden doors at the west end (Plate 41) and served by a row of hatches at the east end (Plate 42). Beyond the hatches an internal twin leaved door (Plate 43) gives access to the kitchen area in building D. Ceramic tiles cover the floor east of the hatches and throughout the open areas of building D (Plates 43 to 46).

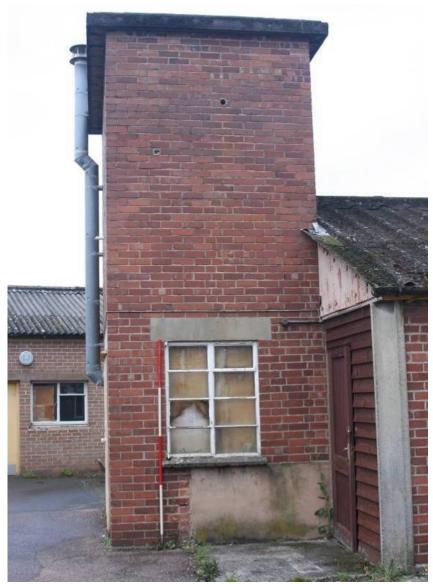
Plate 39. MOWP Hut (D) boiler chimney (scale 2m; from E)

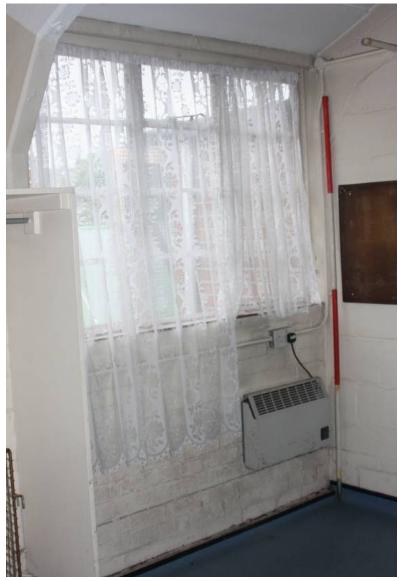
Plate 47. Detail of metal windows within MOWP Hut (D) (scale 2m; from NW)

- 4.15 Original fitting included panelled doors (**Plate 46**) and metal framed windows (**Plate 47**). Bricks under a lintel show that a small room on the south of the east side of the building had internal access but at the time of the survey it could only be reached from the outside. Access to the building was via a projecting porch at the north end of the east side.

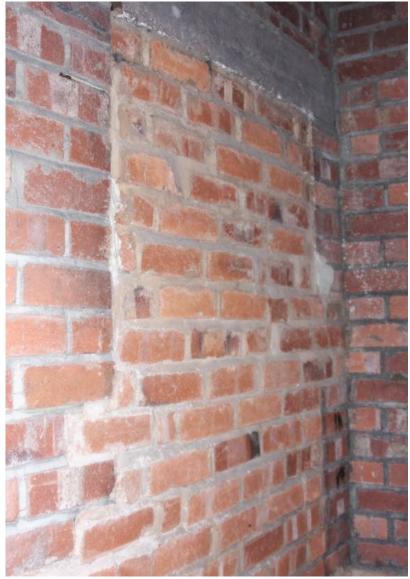
Plate 48. Detail of MOWP Hut (D) brickwork (from SE)
