5583141: 37 Walcot Street, Bath.

A programme of Archaeological Monitoring and Recording

COAS reference: C1/AMR/14/WSB

Wessex Water plc scheme reference: 5583141

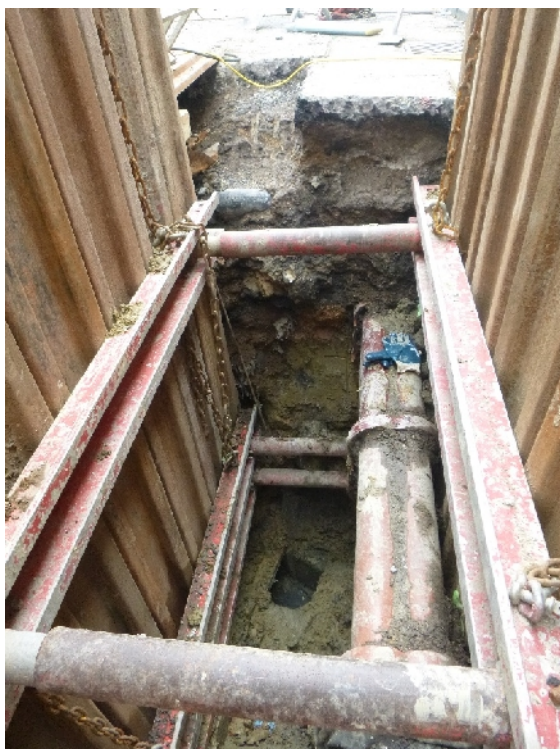
Plate 1. Deposit sequence (from S)

- 4.1 The deposit sequence comprised modern tarmac, above a series of make-up layers and (presumably) earlier road surfaces, overlying the modern pipe trench backfill comprising redeposited greenish grey clay with stones. From a depth of c. 1.5m below the tarmac this overlay natural green clay which continued to the base of the trench (Plate 1).
- 4.2 At a depth of c. 2m a stone culvert (Plate 2) and an iron grate (Plate 3) were observed within the otherwise undisturbed natural green clay. A void in the culvert revealed it was constructed of Bath stone and brick (Plate 2) and photographs taken within the culvert show it had predominantly collapsed (Plate 4).

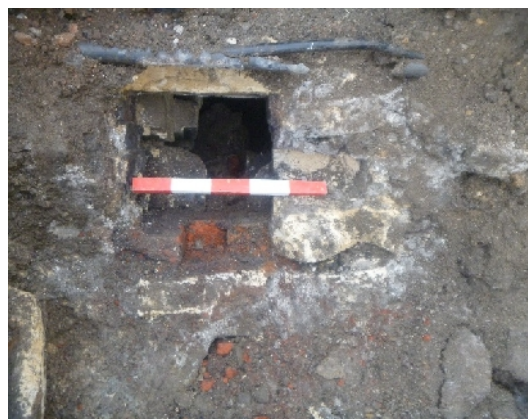
Plate 2. Void in culvert (0.5m scales)

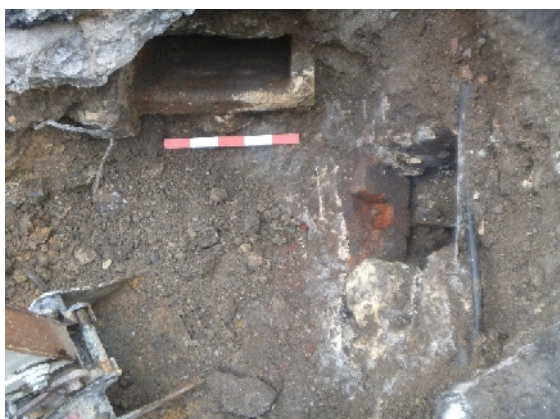
Plate 3. Iron grate & void in culvert (0.5 scales)

- 6.1 Despite the potential for significant Roman, medieval and post-medieval remains on the Site, development excavations exposed only a collapsed Georgian culvert and an iron drainage grate. Both features were set within the seemingly undisturbed natural clay which underlay a series of modern road surfaces and make-up layers, continuing to the base of the trench at a depth of c. 2.5m.

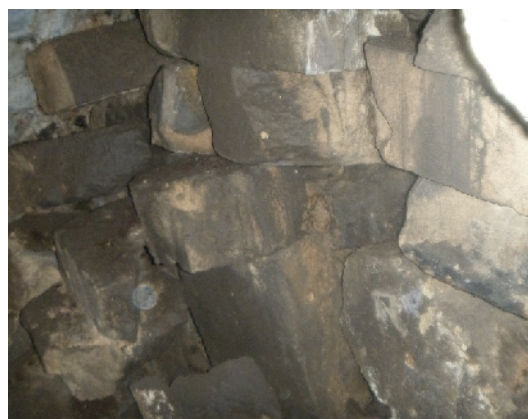
Plate 4. View inside collapsed culvert
