# Former Dairy Building, Court Farm, Wookey, Somerset.

## An Archaeological Evaluation

**COAS reference:** C1/EVA/14/CWW

**Scheduled Monument Consent reference:** S00086622

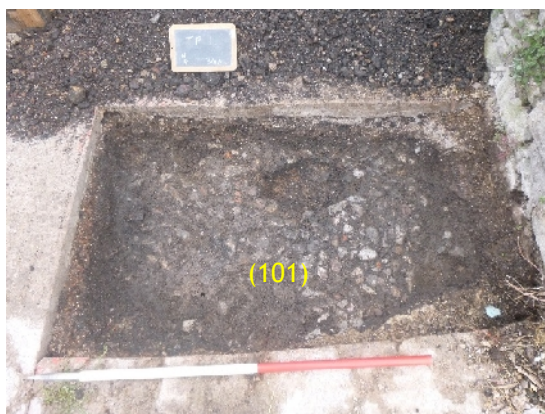
- 5.2 The stratigraphic sequence in all of the trenches was similar. Outside of the former dairy, in TP's 1 and 2 the modern concrete or hardcore (00) overlay a cobbled surface of an exterior yard at a depth of between 0.20m and 0.50m below the modern ground surface (**Plate 1**). The cobbled surface comprised rounded stones (101) in TP1 and sub-angular stones (201) in TP2 within a mid-brown silty matrix containing fragments of ceramic building material (CBM). In TP2 this surface overlay a stony redeposited natural (203) comprising orangey brown silty clay with frequent stones and angular gravels, probably a bedding or levelling layer for the cobbles. Both had been disturbed by a modern service trench (202).

Plate 1. TP1, cobbled surface (from S; 1m scales)

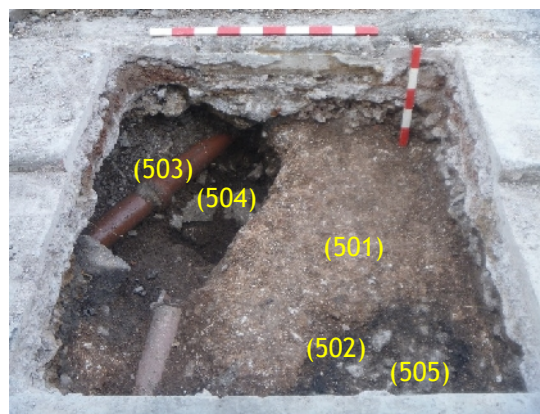
- 5.3 In TP5, also outside the dairy, modern concrete/ hard core (500) overlay a modern pipe trench (503) and throughout most of the trench a mortary demolition layer (501) comprising light/ pale orange cream silt mortar with frequent gravels and CBM fragments (**Figure 2, Plate 2**). This was recorded at a depth of between 0.40m and 0.55m below the modern ground surface and was

- 5.5 An area of rubble (504) within the north-west quadrant of TP5 comprised lias stones and occasional slate fragments within a loose dark brown clay matrix (**Figure 2; Plate 2**). This was recorded at a depth of 0.7m below the modern ground surface and had been disturbed by the modern drain (503). The rubble continued beneath the drain to the base of the trench (1m below the modern ground surface) but had previously been disturbed. To the east of the modern drain (503) the archaeology was better preserved, the cobbled surface (505) overlying a 0.35m deep disturbed deposit (506) comprising large stones set within a mid-brown silty clay matrix (**Figure 2**). Some of the stones had been semi-dressed with some *in-situ* upright slabs aligned north-north-east to south-south-west (**Figure 2; Plate 6**) suggesting the remains of a drain or culvert. The surface of these remains were located at 0.50m below the modern ground surface. This feature was removed with the agreement of EH in order to reach the proposed construction depth of 1m. Just below this depth was a probable wall (507) aligned north-north-west to south-south-east constructed of semi-dressed blue lias and local yellow stone with no apparent bonding material (**Figure 2; Plate 7**). The disturbed rubble (504) in the north-west corner of the TP shared an identical alignment and is likely to represent a continuation of the same wall. The wall was set within a deposit (508) comprising compacted mid orange brown silty clay with moderate to small subangular stones; while no construction cut was discernible this may be redeposited natural associated with the wall construction.

Plate 2. TP5, part-excavation with modern drain, mortar, cobbling & disturbed ?wall (from S; 0.50m & 1m scales)

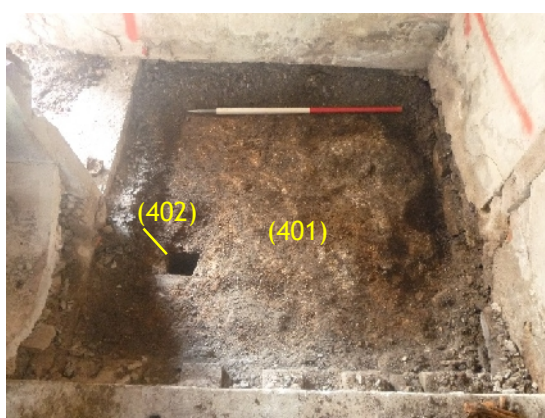
- 5.5 Two voids lined with post-medieval brick ((402) and (703)) were recorded in TP4 and TP7 at a similar depth of c. 0.25m below the modern ground surface (**Plate 3**). Interpreted as post settings within the former dairy building, neither penetrated the bedding or levelling layers (403) (704) beneath surface (401) and hard core layer/ surface (701).

Plate 3. TP4, mortar surface & brick-lined post-setting (from W; 1m scales)

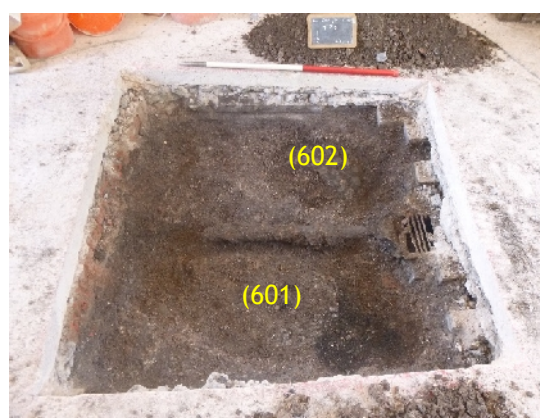
Plate 4. TP6, cobbling & mortar (from N; 1m scales)

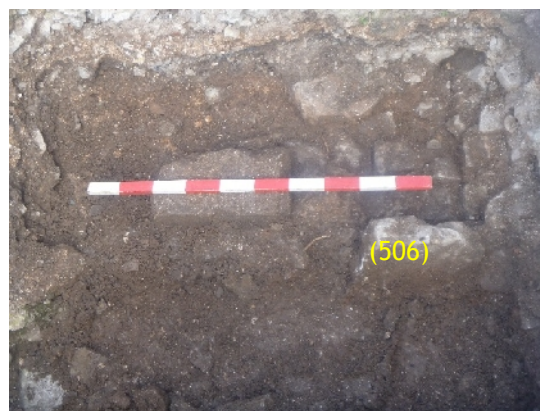
Plate 6. TP5, remains of disturbed culvert/drain (from WSW; 1m scales)

- 6.1 The archaeological evaluation has identified three archaeological features. To the west of the former dairy (within TP5; **Figure 2**) a stone-lined culvert or drain (506) aligned north to south was recorded above a wall (507) aligned north-north-east to south-south-west. The culvert or drain may relate to the medieval water system, sharing the same orientation as the previously identified medieval culvert to the east. The surface of this feature was located at a depth of 0.50m below the modern ground surface and continued to a depth of 0.90m. Consequently, the culvert or drain falls within the proposed construction depth of 1m for this area and as such the foundation trenches would necessitate the removal of two short sections, if indeed the feature is continuous which heavy disturbance suggests it may not be. The surface of the earlier wall was located at a depth of 1m and therefore falls immediately beneath the proposed construction depth.

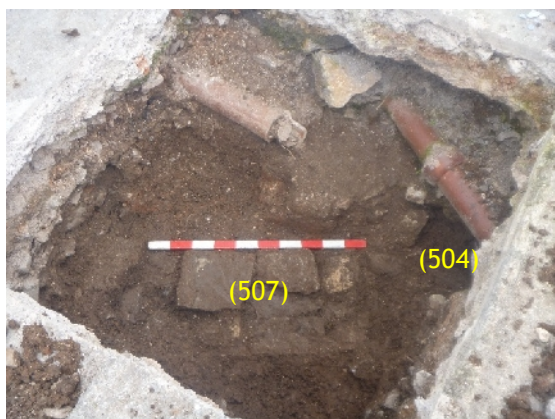
Plate 7. TP5, base of wall (507) (from NE; 1m scales)
