# Rose and Crown, 52 Newport Road, Barnstaple, Devon.

## An Historic Building Assessment

**Mazzard Investments Ltd**

May 2014

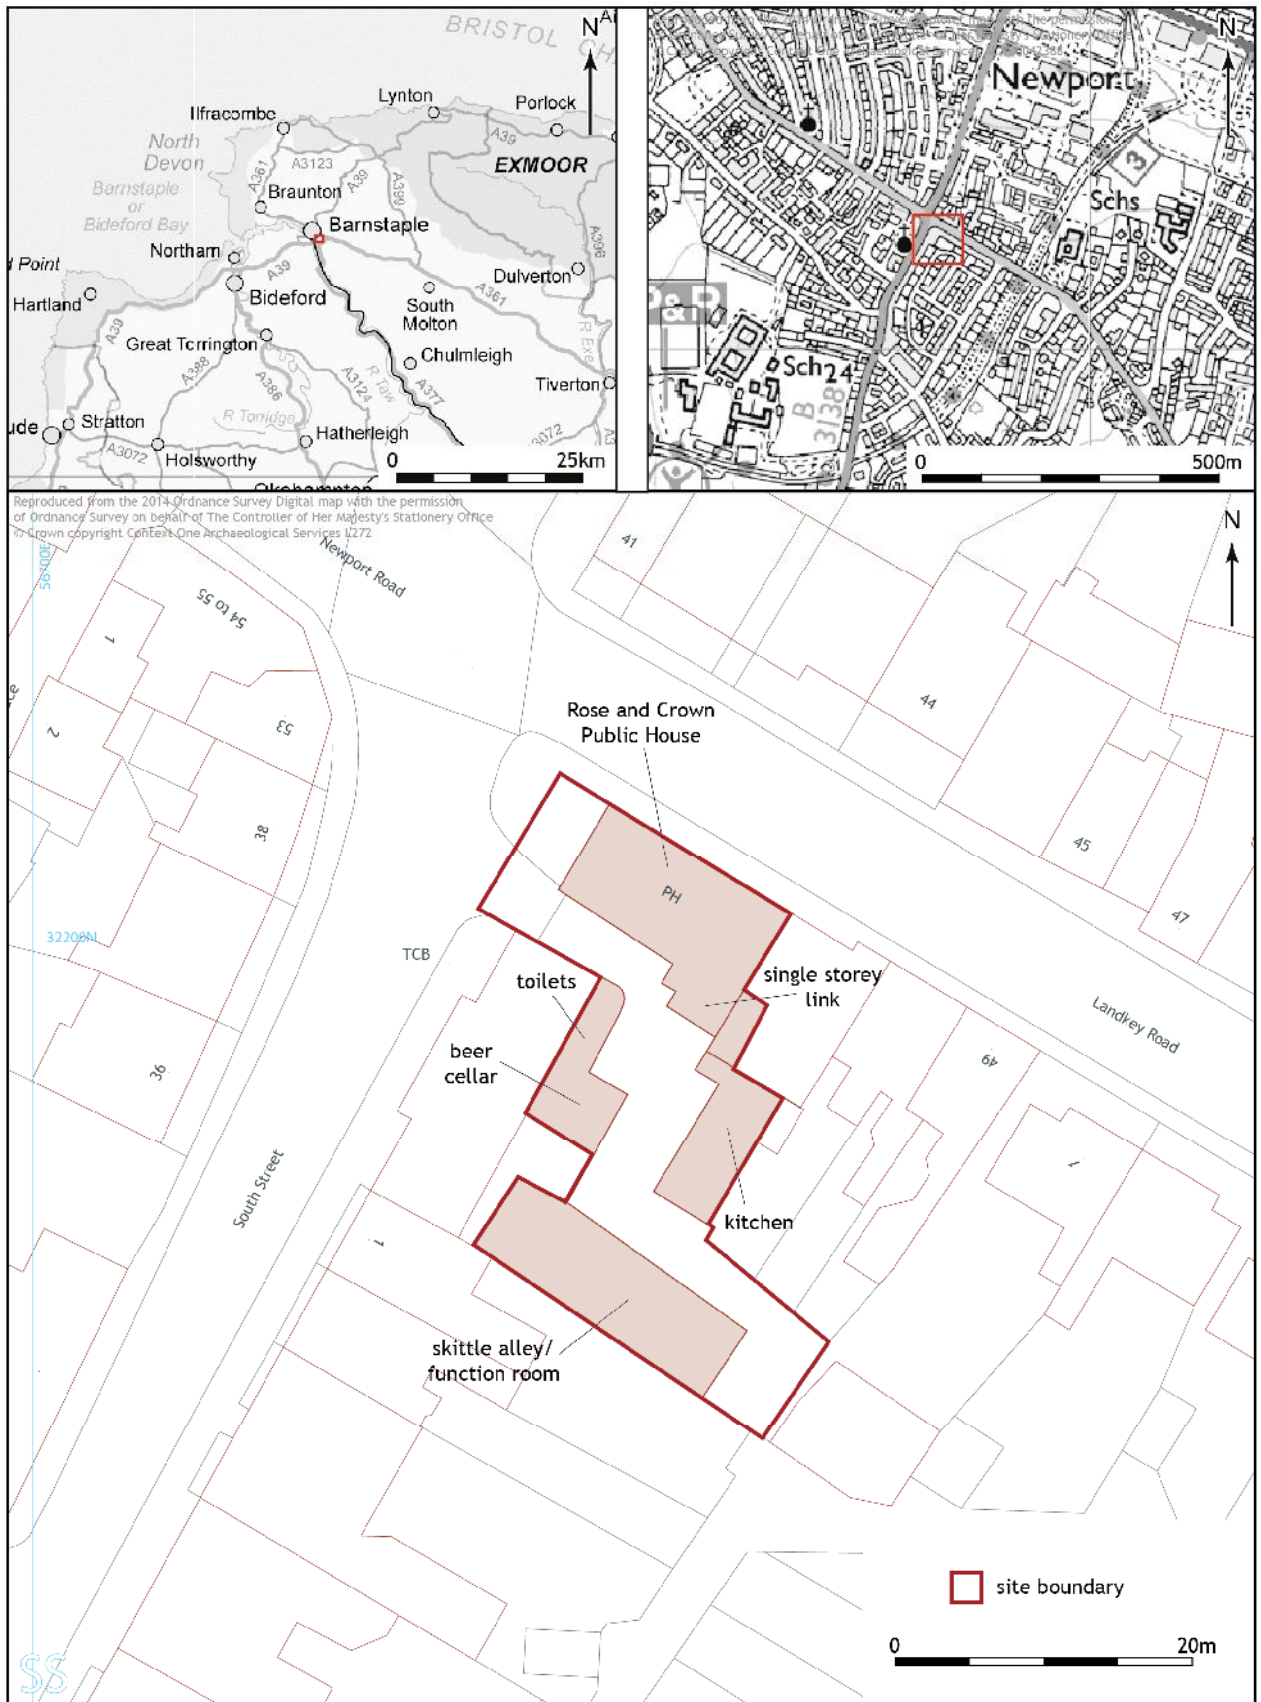
Figure 1. Site setting

- 3.1 The Rose and Crown public house is located at the eastern end of Newport Road in Barnstaple, Devon, at the junction with South Street (**Figure 1**). The Site (centred on NGR SS 56741 32189) occupies an area of land in the south of the town, with St John's Baptist Church to the south-west. The complex of buildings includes the public house fronting Newport Road, with further buildings to the rear of the pub arranged around a central courtyard. These comprise a single-storey kitchen extension connected to the public house via a single-storey link building; a single-storey skittle alley; a beer cellar and adjoining toilets. The buildings occupy level ground at an average height of c. 20m above Ordnance Datum (aOD).

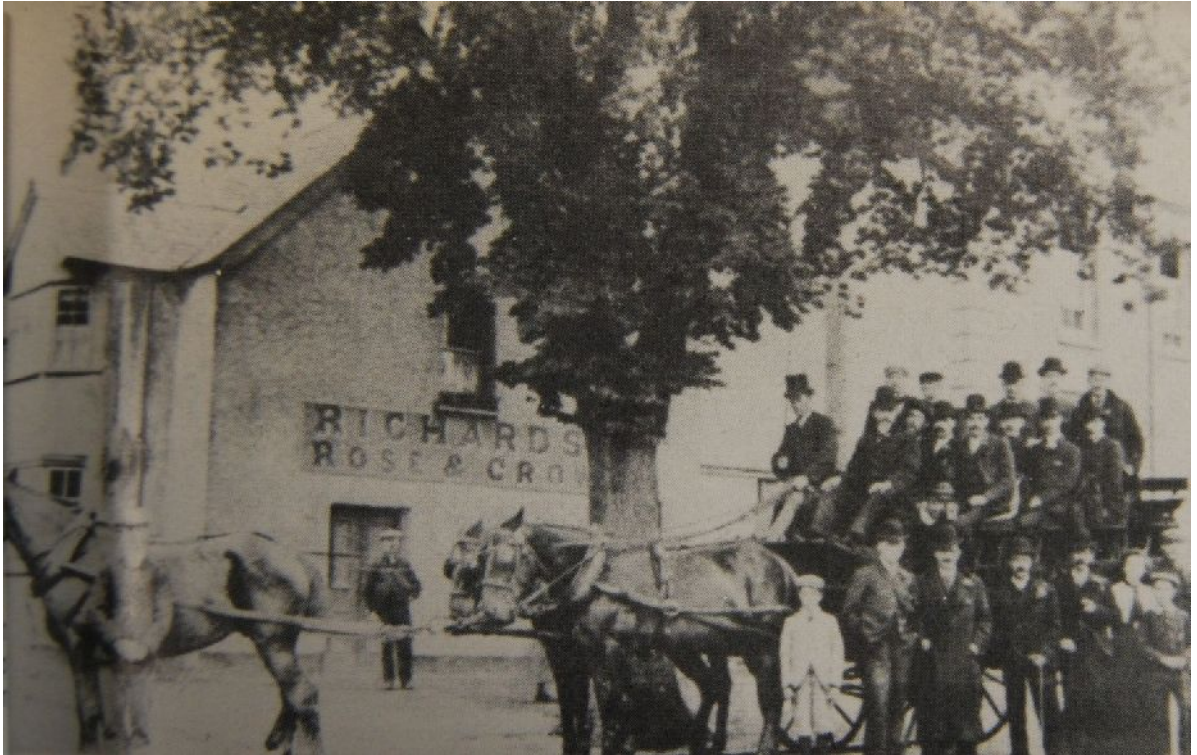
Plate 2. 'Richards Rose & Crown' with hollow tree, late 19<sup>th</sup> century (Baxter 1980, pl 61)

- 4.6 A late 19<sup>th</sup> century photograph (Plate 2) shows a sign saying 'Richards Rose and Crown' on the north-west elevation. A through-storey bay window is also present at the north-western end of the north-east elevation. The caption for Plate 2 states that in early Victorian times the hollow tree, which stood outside the Rose and Crown, was 'a favourite resort for picnic parties. They would sit on the half dozen seats inside the tree and dine on strawberries, junkets and cream'. In 1886 a regular bus service from Rumsam to Pilton was set-up to ferry tourists.

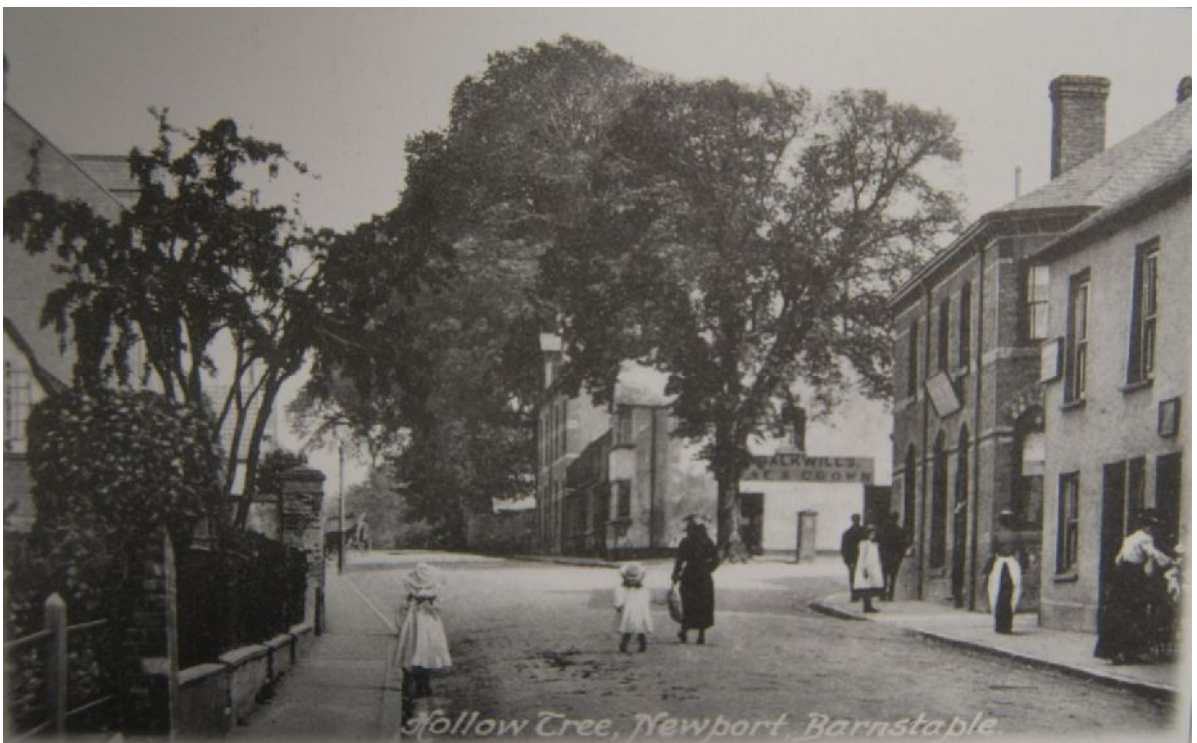
Plate 3. 'Chalkwills Rose & Crown' with hollow tree, c. 1900 (Barthram 2002)

- 4.7 In c. 1900 the sign on the north-west elevation read 'Chalkwills Rose and Crown (Plate 3). The hollow tree was still present in c. 1911 with the now demolished 39-40 Newport Road on the right, the three cross-room passage farmhouse probably dating from the 17<sup>th</sup> century (Plate 4).

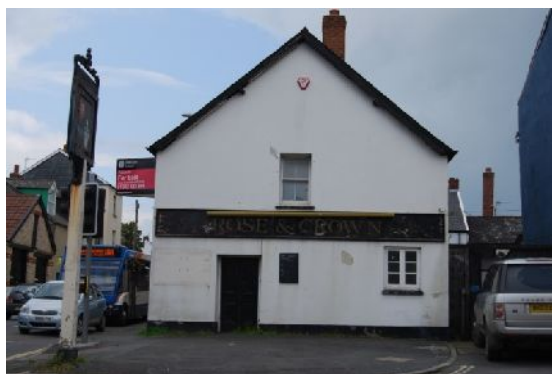
Plate 5. North-west elevation overlooking South Street (from NW)

- 5.3 The Rose and Crown is a low two-storey building on Newport Road at the junction with South Street (see **Cover image**; **Plate 5** & **Figure 1**). Both the north-east and north-west elevations are rendered (**Plates 5** & **6**). To the south-east is an adjoining cottage, the north-east elevation sharing the same eaves level as the Rose and Crown (see **Plate 6**) although the roof of the cottage is higher and the south-west elevation is on a different alignment (see **Plate 7**) indicating that the property is separate. The cottage appears to have been added later, encompassing the substantial rubble built chimney which protrudes from the south-east gable end of the Rose and Crown (see **Plate 8**). A line of slates on the chimney indicate the original height of the roof, the depth above the level of the original roof trusses (see below) indicating it was once thatched.

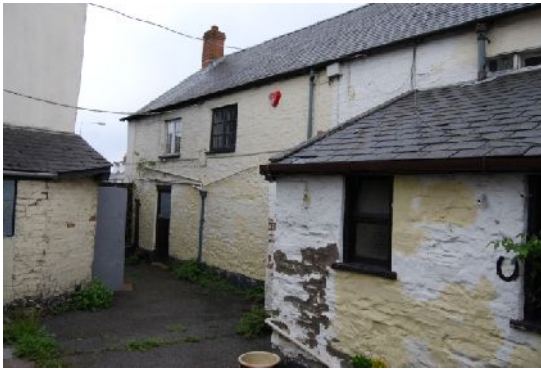
Plate 9. Rear of Rose & Crown with outbuildings (from SSE)

- 5.4 The construction of the rear elevation is visible beneath the whitewash (see **Plate 9**) revealing alternating areas of rubble and brick with several blocked openings. A single-storey rubble built lean-to structure is attached to the eastern end of the elevation, butting against the western side of the kitchen extension (see **Figure 3**; **Plate 7**). A small brick-built outbuilding was later constructed on the east side of the lean-to, with a further small lean-to providing access to the extension. The eastern end of the Rose and Crown is accessed from this extension. The former kitchen extends south-eastwards from the extension; Victorian floor tiles were noted.

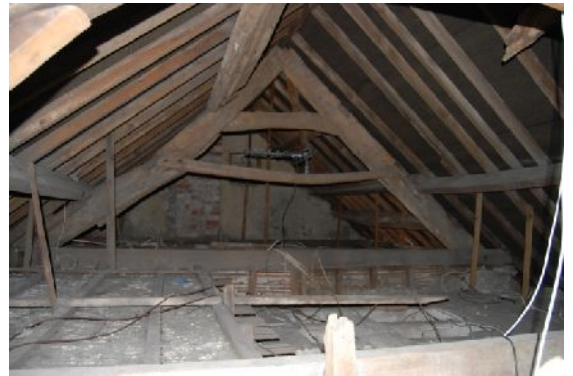
Plate 10. Roof showing jointed cruck truss towards W end (from SE)

- 5.5 Within the roof were three jointed cruck roof trusses; one near the north-west gable end (see **Plate 10**); one to the south-east; and a further one near the south-east gable (see **Plate 11**). A joint in each of the north-western and south-eastern trusses have given way although the other cruck joints remain intact (see **Plate 12**). Some of the original purlins are in-situ (see **Plates 10-13**) together with several arched wind braces (see **Plate 13**). The bays at either are raised slightly higher than the central area; the remains of lathe and plaster walls with attached uprights indicates divisions within the loft space (see **Plate 13**). The crucks are visible in six first storey rooms, either as curving timbers (painted in black gloss paint) or as shapes beneath the plastered walls. The approximate locations of the curved crucks are indicated on **Figure 4**. Two of the curved timbers (presumably within principal rooms) have been carved; one with a rose and the other with two stylized leaves with buds (see **Plates 14, 15** & **16**).

- 6.4 To conclude, the surviving original roof timbers are important historic features; these comprise the jointed cruck trusses, curved blades (including the rose and leaf carvings), purlins, arched braces and remnants of timber partitions. More detailed recording of the roof timbers would perhaps provide a closer date for the building. Nevertheless, the jointed cruck construction set within a solid wall is in-keeping with late medieval/early post-medieval rural houses. This would make it contemporary with the group of 16<sup>th</sup> and 17<sup>th</sup> century buildings centred on the medieval marketplace, within the borough of Newport and on the outskirts of the medieval town of Barnstaple. Despite extensive later alterations within the building, it is possible that further historic features, such as blocked windows and doors or evidence for internal partitions, may be uncovered during renovation works. With the exception of the kitchen range which was present by 1840, the other buildings within the Rose and Crown complex date from the late 19<sup>th</sup> century; none are considered to be historically significant.

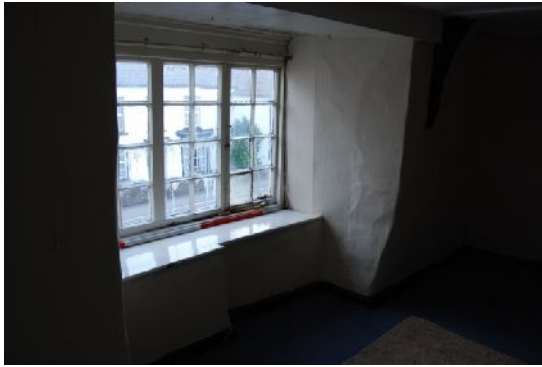
Plate 17. Window recess & cruck blade (from WSW)

- 5.6 The thickness of the walls is evident in the window recesses at first floor level (see **Plate 17**) and the ground floor, where openings have been re-modelled and blocked. The ground floor is mostly occupied by the bar (see **Plate 18**); the solidly built entrance lobby from the front elevation is probably a later insert. The large exposed timber joists do not correspond with the jointed cruck trusses and therefore are likely to be a later insert. However, a partially exposed timber on the left side of the central entrance lobby may be part of the original frame but requires further investigation. The chimney in the north-west gable is entirely set within the wall (now used as a cupboard) and therefore is likely to be later than the protruding chimney at the south-east end.

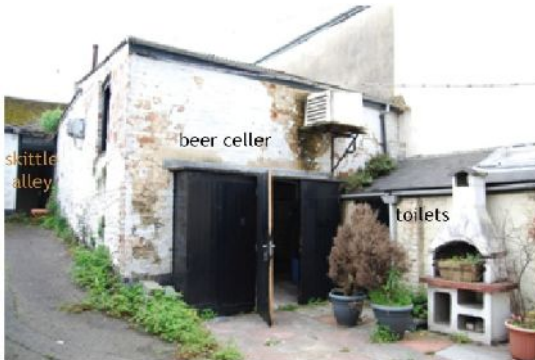
Plate 19. Beer cellar, toilets & skittle alley (from NNE)

- 5.7 On the opposite side of the courtyard to the Rose and Crown is a single-storey lean-to structure (toilets) and a two-storey beer cellar, both constructed against the curtilage of the neighbouring auction house (see **Plate 19**). Along the southern side of the Site is the skittle alley (see **Plate 20**); the north-east elevation is predominantly of rubble with brick around the window openings. Despite the presence of whitewash the windows appear to have been inserted within blocked openings (see **Plate 21**). The skittle alley is accessed through a wooden door at the west end of the north-east elevation. Narrow piers are attached at regular intervals along the internal south-west wall (see **Plate 22**) and a large window is present in the south-east gable (see **Plate 23**). The timber roof frame is original 19<sup>th</sup> century with modern steel supports (see **Plate 24**).

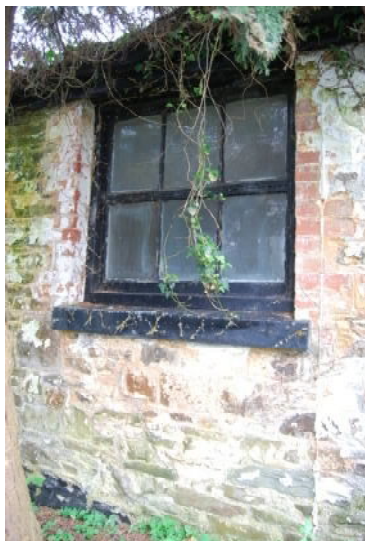
Plate 21. Skittle alley window (from NE)

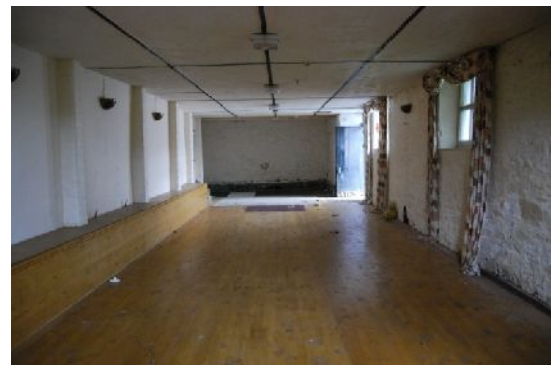
Plate 22. Interior of skittle alley (from SE)

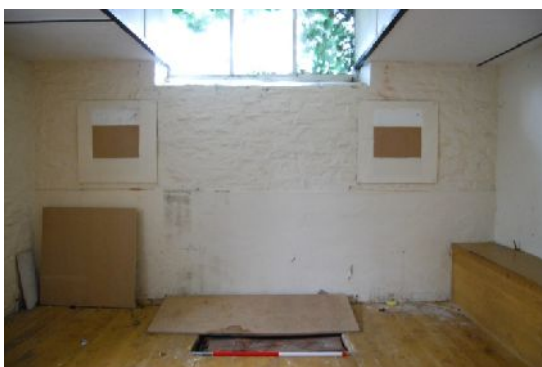
Plate 23. Interior of skittle alley (from NW)

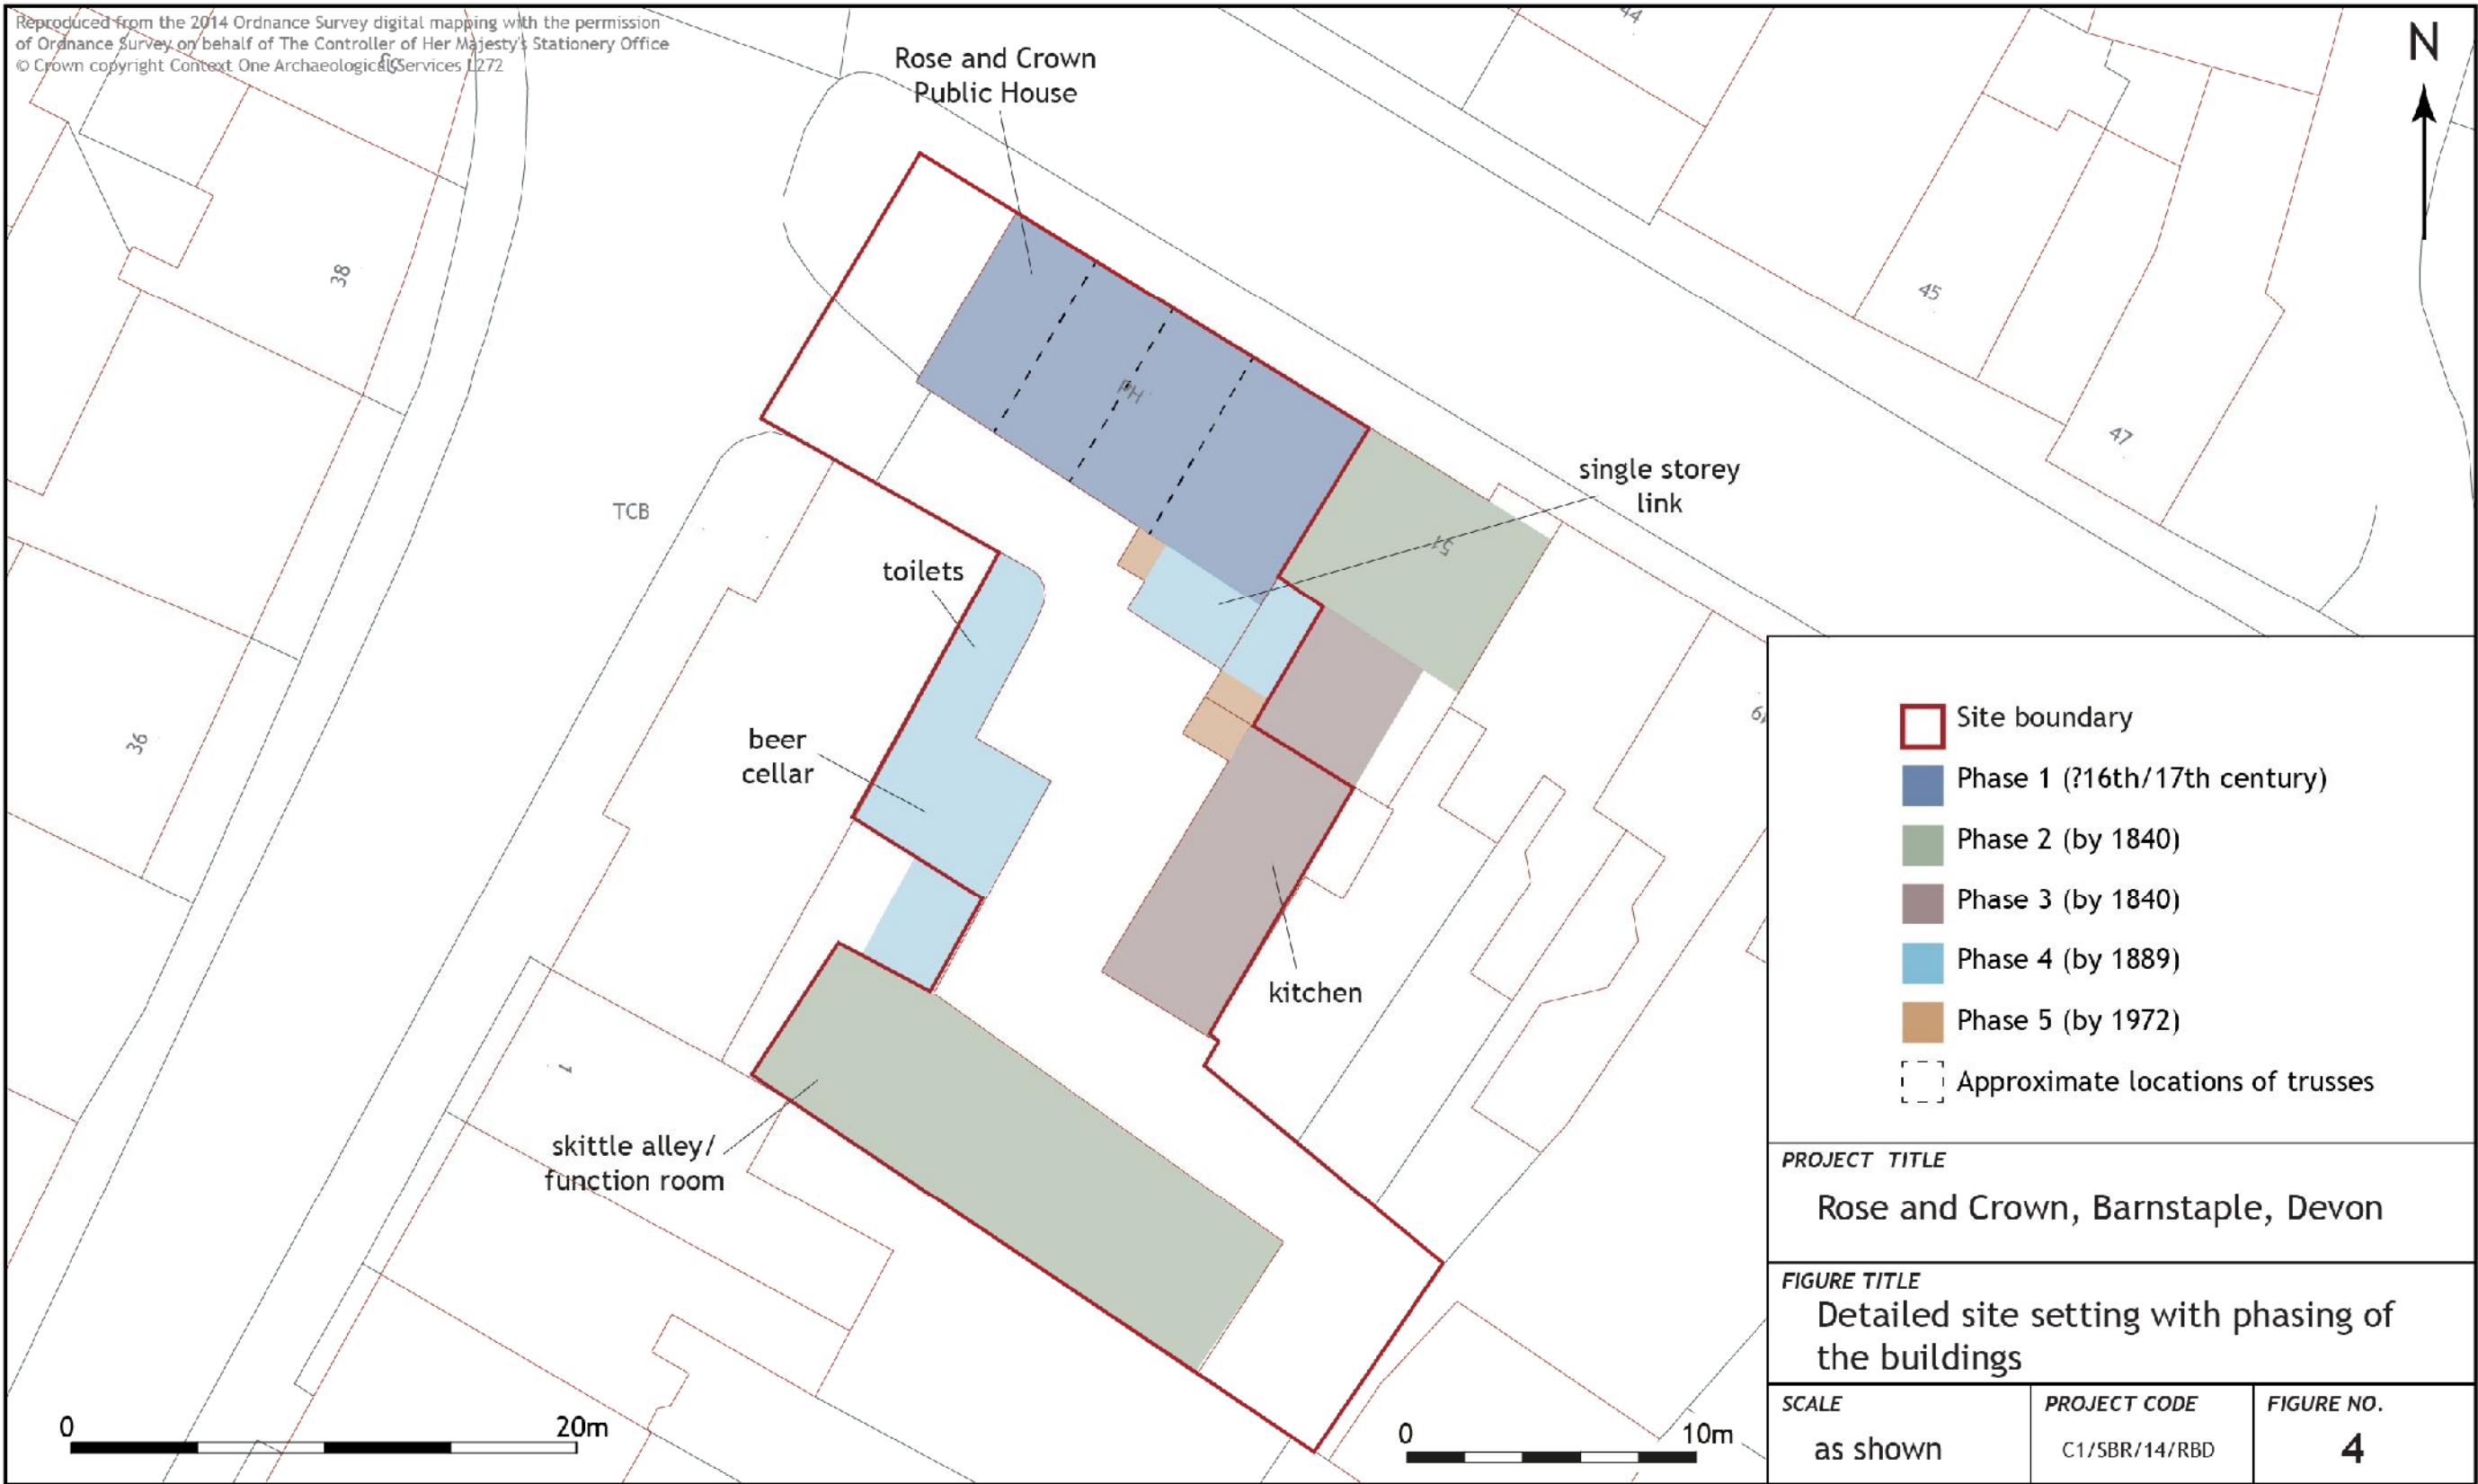
Figure 4. Detailed site setting showing phasing of building

- 6.1 The assessment has confirmed that the Rose and Crown originated as a 16<sup>th</sup> or 17<sup>th</sup> century house (see **Figure 4**). This is based on the three surviving jointed cruck trusses within the roof, the curved blades continuing to the first-floor rooms and set within solid walls. Devon rural crucks of the fifteenth to seventeenth centuries were set into solid walls of cob or stone as opposed to the timber frames used for pre-18<sup>th</sup> century town houses, several of which are known in Barnstaple (Beacham 2001, 17). However, internal timber-framed partitions were common in rural houses the first floor rooms without ceilings and therefore open to the roof (*ibid.*, 17-18). Indeed, there are remnants of timber internal partitioning within the roof of the Rose and Crown. Together with the absence of smoke-blackening to the roof timbers, it is concluded that this was not an open hall. This would suggest that the large chimney constructed within the south-east gable end may be original, although chimneys are not usually associated with cruck building (except as later inserts) and are generally accepted as being a 17<sup>th</sup> century adaption.

- 6.2 The building had become the Rose and Crown public house prior to 1798, with sales particulars listing a tenement, a stable, a plot of ground and the Rose and Crown. The 1840 tithe map only shows the public house and kitchen extension (see **Figure 4**). Although the 1843 tithe apportionment lists a house and court, this does not correspond with a sale document for the Rose and Crown dated 1859 which proves it remained a public house. This also reveals that the public house had remained in the ownership of the Isaac family as opposed to the different owner and occupier listed in the tithe apportionment. Another document dated 1859 details repairs to the Rose and Crown following the sale; this includes the stable, brew house, boundary wall, and within the public house to the bedroom ceilings, ceiling joists and windows.

- 6.3 By 1889 the buildings around the courtyard were in place, although the present skittle alley was in a separate plot which may have been a school (see **Figure 4**). This had been amalgamated with the Site by 1904. A small brick lean-to had been added by 1972 but overall there have been no significant changes to the building footprints. In contrast, the interior of the public house has been altered significantly throughout its history, with evidence of blocked openings, a change in the first-storey floor level, insertion of ceilings to the first floor bedrooms, and the insertion and later removal of a bay window to the north-east elevation.
