B0405: Danesborough Reservoir to Dancing Hill, Bridgwater, Somerset.

A programme of Archaeological Monitoring and Recording

Wessex Water plc scheme reference: B0405

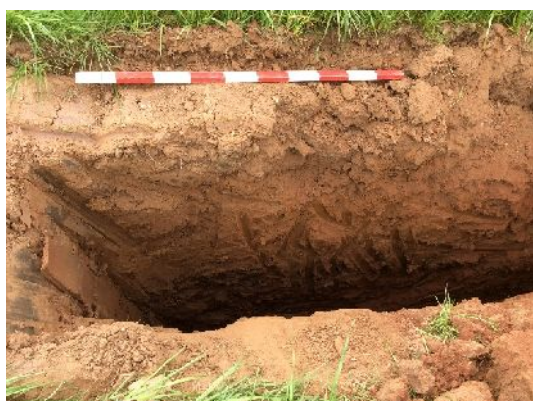
Plate 1. Profile Test Pit 2 (from N; 1m scales)

- 4.1 Despite the proximity of the course of the pipeline to crop marks which might have been indicative of prehistoric or later land division, no features or deposits of archaeological interest were encountered during the programme of archaeological monitoring.
- 4.2 Each of the sixteen test pits were excavated to c.3m deep and demonstrated a similar depositional sequence across the Site. Each sequence consisted of a grey-brown sandy clay topsoil of variable depth, which overlay a deep subsoil of reddish-brown clay. This in turn lay over a heavy, dark reddish-brown coloured, natural clay deposit with few or no stone inclusions (Plates 1-4).
