C9878: The Nag's Head  
Durrington Sewage Pumping  
Station  
Bulford Hill  
Durrington  
Wiltshire

Archaeological Monitoring and  
Recording

**C1 project code: C1/AMR/16/NHD**

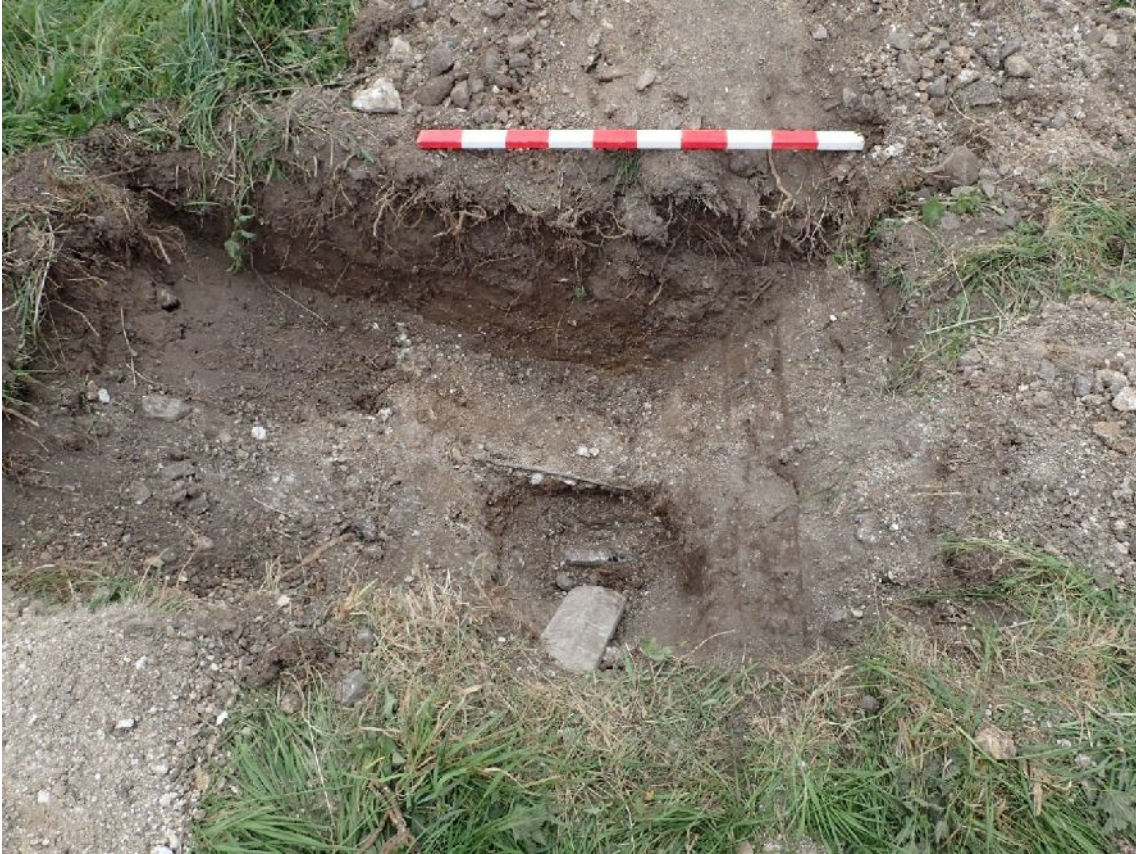
Plate 1. Trial pit 1 (facing E; 1m scale)

- 5.1 Profiles were observed in eight locations along the line of the pipe (**Figure 1**), within the three test pits (**Plates 1-3**) and at regular intervals along the easement (**Plates 4**). Details of the deposit sequence are set-out in **Appendix 1**. Topsoil was seen in six of these profiles (contexts 100, 200, 300, 400, 500, and 600), and in general consisted of dark brown or dark greyish brown (10YR 3/3) silty clay with either frequent angular gravels or flint fragments <0.01m. This was generally 0.25m-0.30m deep, but exceeded this in areas where excavation was confined to the removal of topsoil and the underlying deposits were not reached. The subsoil was seen in Profiles 1, 3 and 7 (contexts 101, 301 and 700), and was either a dark greyish brown (10YR 3/3) or dark yellowish brown (10YR 4/6) silty clay with frequent angular gravel fragments <0.01m with frequent rounded chalk <0.005m, and measured 0.23-0.27m thick. In the case of Profile 7, the subsoil comprised yellowish brown (10YR 5/6) silty chalky clay with occasional angular flint <0.015m, and exceeded 0.80m deep. The natural weathered chalk was seen in the two profiles recorded within the pipe trench (**Plates 5 & 6**). In Profile 7 this comprised light yellowish brown (10YR 6/4) silty degraded chalk (701) with occasional angular flint <0.015m, and in Profile 8 white (10YR 8/1) chalk (800) with frequent angular flint fragments <0.01m.

- 5.2 Electricity cables were seen in trial pits 1 and 2 and an existing sewer pipe in Trial pit 3 (**Plate 3**). No archaeological features or deposits were observed.

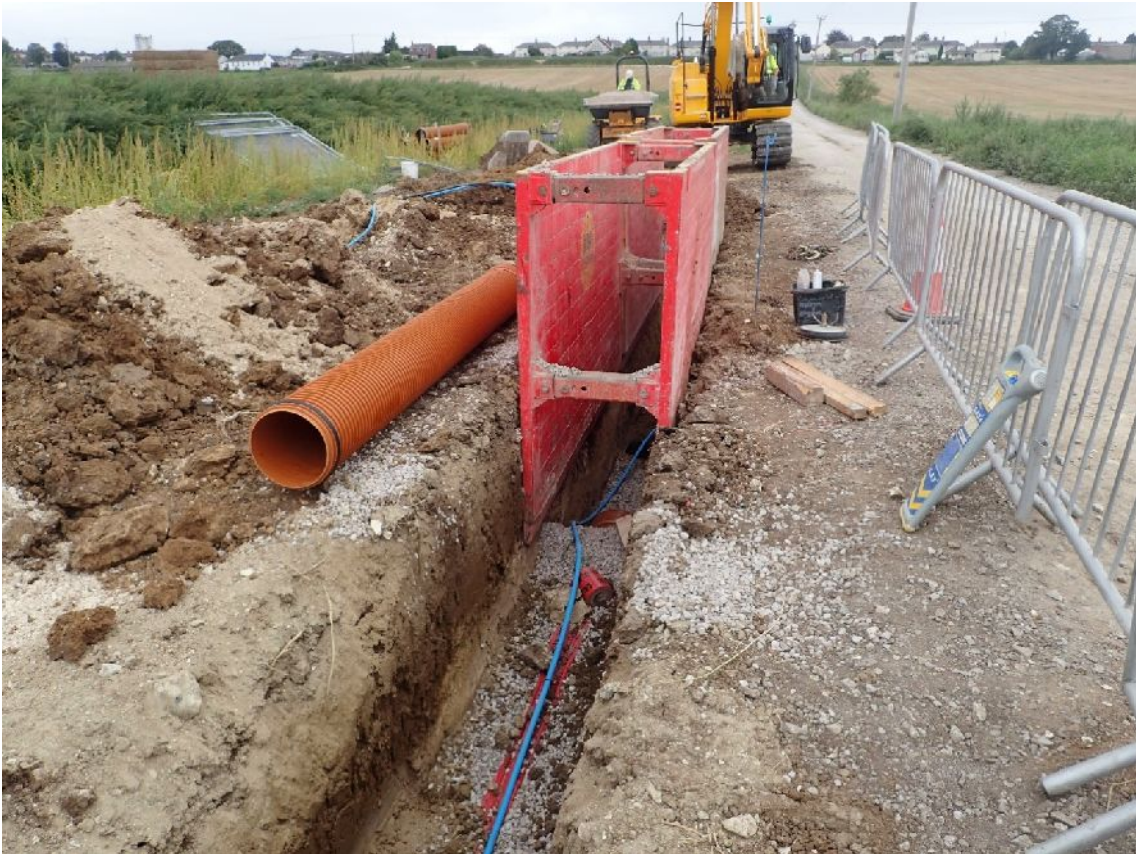
Plate 5. Pipe trench Profile 7 (facing N)

301	Modern	Layer	Subsoil. Soft dark yellowish brown (10YR 4/6) silty clay with frequent angular gravel fragments <0.01m with frequent rounded chalk <0.005m	300		NA			0.26m
<b>Topsoil strip – Profile 4</b>									
400	Modern	Layer	Topsoil. Firm dark brown (10YR 3/3) silty clay with frequent angular flint fragments <0.01m	NA		NA			0.30m
<b>Topsoil strip – Profile 5</b>									
500	Modern	Layer	Topsoil. Firm dark brown (10YR 3/3) silty clay with frequent angular flint fragments <0.01m	NA		NA			0.25m
<b>Compound strip – Profile 6</b>									
600	Modern	Layer	Topsoil. Firm dark brown (10YR 3/3) silty clay with frequent angular flint fragments <0.01m	NA		NA			0.25m
<b>Pipe Trench – Profile 7</b>									
700	Modern	Layer	Subsoil. Firm yellowish brown (10YR 5/6) silty chalky clay with occasional angular flint <0.015m	NA		701			0.80m
701	Geological	Layer	Natural. Friable light yellowish brown (10YR 6/4) silty degraded chalk with occasional angular flint <0.015m	700		NA			>0.30m

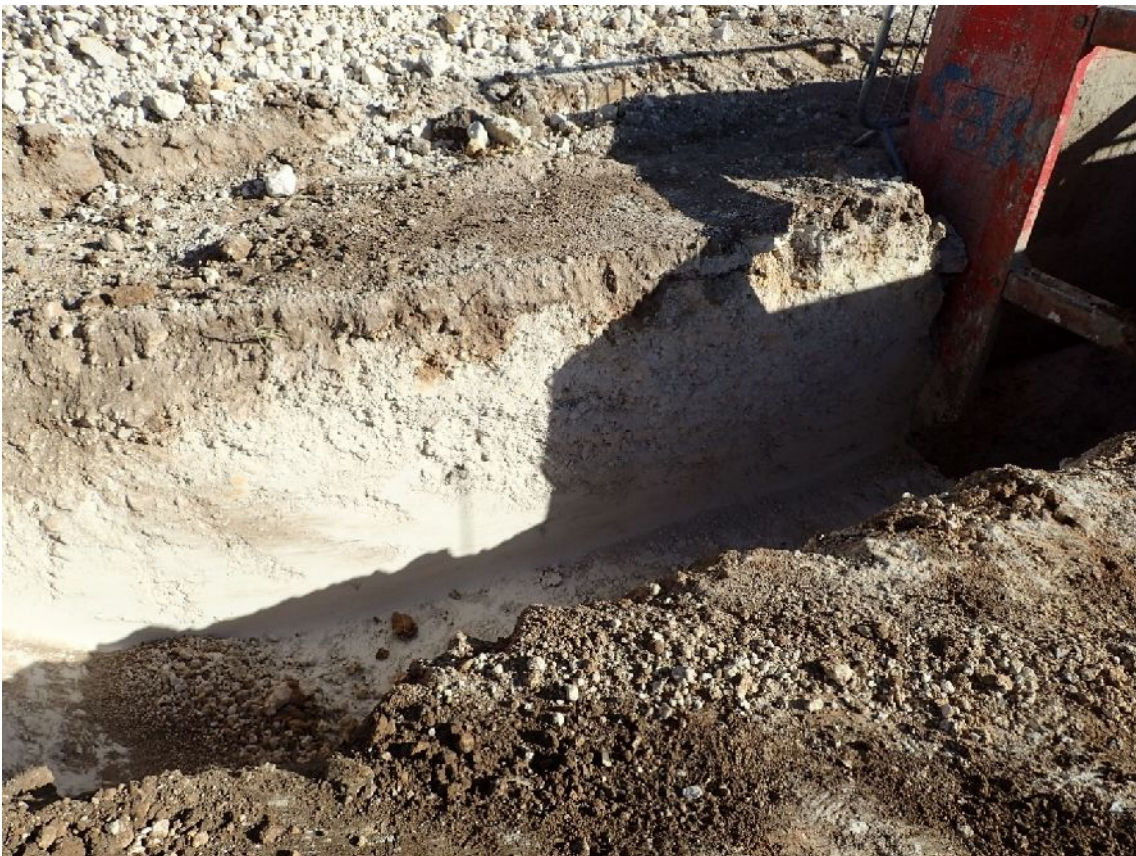
Plate 6. Pipe trench Profile 8 (facing S)

<b>Pipe Trench – Profile 8</b>									
800	Geological	Layer	Natural. Firm white (10YR 8/1) chalk with frequent angular flint fragments <0.01m	NA		NA			>0.50m
