Holiday Unit at Rock Mill, Prideaux, St Blazey, Cornwall.

A programme of Historic Building Recording and
Archaeological Monitoring and Recording

COAS reference: C1/SBR/16/RMP
Cornwall Council planning application reference: PA13/06904
National Grid Reference: centred on SX 05711 56968
OASIS reference: contexto1-250067

May 2016

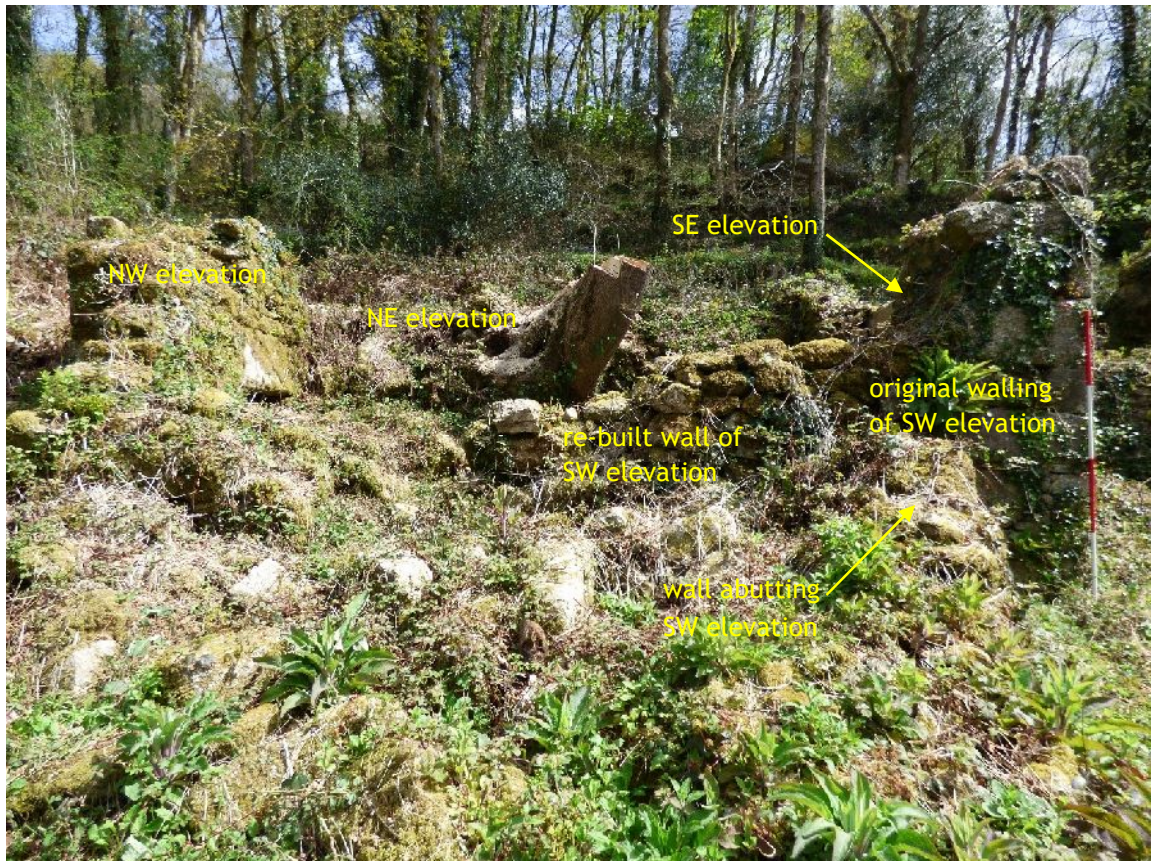
Plate 1. Building A (from SW; 2m scales)

- 4.2 Building A is the smaller of the two cottages, with internal measurements of 6.00m long and 3.80m wide (**Plate 1**). The walls survive to a maximum height of 3.15m (**Plate 2**), however only the north-east elevation is present to eaves level, showing a pitched roof construction (**Plate 3**). Aligned approximately north-west to south-east, the rear wall (north-east elevation) is constructed against

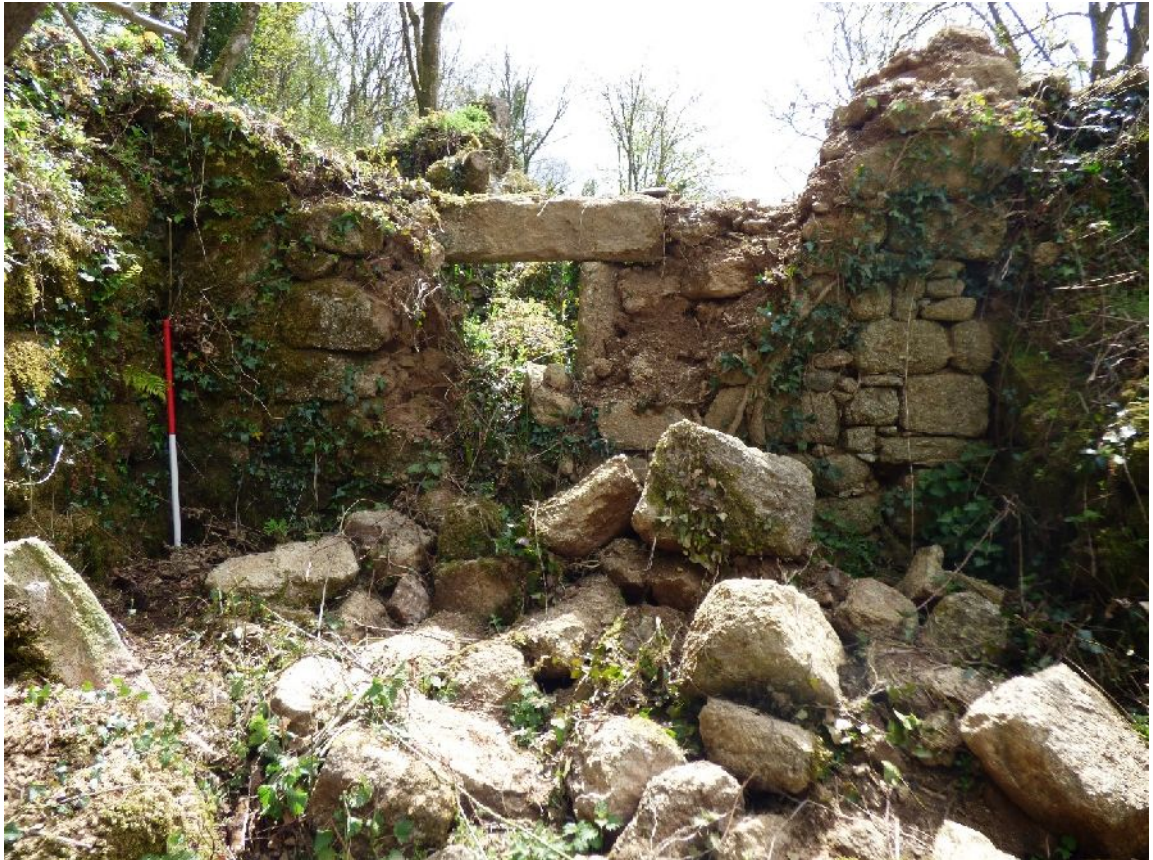
Plate 5. Building A - interior SE elevation with window (from NW; 1m scales)

- 4.3 The single surviving window is offset within the south-east elevation, and consists of a large lintel and jambs (**Plate 5**). A rectangular chimney protrudes from the north-eastern end of the north-west elevation (**Plate 3**), with a monumental lintel above the fireplace inside the cottage (**Plate 6**). The single entrance must have been located in the re-built south-west elevation although no evidence survives to indicate the exact position, which probably does not relate to the present opening. To the north-west of the cottage is a small-outbuilding comprising two narrow rubble walls constructed against granite boulders, which form the other two walls (**Plate 7**).

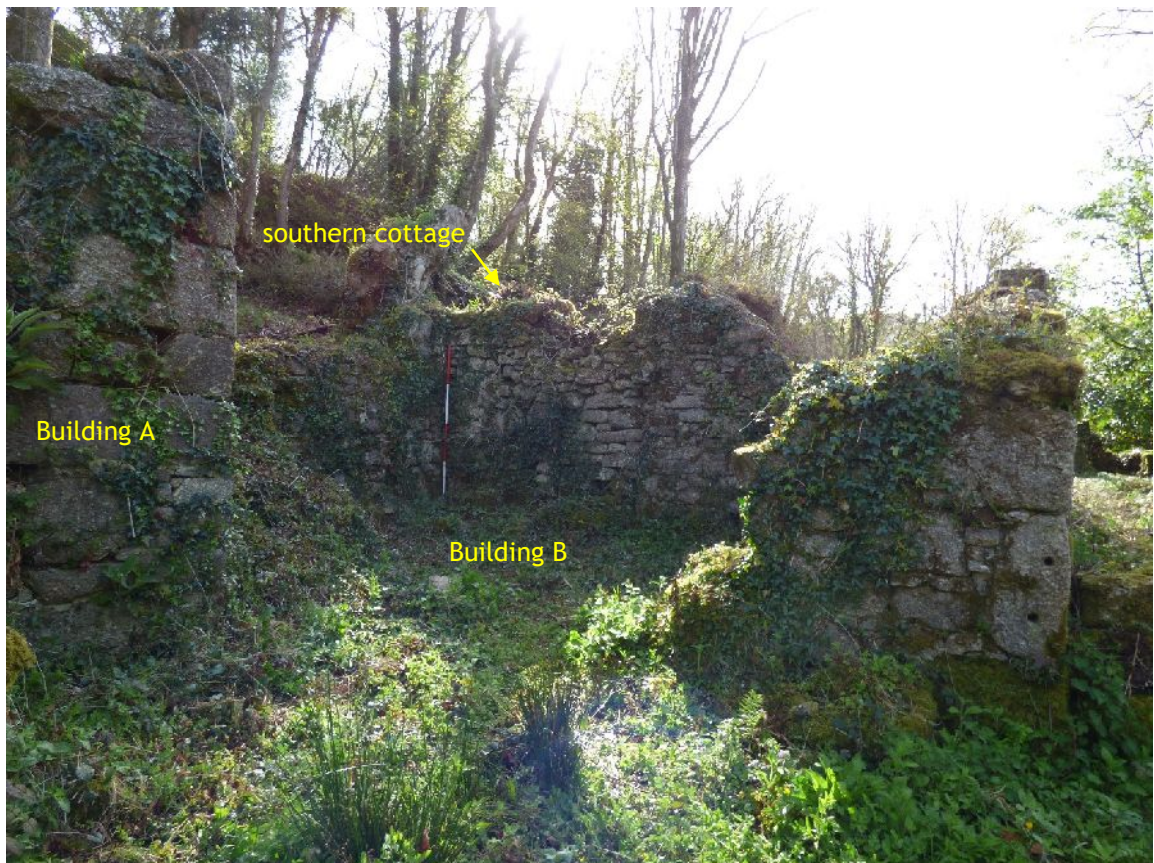
Plate 8. Building B (from NW; 2m scales)

- 4.4 Building B is a rectangular room attached to the north-west elevation of the southern cottage, with internal measurements of 5.95m long and 2.70m wide (**Plate 8**). The walls survive to a maximum height of 2.55m, however none of the elevations are intact to eaves level. Indeed, there is no north-west elevation with the exception of two short wall stubs at either end. Constructed of random coursed and uncoursed rubble bonded with hard lime mortar, larger blocks were employed for the dressings, and small to medium sized blocks for the main walling. Aligned approximately north-east to south-west, the room was accessed from the southern cottage via a doorway. However, this opening has since been carefully blocked with unmortared random rubble suggesting there was also access through the north-west elevation (**Plate 9**). A low but wide window is present in the south-west elevation, comprising a monumental lintel above a single-height metal casement window with two vertical bars (**Plates 10 & 11**). A few small patches of greyish plaster with cream-coloured lime render survive on the internal walls, from which a sample was taken. Although the space between Buildings A and B is now filled with rubble, it appears this was once a passage which extended around the rear of Building B (**Plate 12**).

- 4.5 The external quoin at the north-west corner of Building B includes a block with two holes, probably for mounting a gate (**Plates 8 & 13**). To the south-west is a small rectangular outbuilding measuring 2.90m long and 2.00m wide, the doorway with stone threshold facing north-east towards Building B (**Plate 14**). Extending north-westwards from this outbuilding is the remains of a boundary wall (**Plate 15**). A further wall continued south-westwards from the south-west corner of the outbuilding; this was traced for 5.00m before being lost beneath a wood stack. A rough, wide, dry stone rubble wall runs at an angle between Building B and the outbuilding, abutting both buildings which suggests it was a later addition (**Plate 13**).

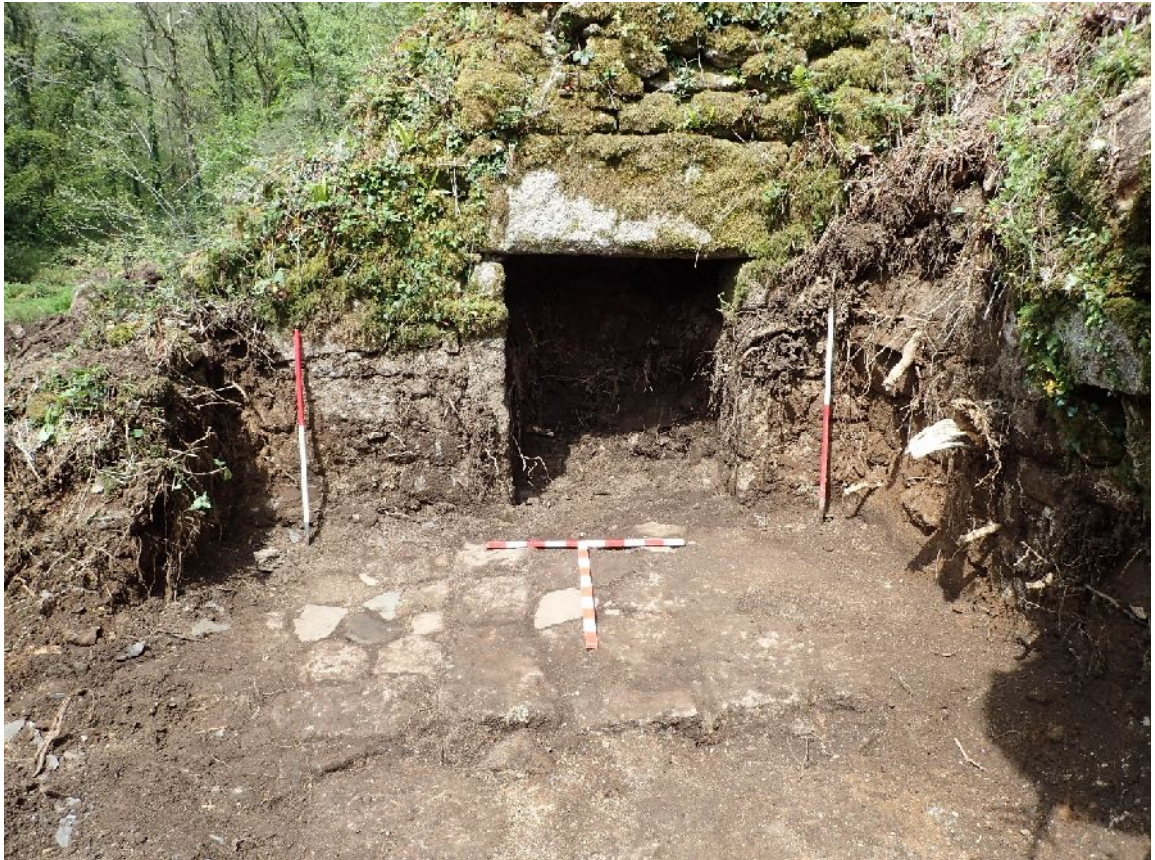
Plate 18. Building A - granite floor (7-100) in front of fireplace (from SE; 4 x 1m scales)

- 4.8 The rubble overburden (7-101) within Building A comprised a very dark greyish brown (10YR 3/2) silty clay with frequent granite rubble and slate roof tiles, yielding a large iron gear lever. The overburden covered a granite floor surface (7-100), with an overall colour of light greyish brown (10YR 6/2) and comprising frequent rounded or shaped granite and slate blocks (**Plate 18**). On average, these measured 0.30m by 0.40m, and covered an area measuring 2.00m wide, 3.80m in length and 0.12m deep. The floor occupied the north-western third of the building, immediately in front of the fireplace, and was very worn from trampling. Two long granite stones were aligned north-west to south-east (**Plate 19**). In the central third of the cottage, the overburden (7-101) covered a light greyish brown (10YR 6/4) compacted sandy layer (7-102) with frequent large granite blocks, some measuring 1.00m wide. This extended across an area measuring 3.80m long and 2.00m wide. The south-eastern third of the cottage at the same level was disturbed.

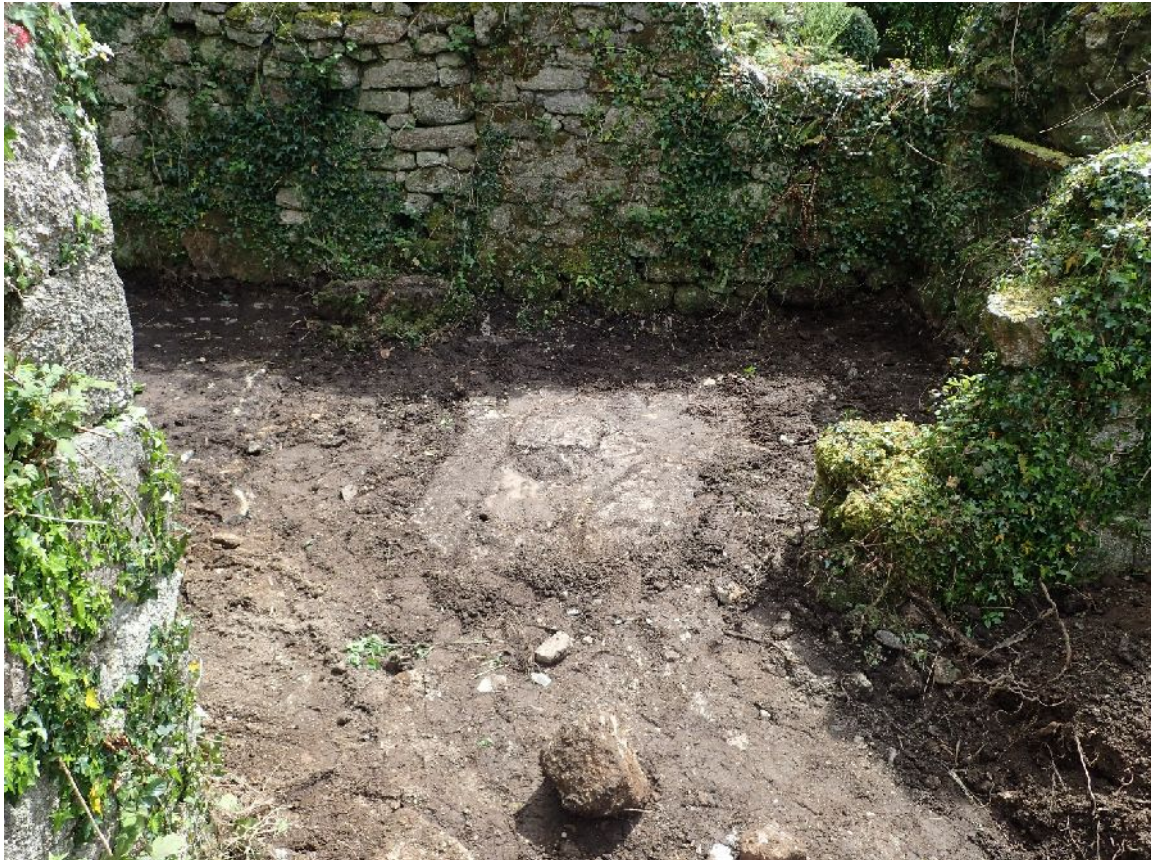
Plate 20. Building B - location of granite floor (7-200) & concrete slab (from NW)

- 4.9 The very dark greyish brown (10YR 3/2) silty clay (7-201) within Building B yielded a single sherd of pottery. This covered a granite block floor surface (7-200) with an overall colour of light greyish brown (10YR 6/2), comprising large square to rectangular granite blocks with some later concrete patching (**Plates 20 & 21**). An sondage measuring 2.50m square was cleaned within the central to south-western part of the building, the exposed granite blocks measuring on average 0.40m by 0.50m. In the north-east corner of the room was a concrete slab (**Plate 20**) obscuring the cobbles which ran underneath.

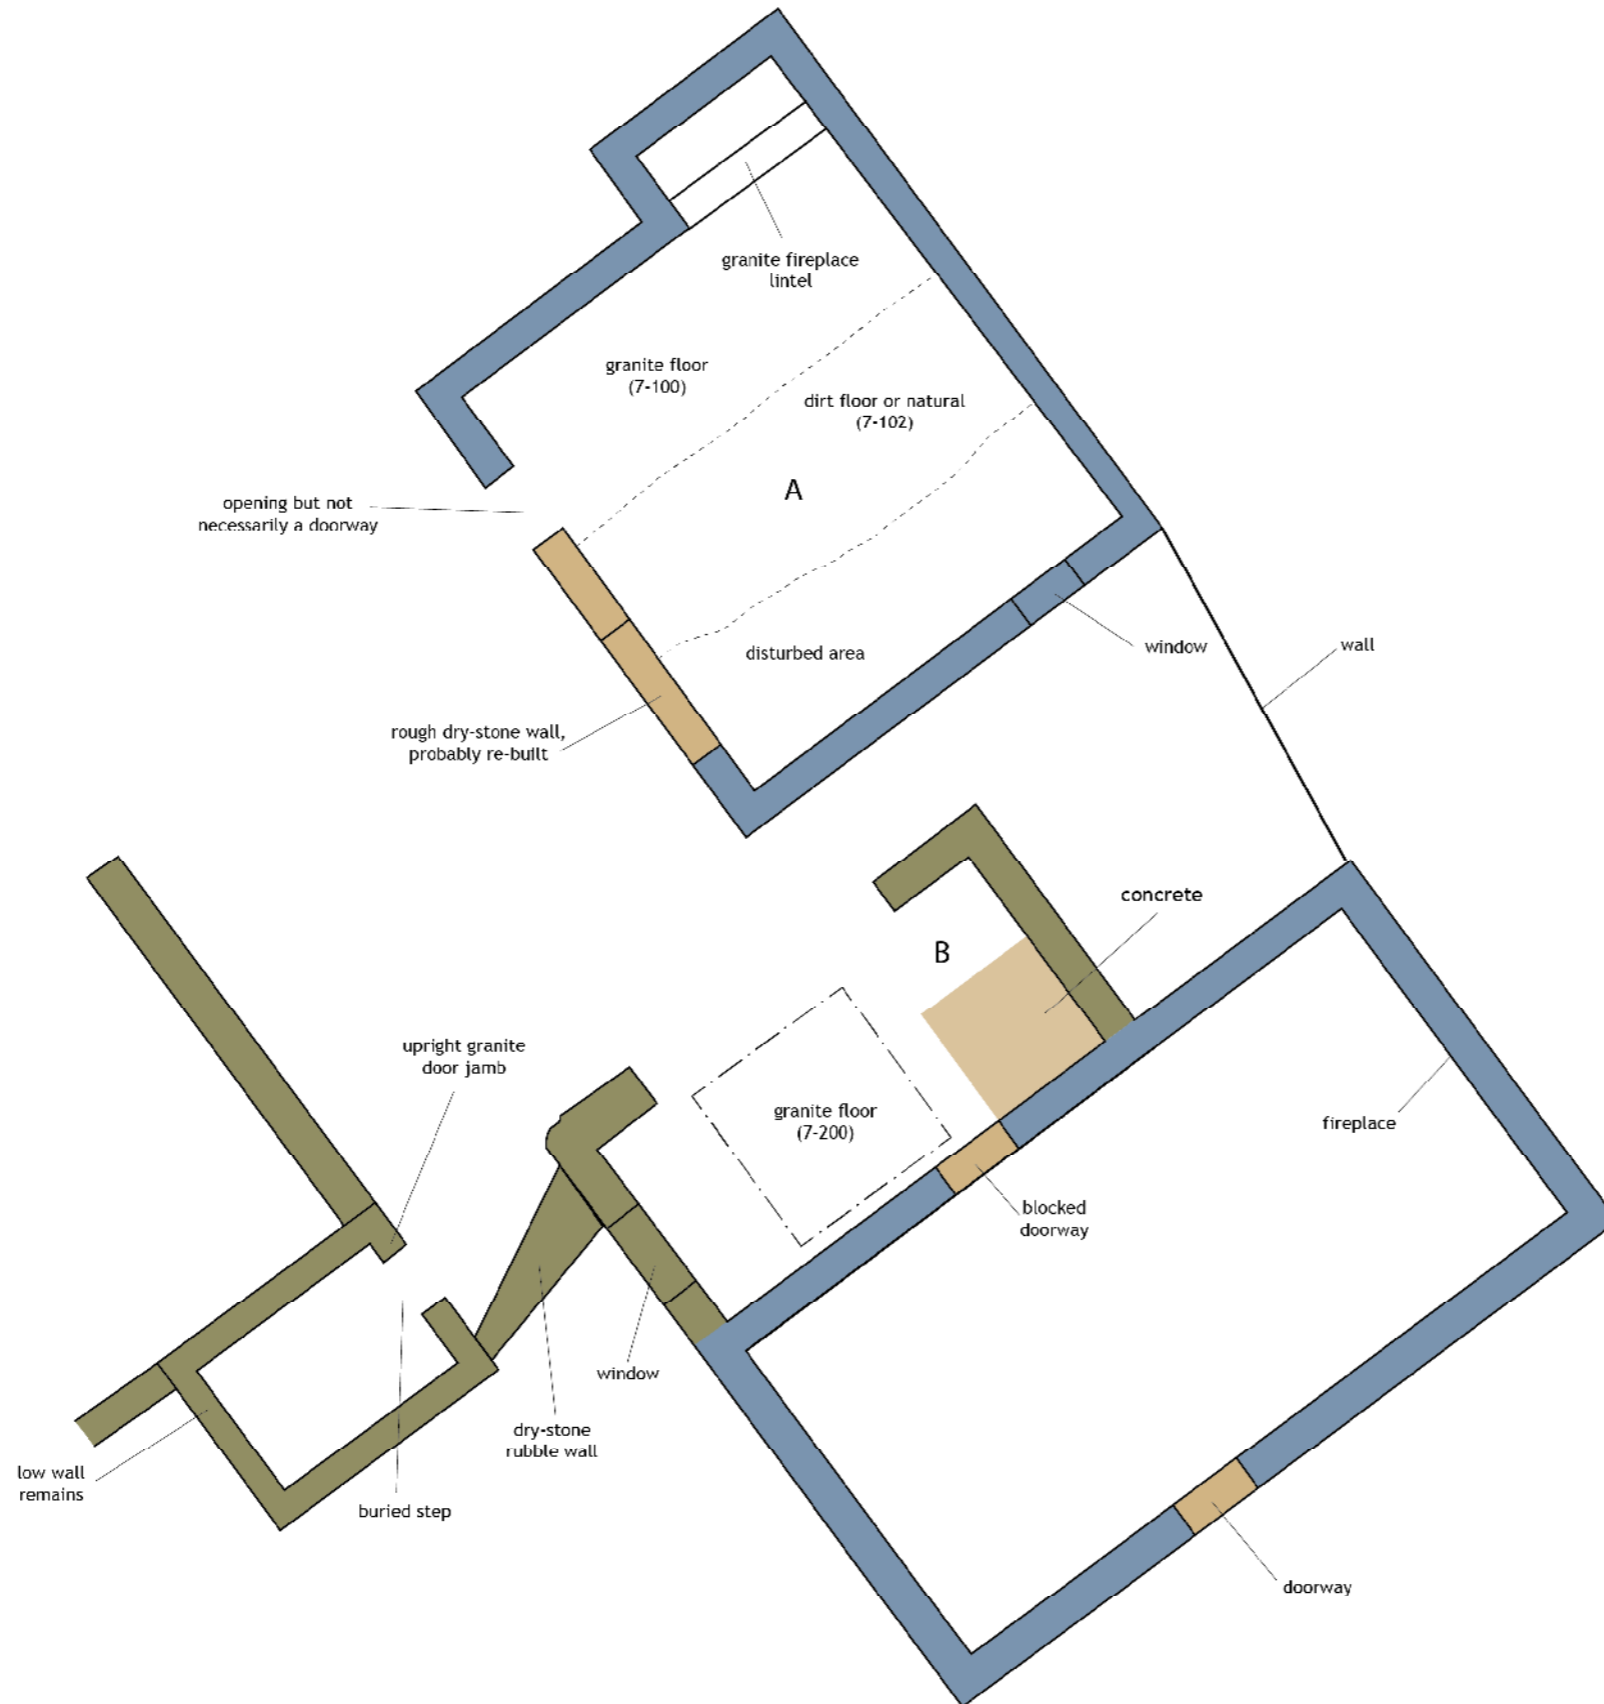
Figure 3. Phased plan

- By 1839
- By 1881
- Later (modern)

- 6.1 The historic building survey not only confirmed the findings of the Desk-Based Assessment in terms of the phasing of the cottages, but has also added considerably to our understanding of the layout of the cottage complex on the eastern bank of the River Par, opposite Rock Mill (**Figure 3**). The earliest phase comprises the northern cottage (Building A) and the southern cottage, which were both present by 1839. The Lanlivery census suggests that one cottage was occupied by the Pound family, and the other cottage by the Treleven family. By the 1851 census only one cottage seems to have remained occupied, this time by the Pooly family, the men of the family recorded as an agricultural labourer and a stone cutters labourer. The granite floor exposed in the northern third of Building A, in front of the fireplace, showed signs of wear indicating the property was occupied for a number of years. Two aligned long granite stones to the left of the fireplace may represent a room division or perhaps a base for an internal feature such as a cupboard. The floor directly overlay the natural sand and gravel. At the same horizon as the granite floor, the central third of the cottage comprised a rough, dirt floor underlain by natural granite boulders, which may have served as a base for a granite slab floor.

- 6.2 By 1881 a room (Building B) had been added to the north-west side of the southern cottage, therefore it is a reasonable assumption that it was the smaller northern cottage that went out of use first. If Building A was not occupied it would explain why the front elevation perhaps fell and was replaced with a rough dry stone wall, not suitable for keeping the cottage habitable but perhaps a suitable storage place or animal shelter. The granite floor in Building B may have extended across the whole room but it was partly covered by an area of concrete and had been largely damaged or destroyed. Again, the floor directly overlay the natural sand and gravels.
