Proposed Expansion of CREDITON HAYWARDS Primary School, Dean Street, Crediton, Devon.

An Historic Building Appraisal

June 2016

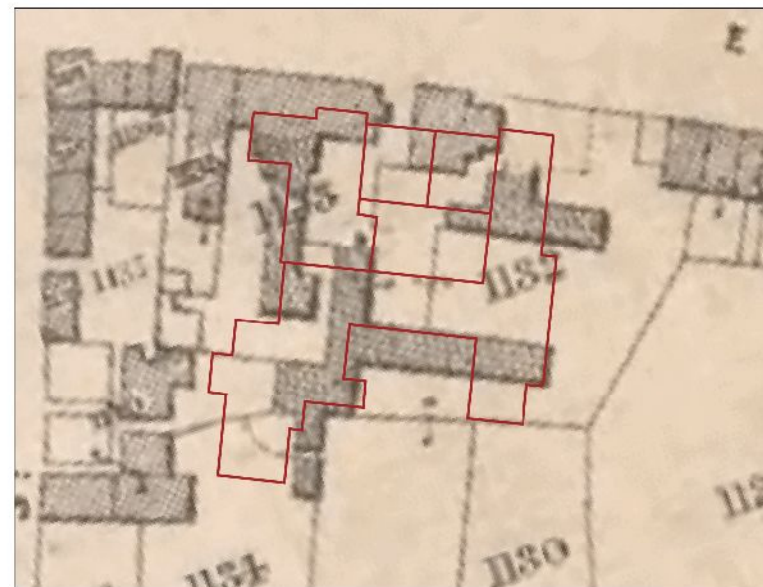
a) Detail from Tithe Map, 1841

- 4.7 The tithe map of 1841 shows the plots of land later occupied by Hayward's Old School encompassing four separate building ranges, probably all relating to the tannery complex (see **Figure 2; a**). The 1889 OS map (both the 1:500 and 25") show Hayward Schools (Boys and Girls) (see **Figure 2; b & c**). This presumably illustrates the school following the first phase of additions in 1874, and depicts four ranges surrounding a central rectangular courtyard. The long east and west ranges were connected by a south range, with no internal structural subdivisions depicted although these were certainly in place. However, the north range, sandwiched between the gable ends of the east and west ranges, was divided into the two teacher's houses. These overlooked a centrally placed garden flanked by two paths leading to each of the front doors (see **Plate 1**). A garden is also shown to the east and west of the garden paths, in front of the gable ends of the east and west ranges. A few small structures were arranged around the periphery of the courtyard, which seems to have been divided by a central wall aligned approximately north to south. The 1874 additions no doubt relate to the rooms projecting from the southern end of the east and west ranges, and to the west of the northern end of the west range.

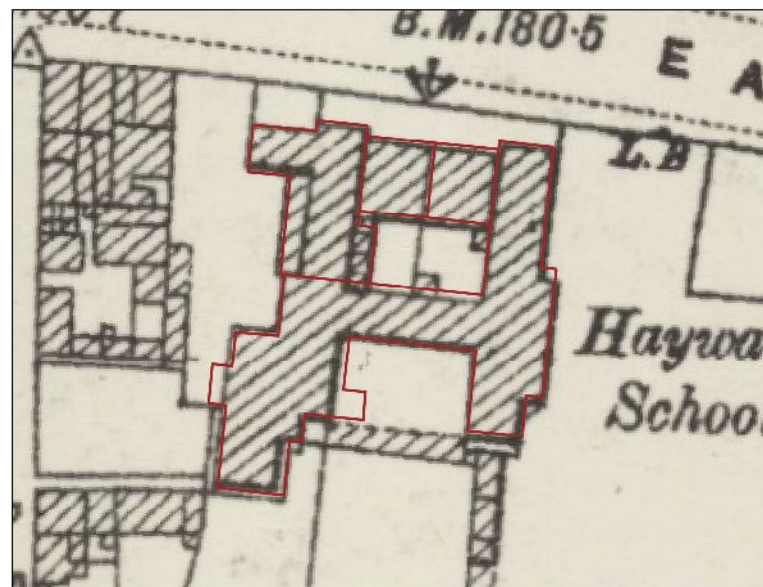
d) Detail from Ordnance Survey 25" Map, 1905

- 4.8 The 1905 OS map shows further extensions to the southern end of the east and west ranges, again with the more substantial work relating to the west range (see **Figure 2; d**). For the eastern range, the south extension was expanded slightly further to create another room, with a small narrow passage added to the east side of the earlier extension. By this time, buildings were present to the south of the school, almost enclosing the space between the south extensions and effectively creating a second southern courtyard.

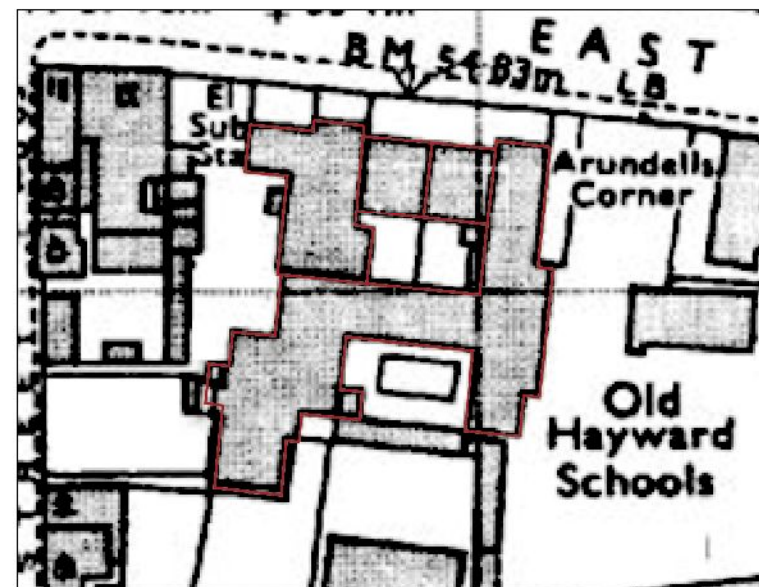
e) Detail from Ordnance Survey 25" Map, 1971

- 4.9 The 1971 OS map shows little change, with the exception of two small additions to the west range, however by this time the buildings are labelled as Old Hayward School (see **Figure 2; f**). By 1985, OS mapping shows the west range as the drama centre and the east range as the youth centre, although overall the entirety was still labelled as Old Haywards School (see **Figure 2; g**).

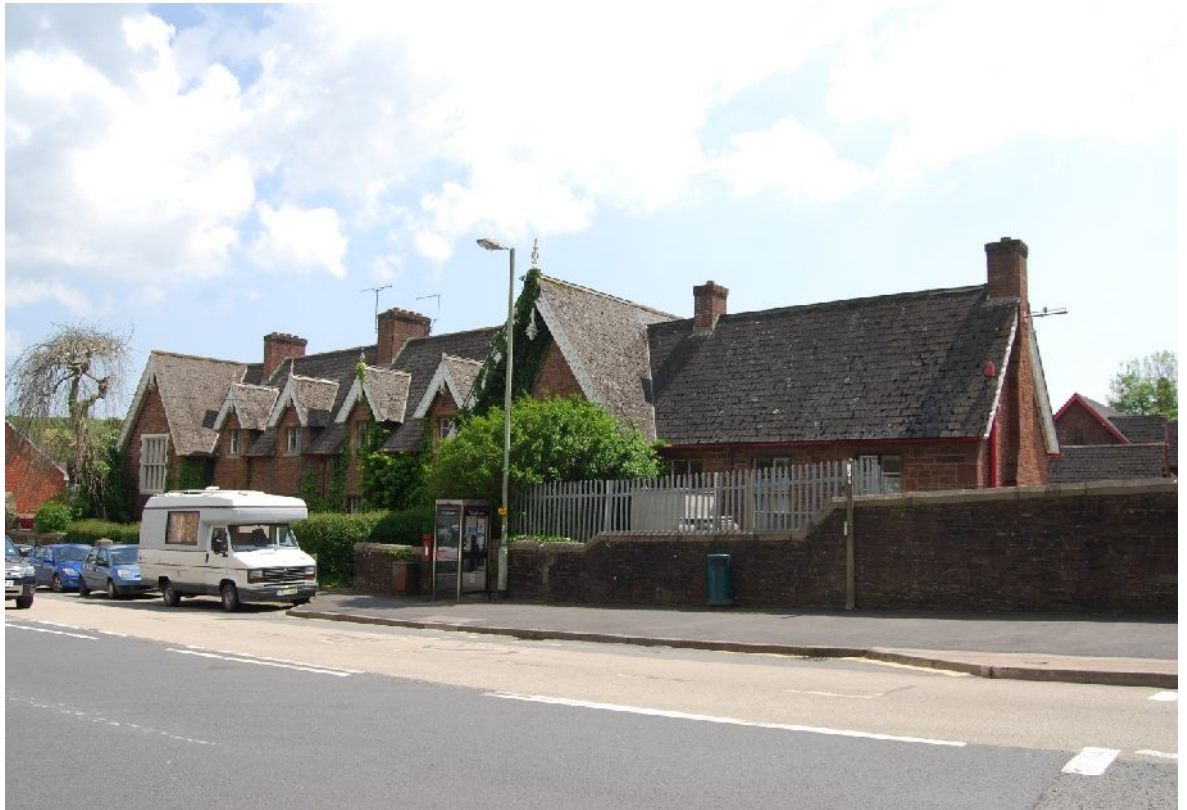
Plate 3. North elevation overlooking East Street (from NW)

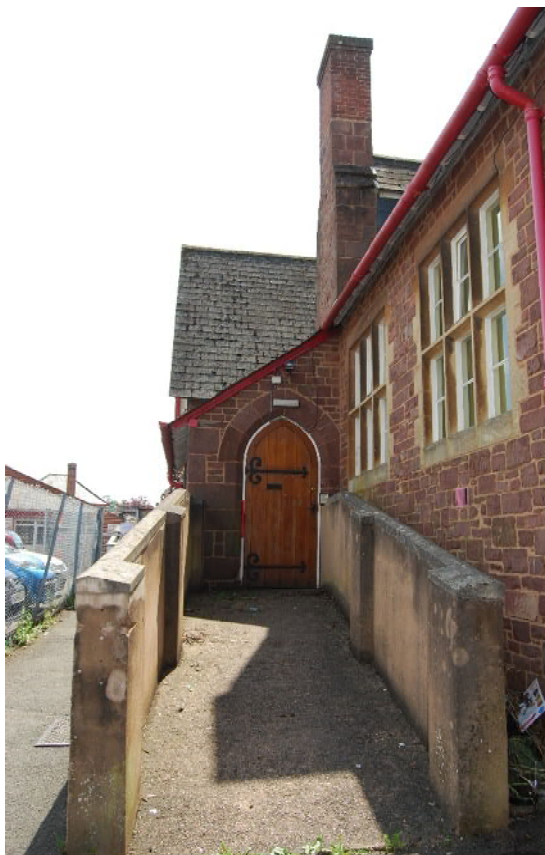
Plate 8. Main porch leading to central room, with modern concrete ramp access (from N)

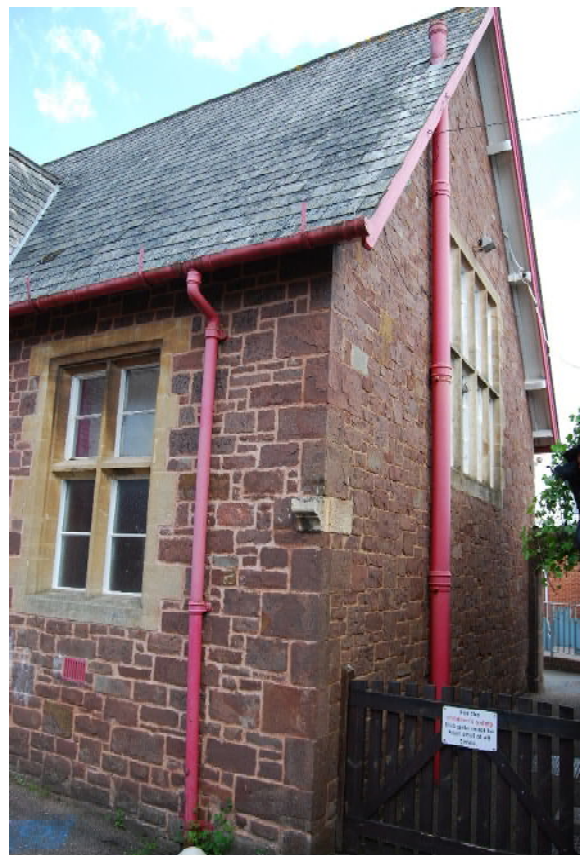
Plate 9. South gable end & west elevation of south extension (from WSE)

- 5.2 The frontage of Hayward's Old School is predominantly unaltered from c. 1874, the only appreciable difference being the absence of the bell-cote to the gable end of the east range, and the loss of the two pinnacles above the centre of the east and west ranges (see **Plates 1, 3 & 4**). The extension to the west presumably relates to the 1874 additions. The removal of the bell-cote and pinnacles is also evident from the east elevation (see **Plates 5, 6 & 7**), the only other alterations on this side relating to the installation of concrete access ramps to the main entrance porch (**Plate 8**) and to the south room (**Plate 7**), and steps to the north room. A path runs between the south extension of the east range and the buildings to the south, providing access to the southern courtyard (**Plate 9**).

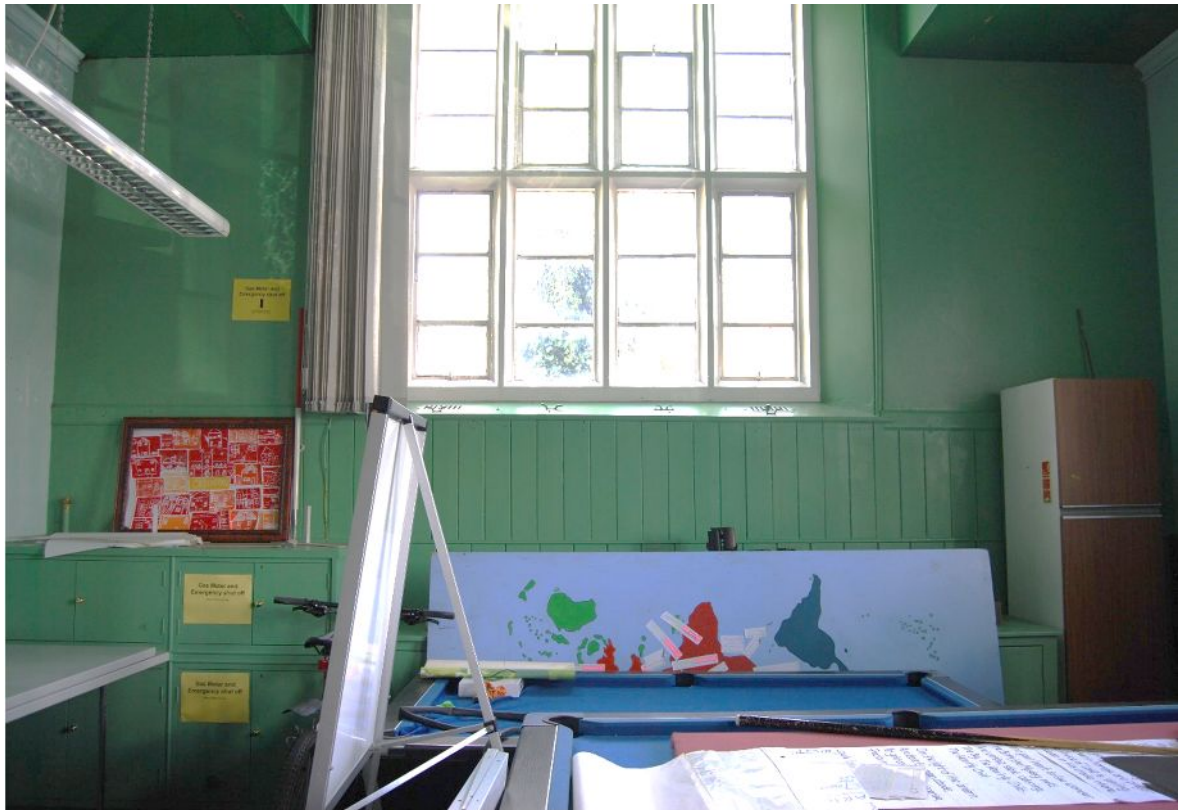
- 5.4 Turning to the interior, the survey runs from north to south. The north room is lit by an imposing mullioned window in the north elevation (**Plate 12**), and two smaller mullioned windows in the east elevation (**Plate 13**). Beneath the level of the east elevation window sills, wood wall panelling extends around the room with an additional tier of panelling in the north elevation (**Plate 12**). This spans the gap between the lower tier and the window sill (the window is positioned higher in this wall). A blocked doorway is evident in the west elevation (**Plate 14**), once providing direct access from the teacher's house into the schoolroom. The doorway at the north end of the east elevation, now occupied by the fire door, appears to be an original opening as the wood panelling continues into the door recess (**Plate 15**). At the southern end of the east elevation, the original fireplace has been blocked, although the fireplace surround is intact together with the ornate metal vents in the wall above (**Plate 16**).

Plate 12. North elevation of north room with two tiers of wood panelling beneath the window (from E; 1m scales)

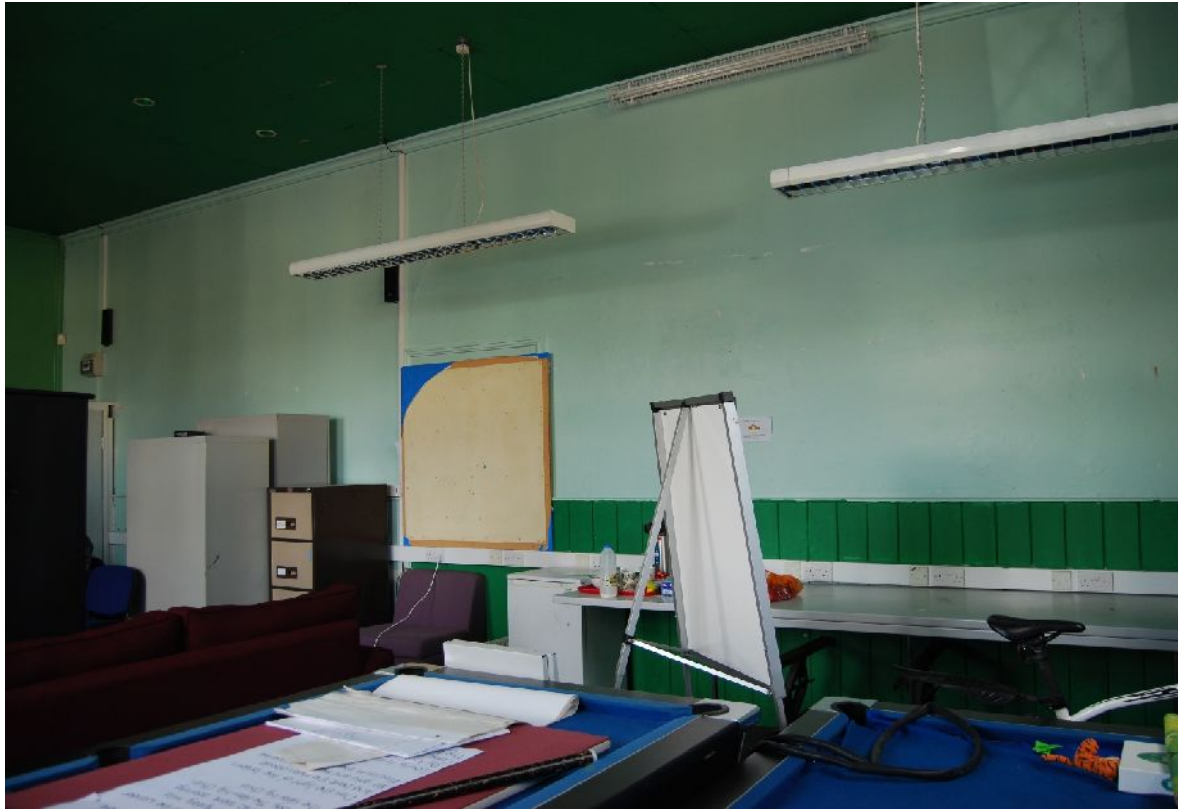
Plate 14. West elevation of north room with blocked doorway behind notice board (from NE)

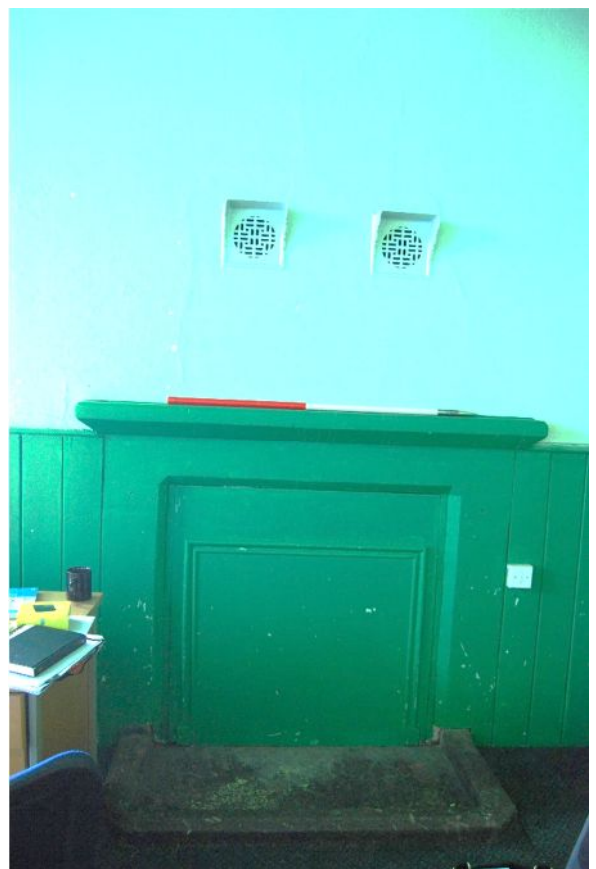
Plate 16. Blocked fireplace in north room with vents above, at south end of east elevation (from W; 1m scales)

the north room (Community Room) will enclose the original fireplace so it will no longer be visible, however the works do not appear to impact the feature. It should be noted that the installation of a new door in the western end of the partition between the north and central rooms will result in the removal of some original wood wall panelling, however the impact of this may be reduced by re-using the panelling in front of the new WC and lobby. Finally, re-painting in neutral colours will be in keeping with a historic building of this type, and will bring the rooms back into harmony by using the same colour scheme throughout.

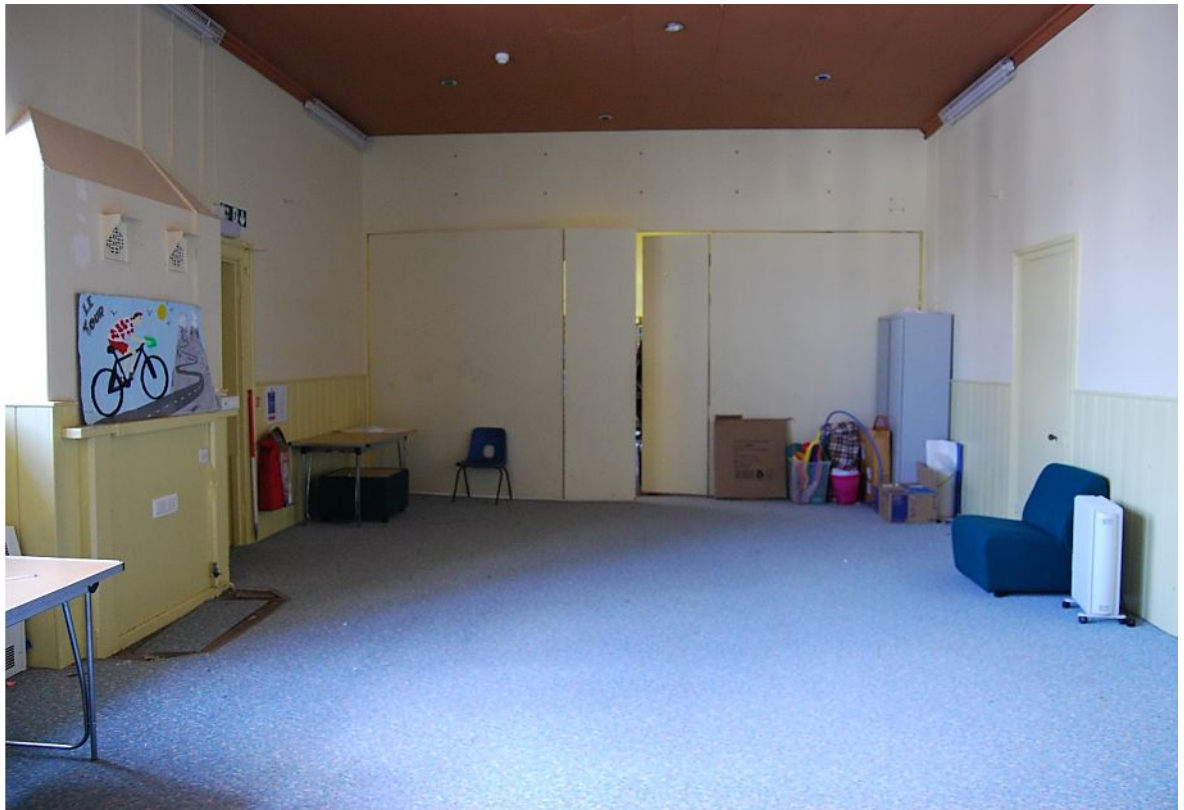
- 5.5 The central room also has two mullioned windows in the east elevation, with wood wall panelling running around the room beneath sill level (**Plates 17 & 18**). A doorway in the east elevation originally opened onto the courtyard but now gives access to a store cupboard. Immediately south of the windows in the east elevation is a large chimney breast with two ornate metal vents, and blocked fireplace beneath with intact fireplace surround (**Plate 19**). On the south side of the fireplace is the original main entrance to this side of the school, accessed through an entrance porch (**Plates 20, 21 & 22**). A door in the south elevation of the entrance porch provides access to a store room alongside the south room. The wall between the central and south rooms has been knocked through and replaced with large folding doors (**Plates 20, 23 & 24**). The south room has been subject to the most alteration, with a wide opening into the south range (currently the kitchen) (**Plate 24**) and two wide openings created within the south elevation providing direct access to the south extension (**Plate 25**). The chimney breast with two ornate metal vents occupies the centre of the south elevation, although with the exception of the stone ledge above, the fireplace is now covered by wood panelling which continues around the walls. It is considered likely that the panelling was re-used from the walls that were knocked through.

Plate 17. Southern part of central room showing door in west elevation (from N; 1m scales)

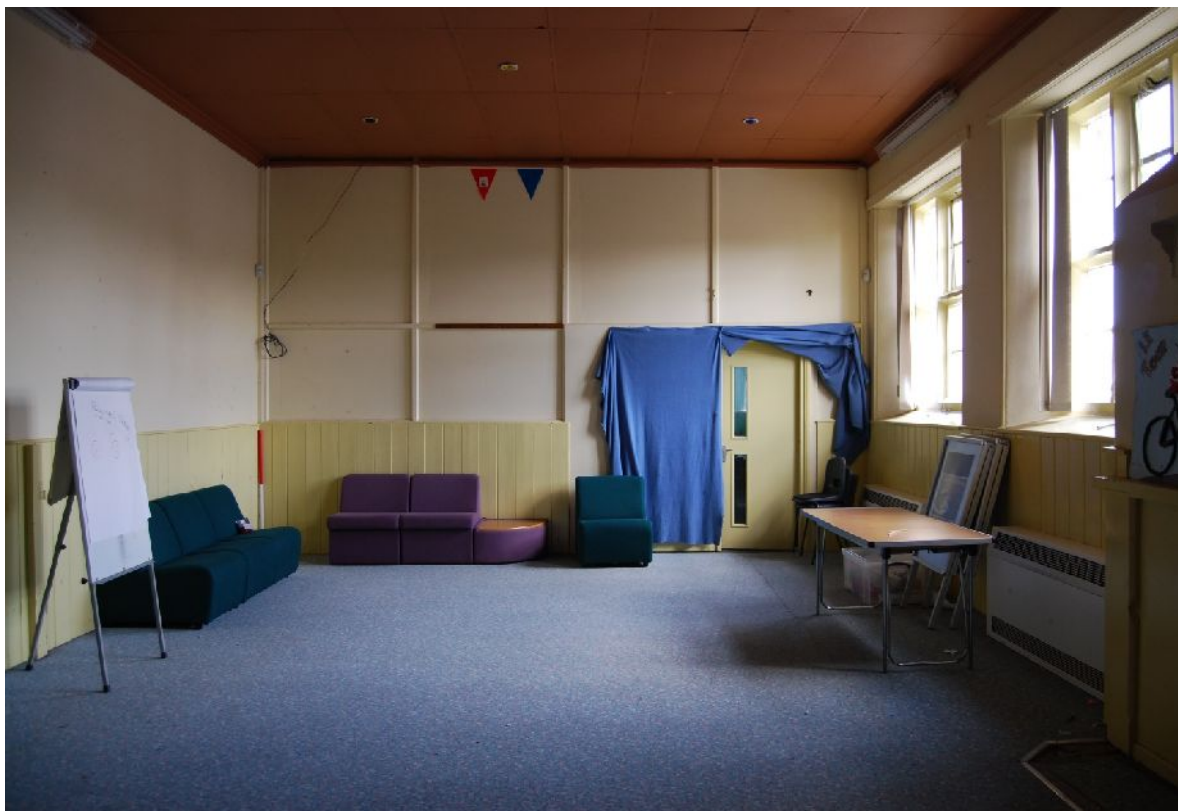
Plate 18. Northern part of central room (from S; 1m scales)

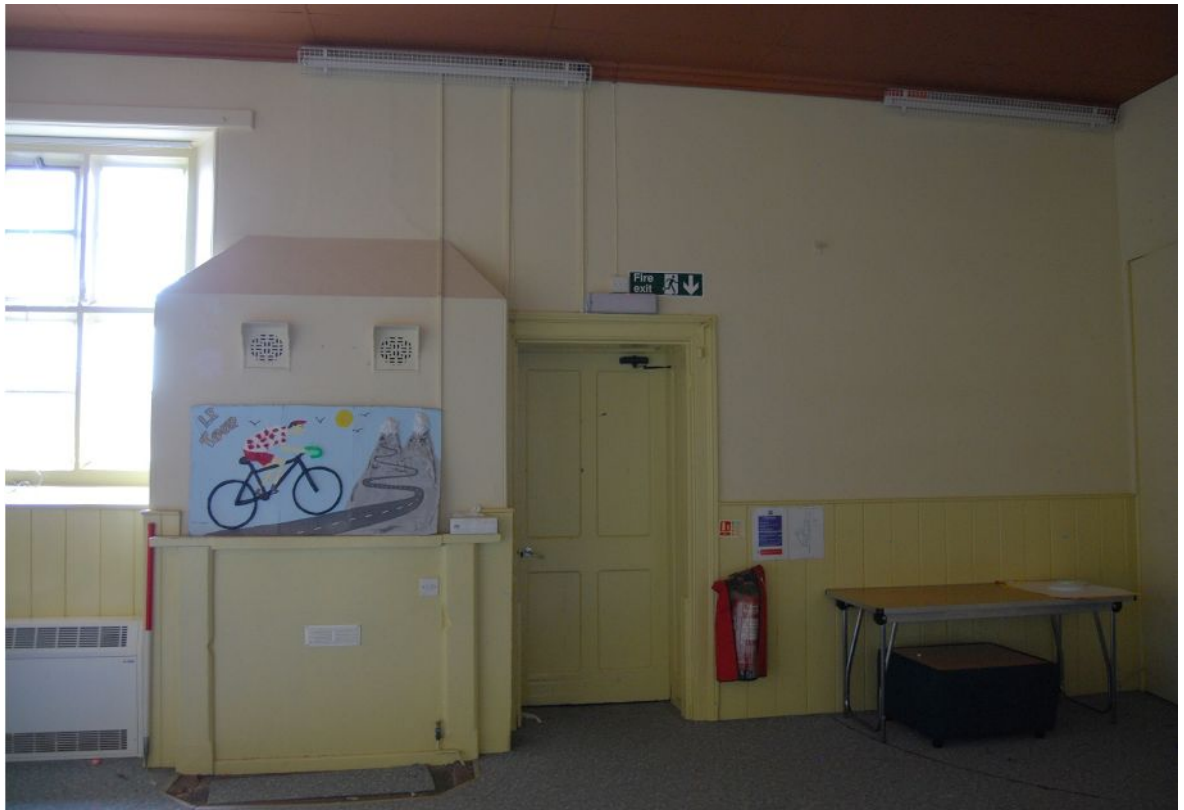
Plate 19. Chimney breast, fireplace & main door in east elevation of central room (from W; 1m scales)

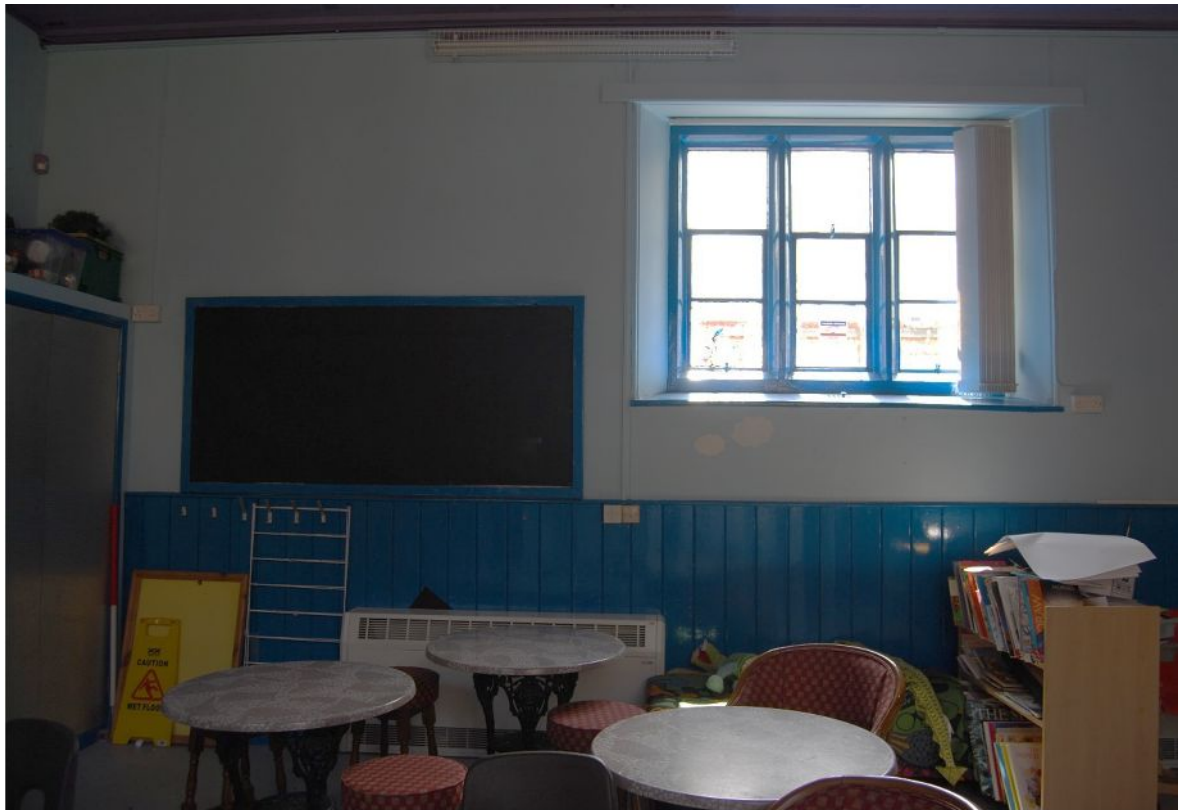
- 5.6 Wood wall panelling is also present around the walls of the south range, with a single mullioned window in the south elevation (**Plate 26**) and two mullioned windows overlooking the courtyard in the north elevation (**Plate 27**). A blocked doorway in the west elevation would have provided access to the western part of the south range (**Plate 28**).

Plate 26. South elevation of south range overlooking south courtyard (from N; 1m scales)

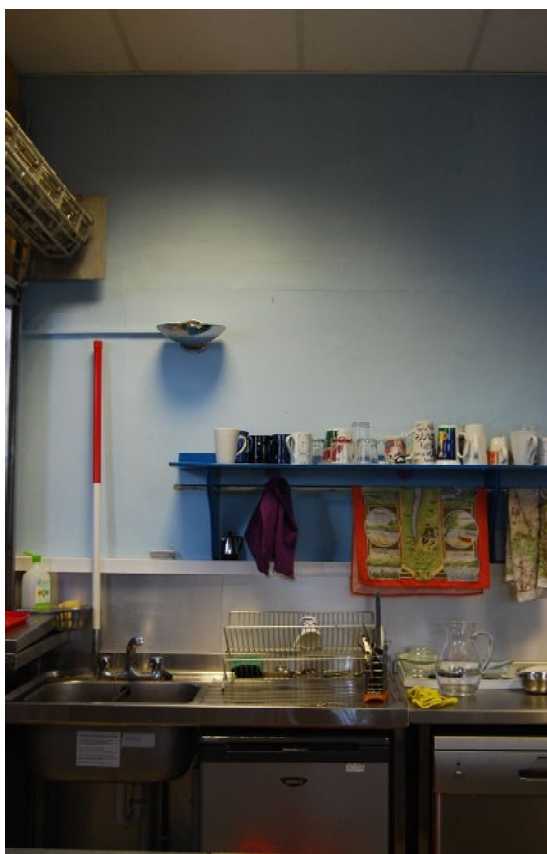
Plate 28. Blocked doorway between two parts of south range (from E; 1m scales)

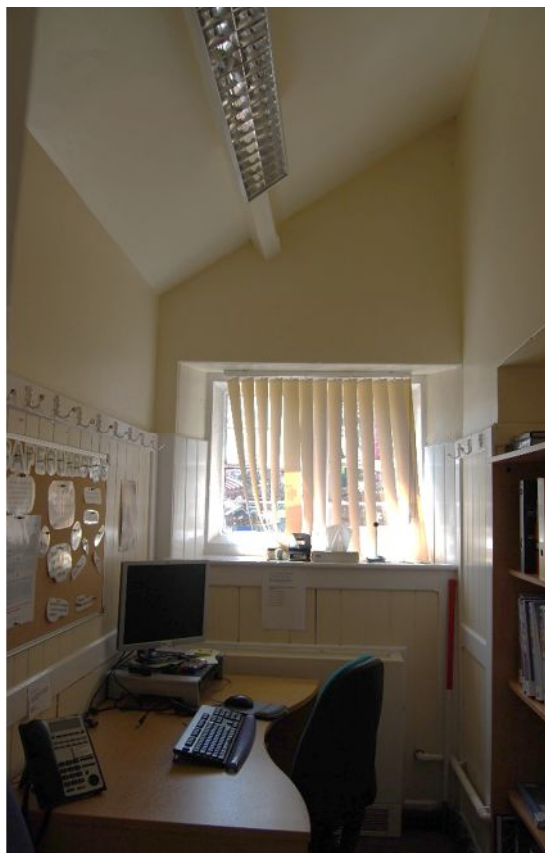
Plate 36. Office in south extension showing wood panelling with coat hooks (from N; 1m scales)

- 6.2 Overall, the present appearance of Haywards Old School is wholly recognisable from the original building. The most significant relevant change involved extensions to the south of the east and west ranges. This had occurred by 1874, and by 1905 both extensions were extended yet again, with a separate set of buildings to the south effectively creating a southern enclosed courtyard. The secondary phase of additions also involved the construction of a narrow extension alongside the south extension, providing an entrance hall for the south room and south extension, and a small room. The latter retains rows of coat hooks at adult height, suggesting this was the teacher's cloakroom.

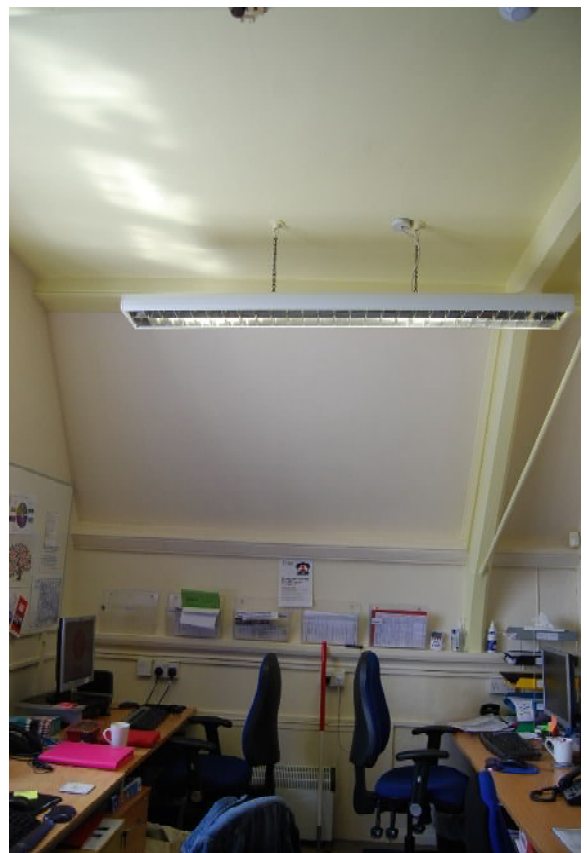
- 5.7 Returning to the south room, a doorway at the eastern end of the south elevation was probably an original doorway, but now leads into an entrance hall with parquet wooden floor which was constructed by 1905 (**Plate 29**). Further doorways lead off the hallway into the eastern side of the south extension (**Plate 30**) and into a small wood-panelled room fitted with rows of coat hooks (**Plate 36**). The wide opening at the western end of the south elevation provides access to the western side of the south extension, lined with wood wall panelling and coat hooks (**Plate 31 & 32**). Parts of the south extension are open to roof level, so that the original open classroom roof can be appreciated (**Plates 33, 34 & 35**); elsewhere modern suspended ceilings are in place at eaves level. The southern end of the south extension is divided into two storeys, the first floor office also open to the roof (**Plate 37**).

Plate 37. 1st floor office in south extension (from E; 1m scales)
