Halberton Court Farm, Halberton, Devon

An Archaeological Desk-Based Assessment with Settings Assessment

COAS reference: C1/EVA/16/HFH

September 2016 (revised January 2018)

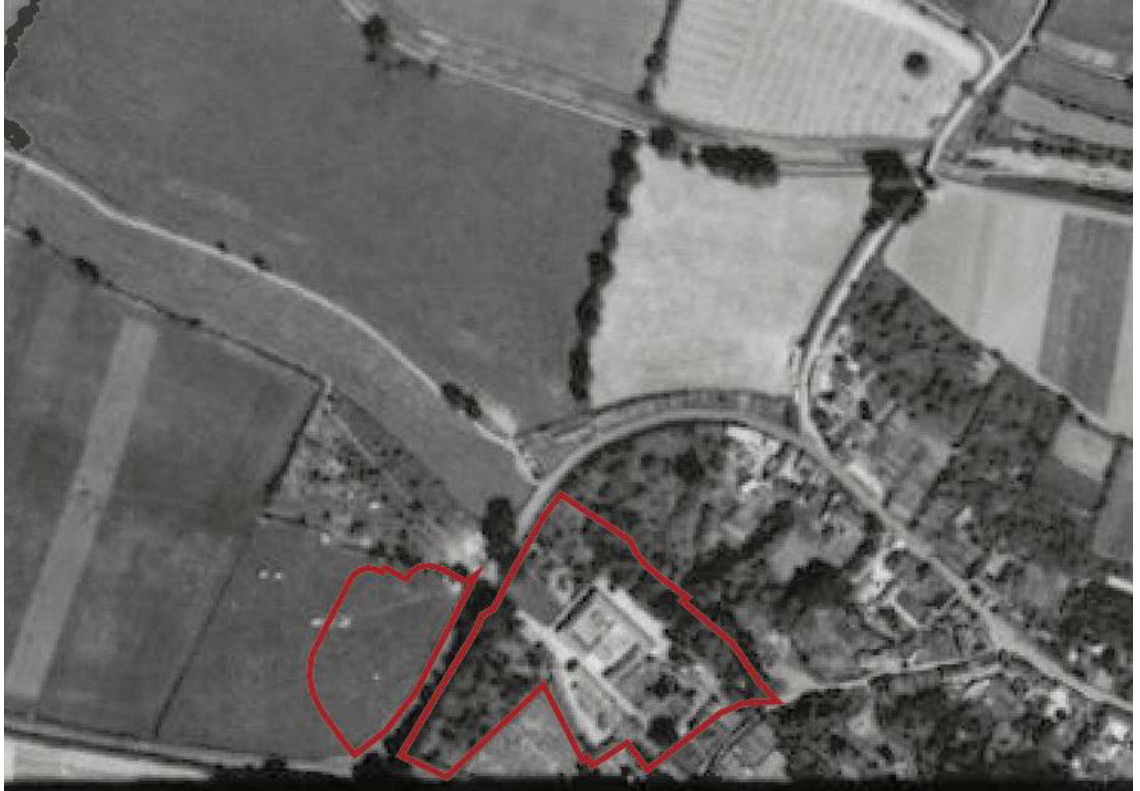
Plate 1. 1947 aerial photograph (Devon HER Arch/DM/HER/MD/CDV28513b)

- 4.18 The Site appears on an aerial photograph from 1947 (**Plate 1**). This shows the north-western part of the Site as pasture and orchard, in keeping with the 1905 map. The southern portion of the Site shows orchard and trees in the north-western area along the Tiverton road, and buildings in the locations shown on the 1905 map. The historic areas of Higher Town to the north-east and Lower Town, part of which is visible to the south-east also appear undeveloped.

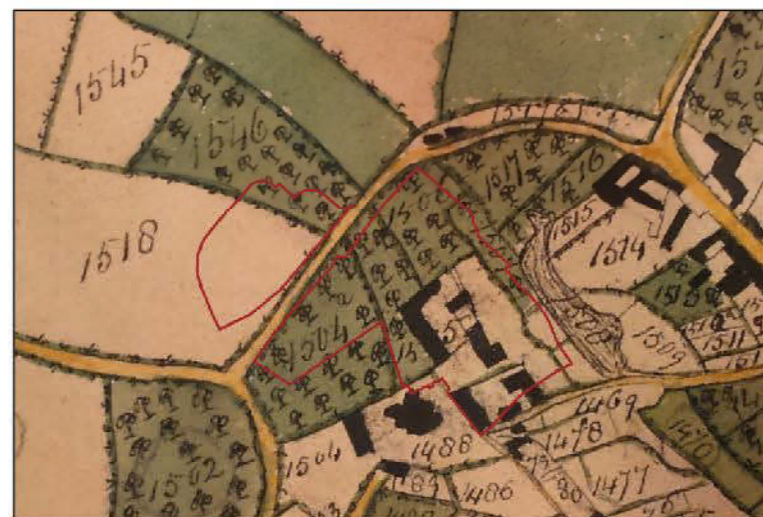
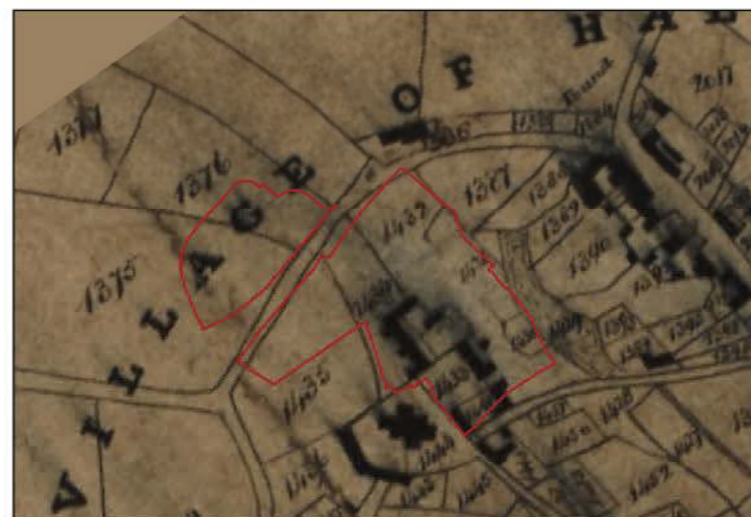
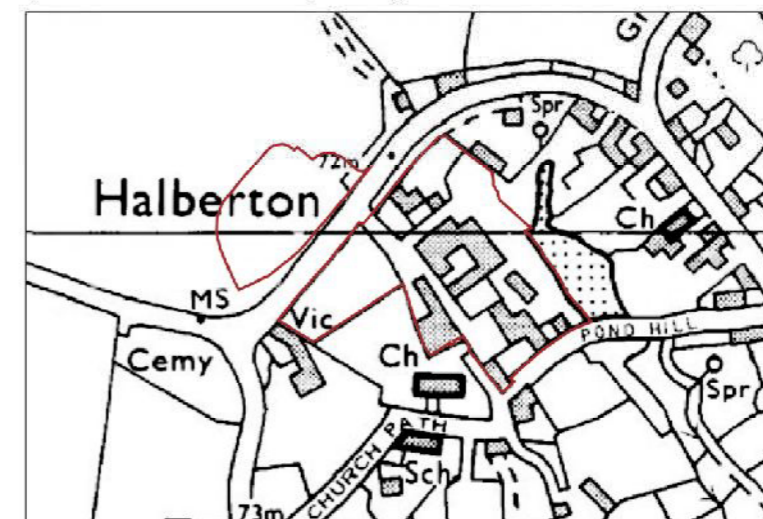
Figure 4. Historic map regression

a) Detail from Parish Map, 1814

b) Detail from Tithe Map, 1838

c) Detail from Ordnance Survey 25" Map, 1889

d) Detail from Ordnance Survey 25" Map, 1905

e) Detail from Ordnance Survey 25" Map, 1969

f) Detail from Ordnance Survey 1:10,000 Map, 1993

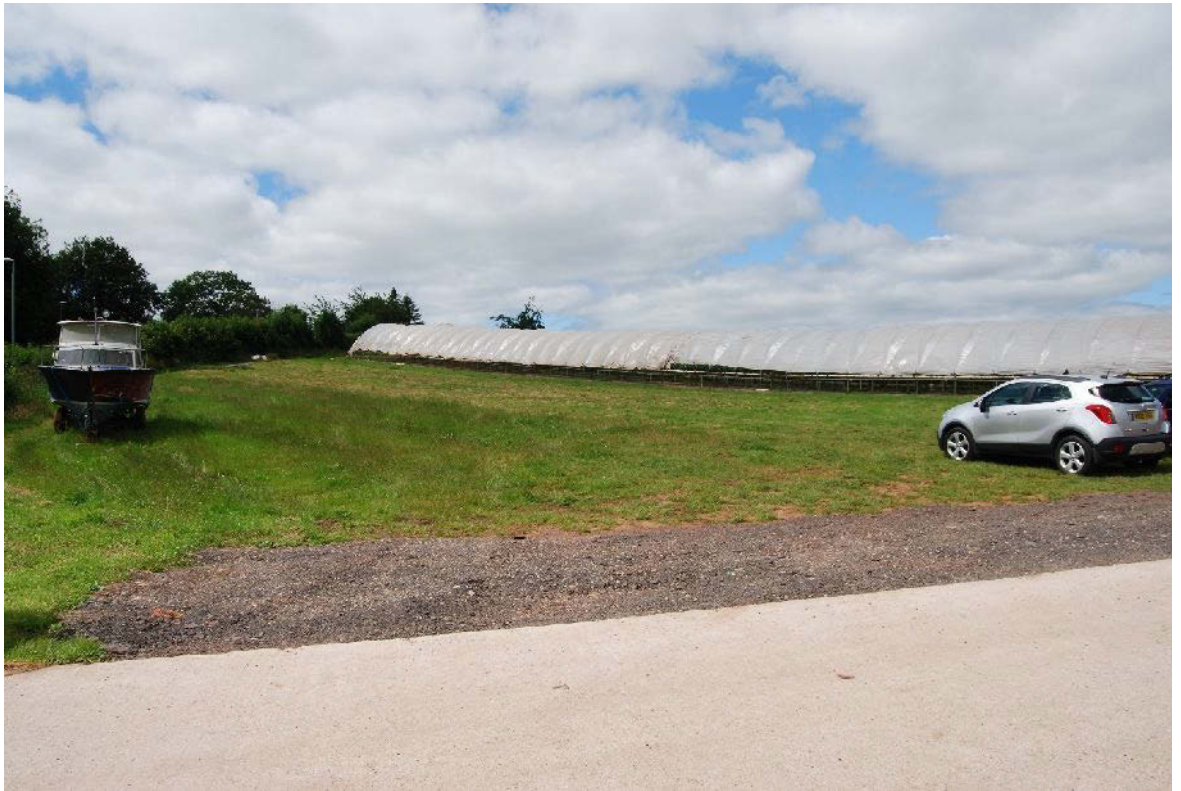
Plate 2. The north-western portion of the Site (from SW) showing the polytunnels

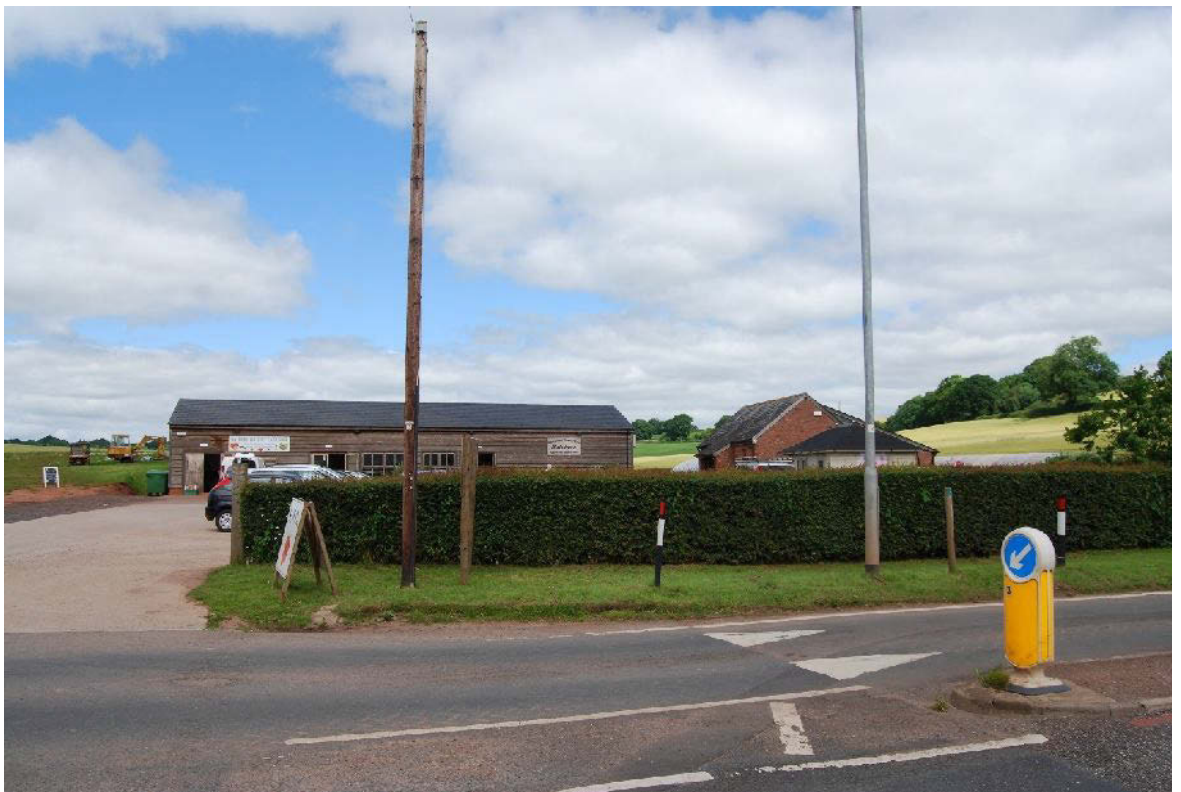
Plate 3. The farm shop and associated structure to the east of the north-western portion of the Site (from S)

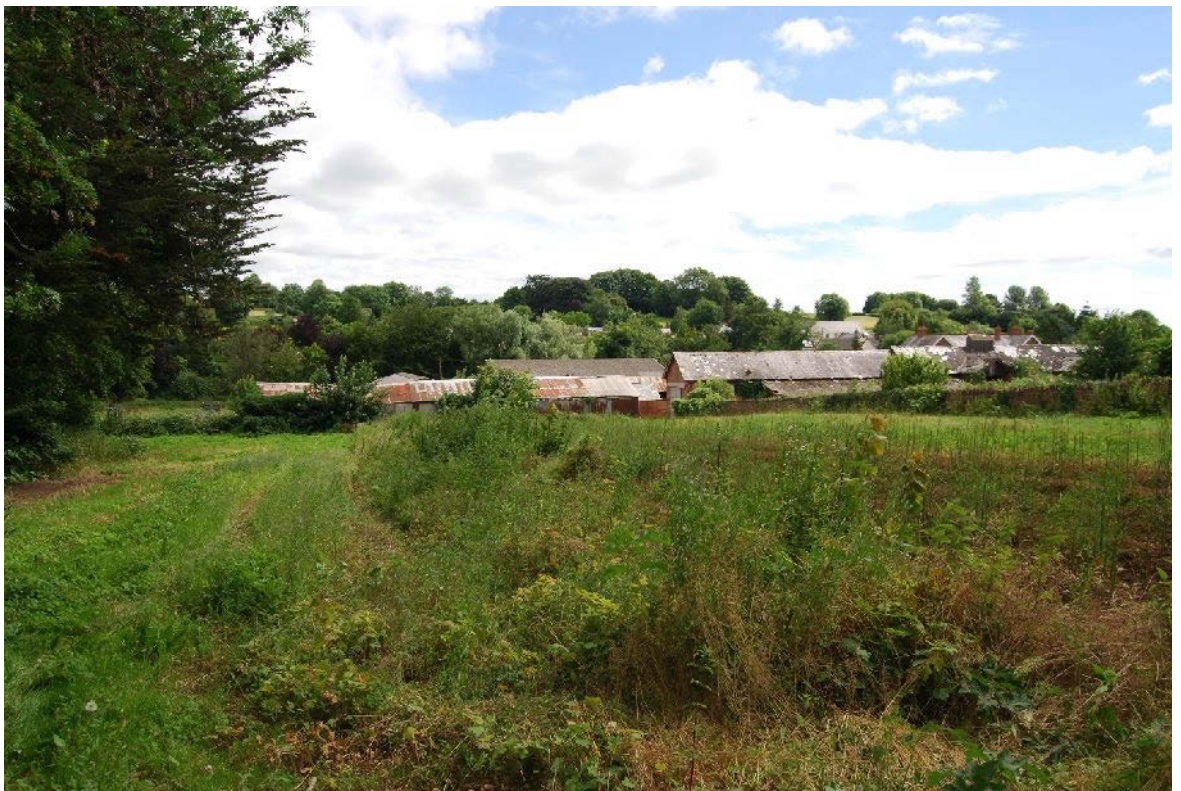
Plate 5. The north-western area of the southern portion of the Site (from NW) showing the asparagus beds and the buildings in the centre of the Site to the east

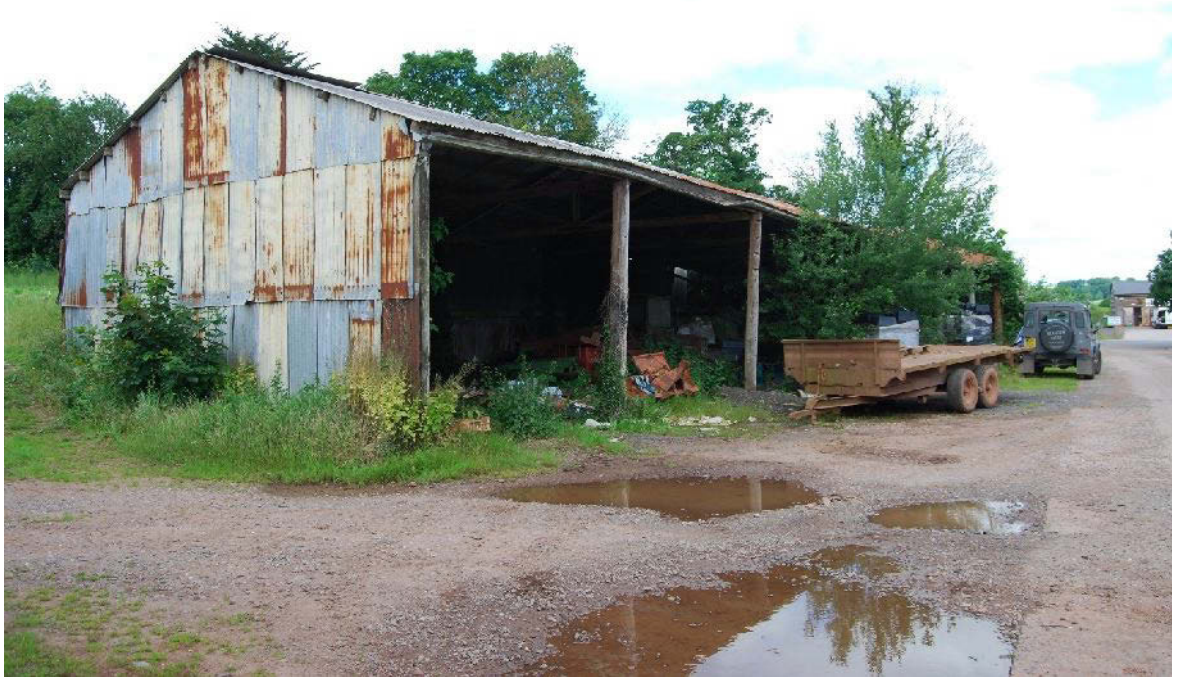
Plate 6. The modern barn on the western side of the entrance track to the southern portion of the Site (from S)

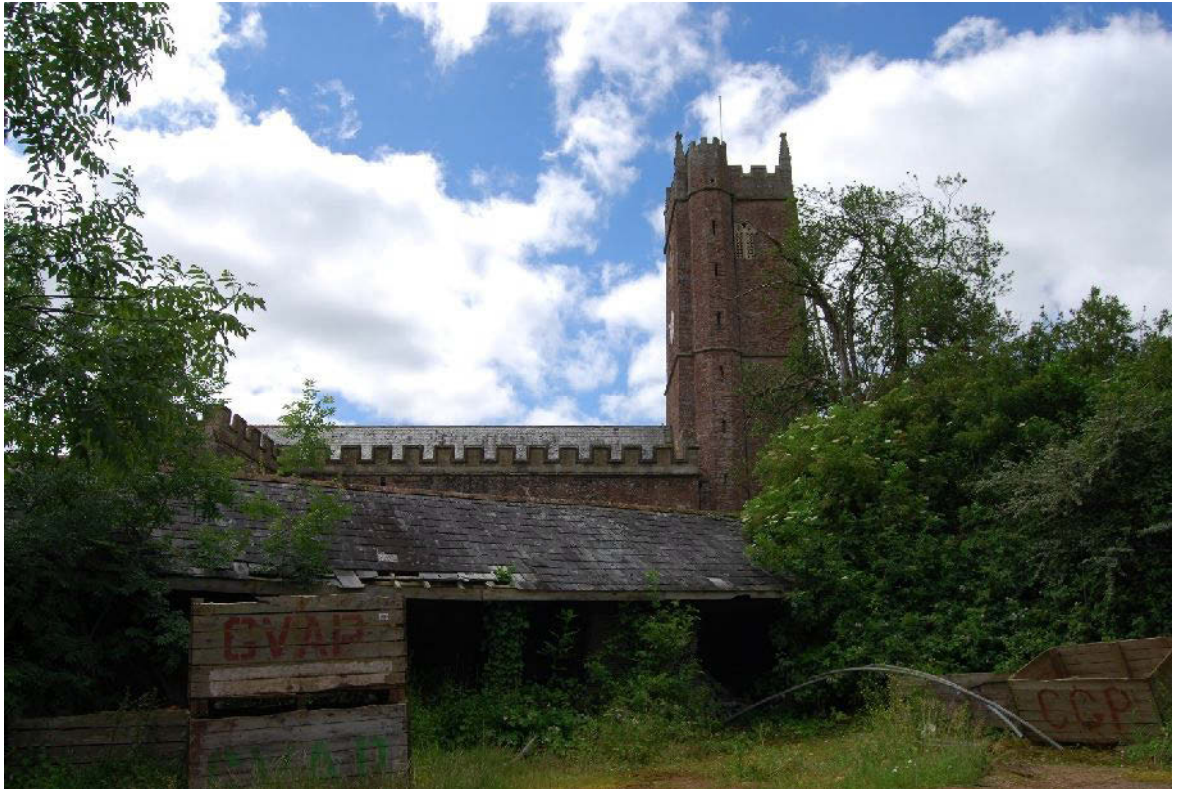
Plate 10. The south-western corner of the southern portion of the Site (from N), showing sheds along the boundary with the churchyard, with the church in the background to the south

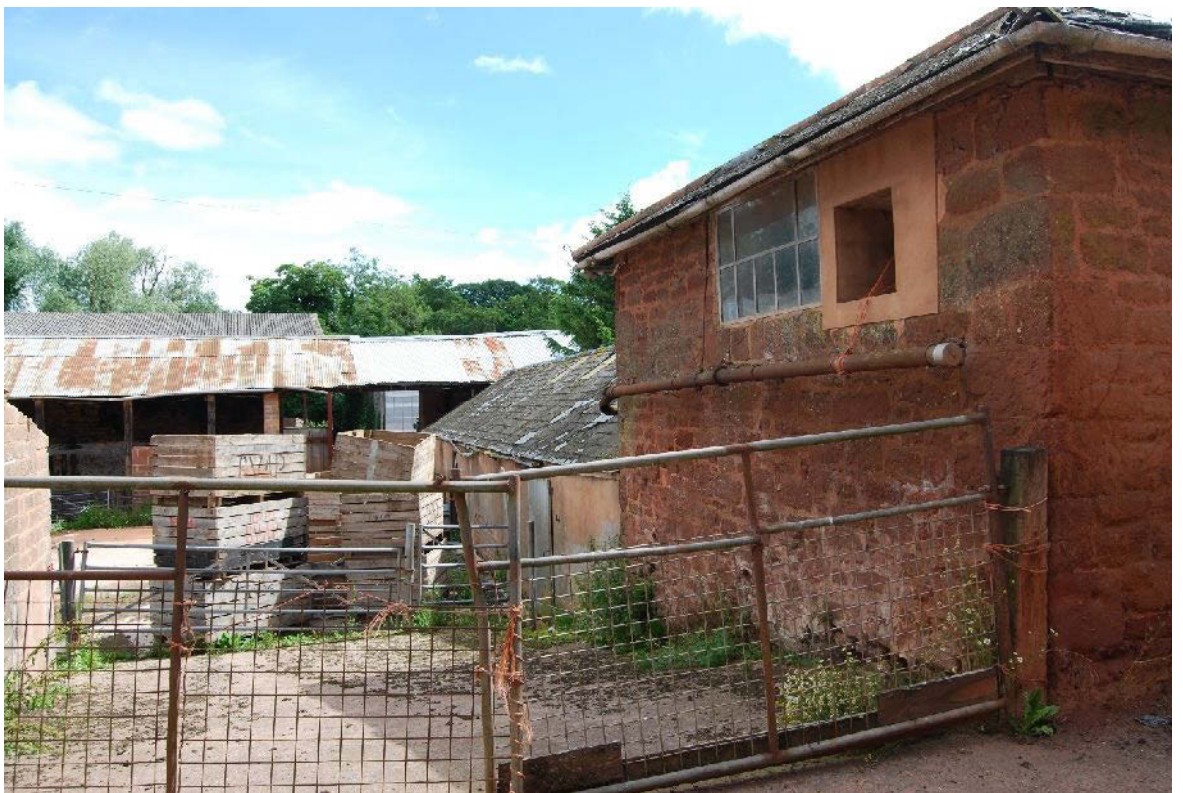
Plate 11. Part of the 'courtyard' arrangement of buildings in the central area of the southern portion of the Site (from W)

- 5.5 The central area of the Site, to the east of the long sandstone barn, on the same alignment on the opposite side of the entrance track, is occupied by a group of barns/sheds in a square/rectangular courtyard arrangement (**Plate 11**). This is also at least partly of red sandstone construction with the addition of modern materials. Single storey stables and sheds opening onto the central track are attached to the south-western corner (**Plate 12**). There is a further modern open-sided Dutch barn (**Plate 13**) on a similar alignment on the eastern side of the 'courtyard'. The entire area around these buildings is under concrete hardstanding. This area is apparently crossed by the main sewer. There is also a silage clamp, and pond, and there is a tradition of a tunnel in this area.

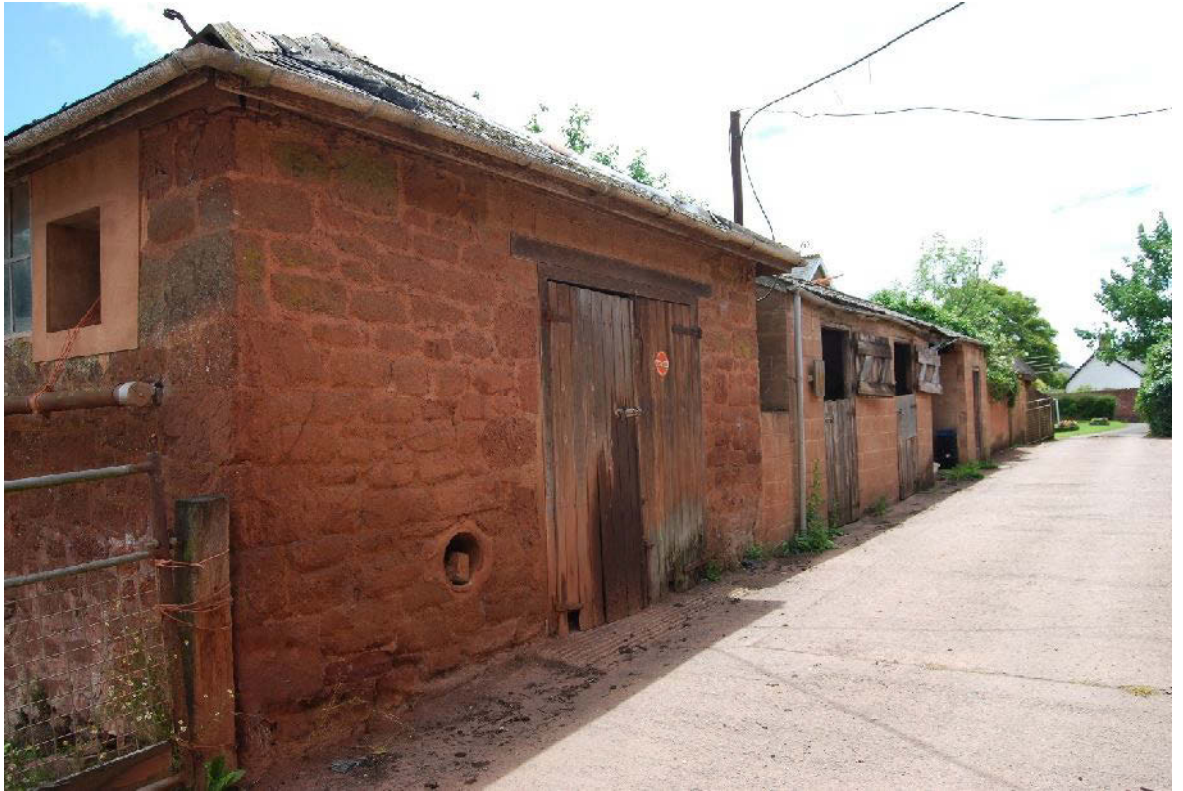
Plate 12. The south-western corner of the 'courtyard' with associated stables and sheds to the south (from NW)

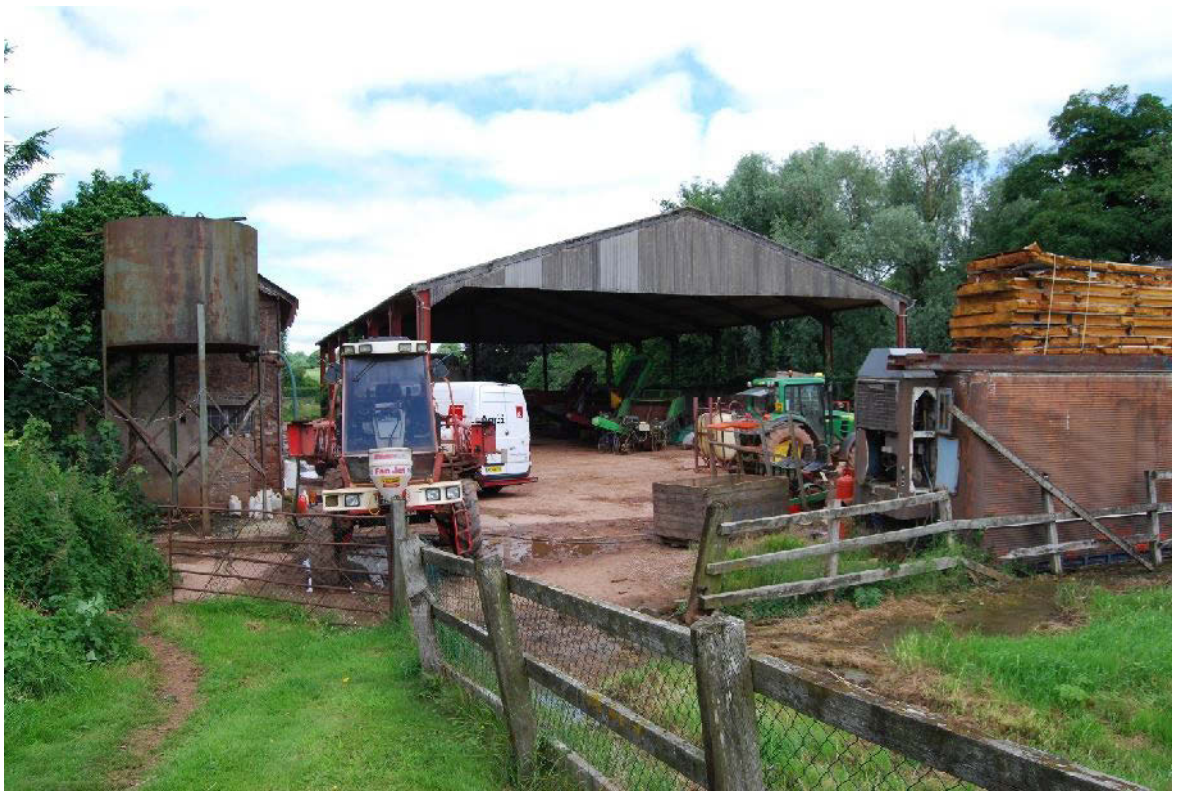
Plate 13. The modern Dutch barn and yard on the eastern side of the southern portion of the Site (from S)

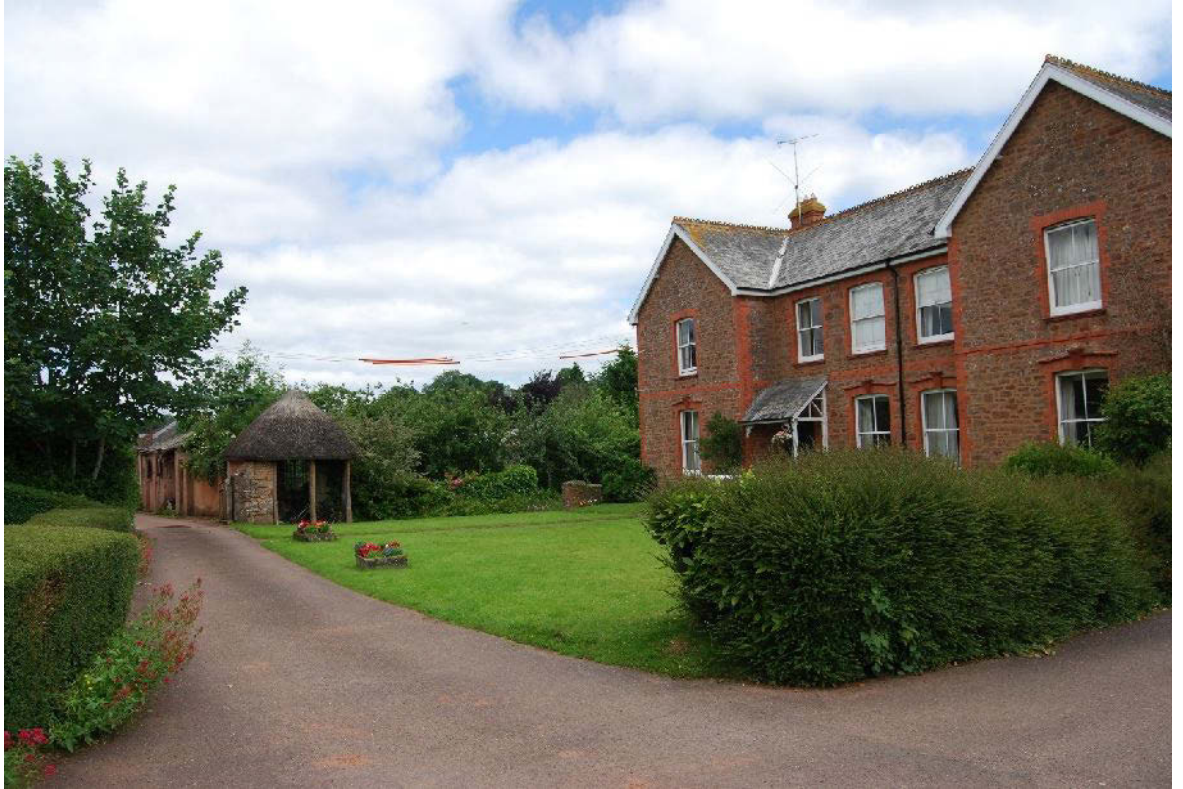
Plate 14. Halberton Court (from SW), showing stables along the central track to the north

- 5.6 The southern portion of this area is occupied by Halberton Court itself (**Plate 14**), a stone constructed detached house with decorative brick stringer courses, and lawns to the front. A single-storey detached garage stands to the south (**Plate 15**). There is an area of garden on the north-east side of Halberton Court, between it and the central group of farm buildings (**Plate 16**). To the east, to the rear of the house, is open grassland (**Plate 17**). The entire eastern boundary of the Site is screened by very large deciduous trees which stand along the edge of the village pond. The southern-most tip of the Site is occupied by Church Barn (**Plate 18**, referred to above), situated lengthways along Church Path, opposite the churchyard, and the adjoining 6 Pond Hill on the corner of Church Path and Pond Hill. There is a high stone wall (**Plate 19**) which forms the boundary along the south-eastern side of the Site down to the Pond (**Plate 20**).

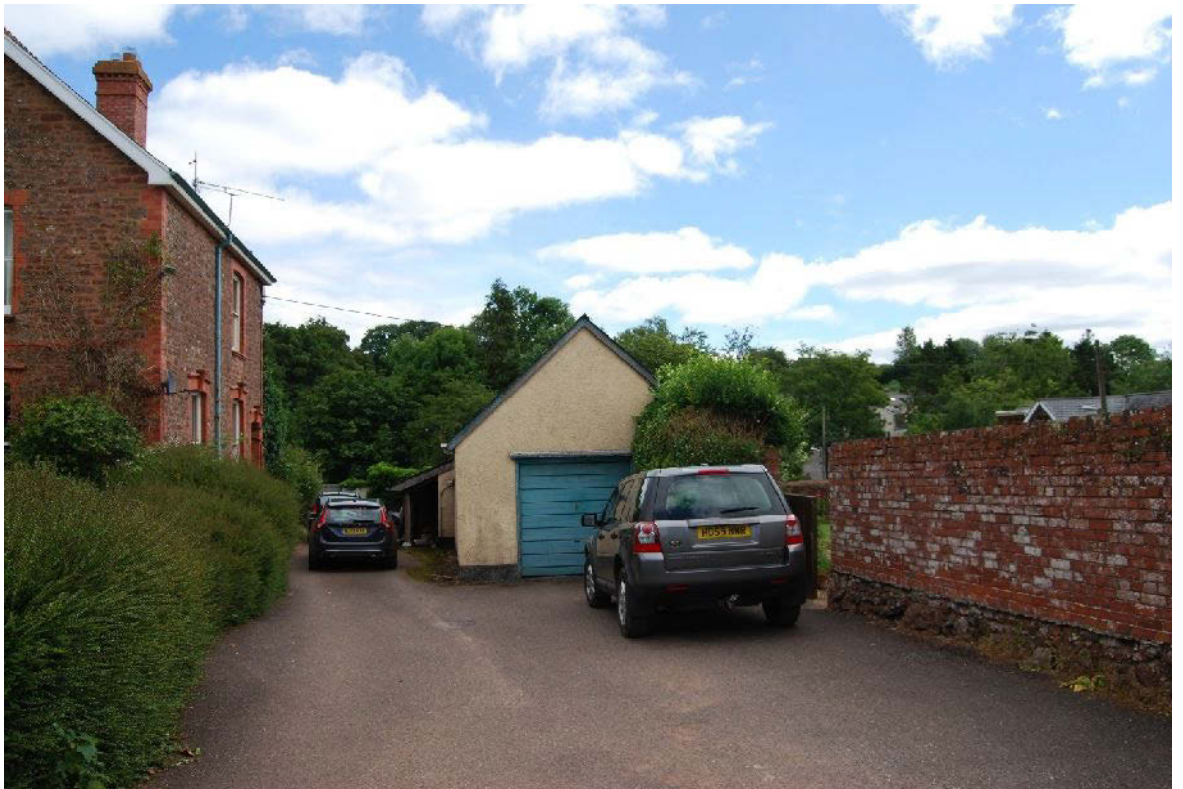
Plate 15. Hard standing and detached garage to the south of Halberton Court (from NW)

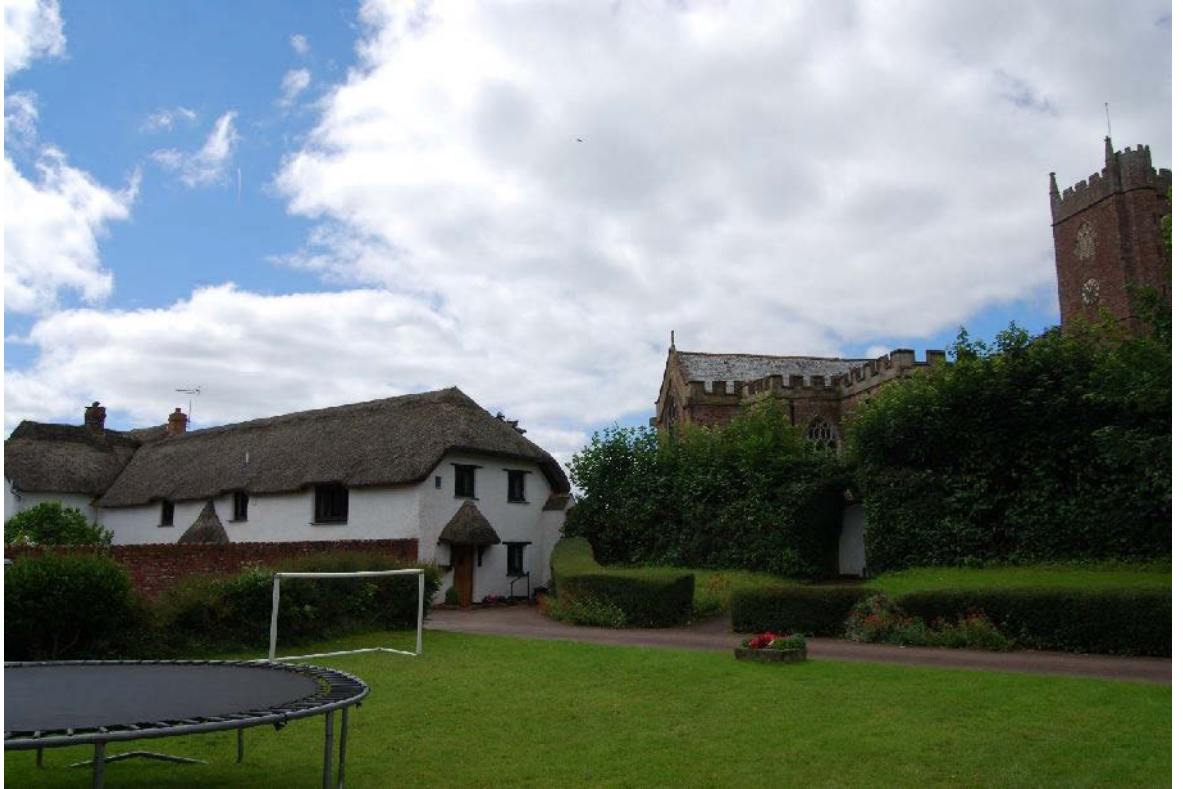
Plate 18. The southern corner of the Site (from N), showing Church Barn in the centre of the frame and the rear of No 6 Pond Hill adjoining to the left, with the Church of St Andrew to the south-west

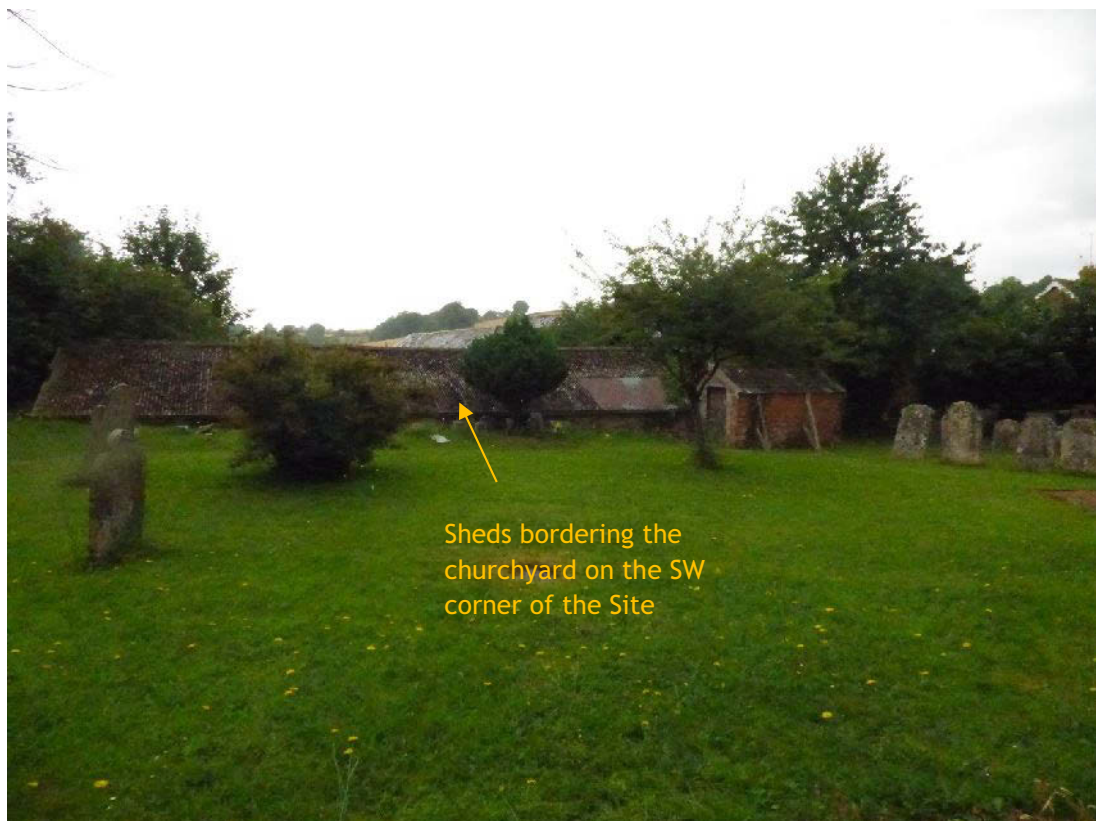
Plate 28. View over the south-western boundary of the Site from the north wall of the Church of St Andrew (Figure 5 No 10) (from S) with the barn along the boundary and glimpses of other farm building roofs beyond

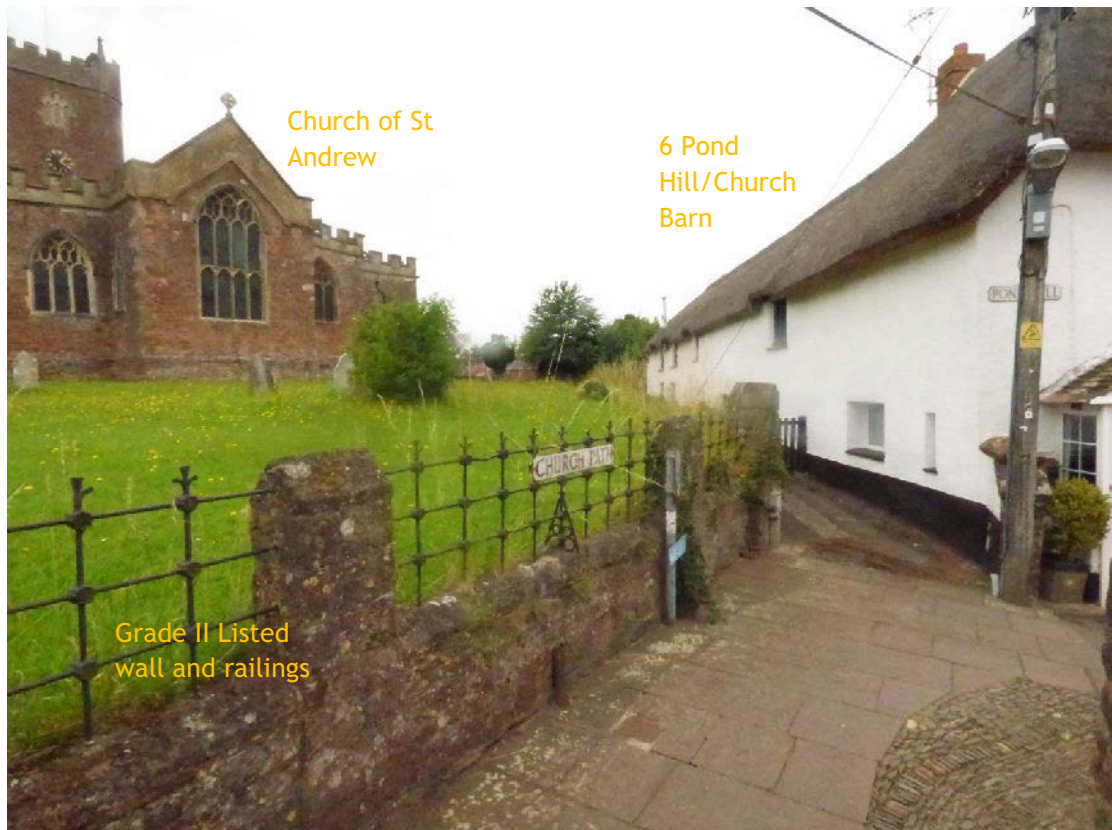
Plate 31. Grade II Listed No 6 Pond Hill/Church Barn (Figure 5 Nos 8 & 9) (from S)

- Buildings on and along the southern Site Boundary*
- 6.23 Grade II Listed Church Barn and No 6 Pond Hill (**Figure 6 No 8; Plate 29, 30 & 31**), of **less than the highest significance**, are now one dwelling and are situated within the boundary of the Site, forming its southern corner, with Church Barn fronting onto Church Path and 6 Pond Hill opening onto Pond Hill, the lane which connects the church with the village pond and High Street. Their immediate position is adjacent to St Andrew's Church, the churchyard boundary of which is immediately to the west. No 1 & No 5 Church Path (**Figure 6 No 6; Plate 30**), Grade II Listed and of **less than the highest significance**, is now one building and situated immediately to the south of 6 Pond Hill. It also fronts onto the churchyard to the west. Willihays, (**Figure 6 No 5; Plate 32**) also Grade II Listed and of **less than the highest significance**, is situated on the south side of Pond Hill, opposite 6 Pond Hill. These buildings, one originating as a historic agricultural building, and the others dwelling houses, form a closely chronologically and physically related group of historic structures at the core of the historic settlement, and are therefore dealt with together. They derive their significance primarily from their fabric which provides evidential value, but also from their historic relationships with the core of the settlement; their aesthetic value which contributes to both the character and appearance of the area; their appreciation as the historic core; and the setting of the church and associated assets.

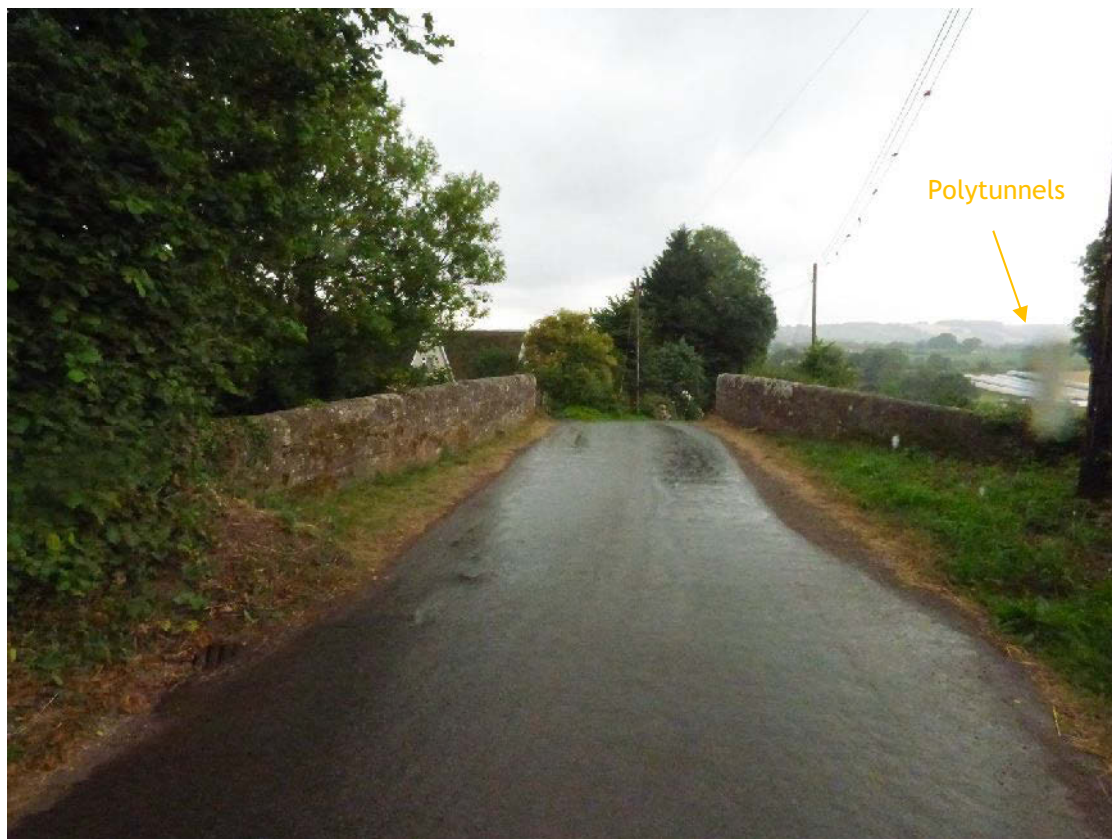
Plate 45. The Greenway Bridge (Figure 5 No 1; from E)

- 6.34 There is no historical link between Greenway Bridge with Grand Western Canal and the Site, but the views from the well utilised towpath on the western side of the canal are open and extensive to the west and south-west towards the Site. From the Greenway Bridge there are already visible structures in the middle ground of the view (Plates 45 & 46) back to the position of the proposed

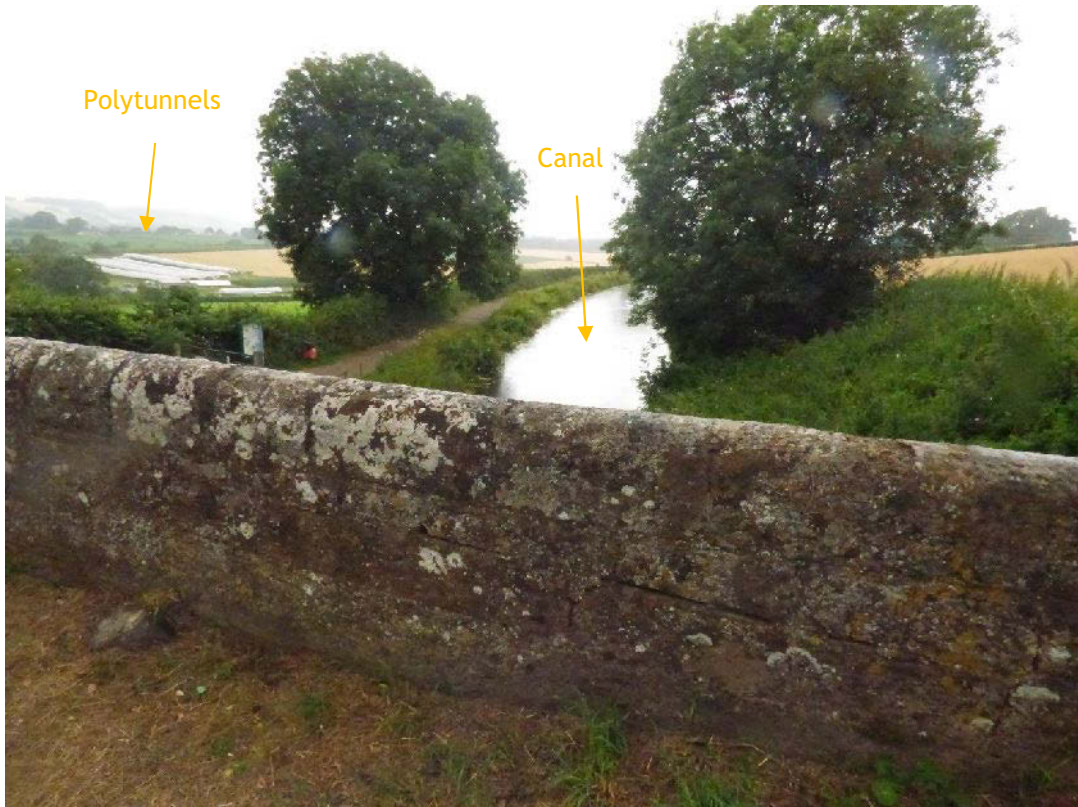
Plate 46. Greenway Bridge (Figure 2 No 46; from SE) and the Great Western Canal

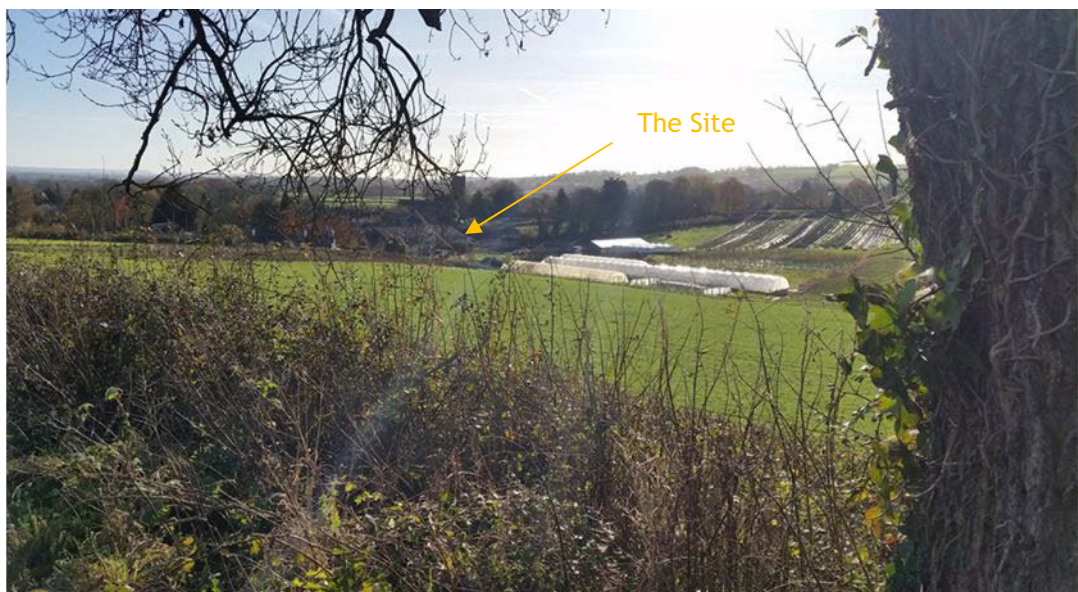
Plate 47. View from the Great Western Canal (Figure 2 No 43) from NNW (Clark 2017 Plate PV3)

development. The views from further along the canal to the north are increasingly distant (Plates 47 & 48) and the re-purposing of some buildings and construction of others is within the outline of the settlement from these views, tucked in below the skyline. As the roof lines proposed are lower they will not block the sightlines between the canal and the church, which will remain the most prominent feature visible from these distances, and the buildings will blend with the backdrop of the current village. It is therefore suggested that it is unlikely that the proposed changes on the Site would cause any detriment to the significance of the assets, and therefore it is considered that there will be **no harm**.

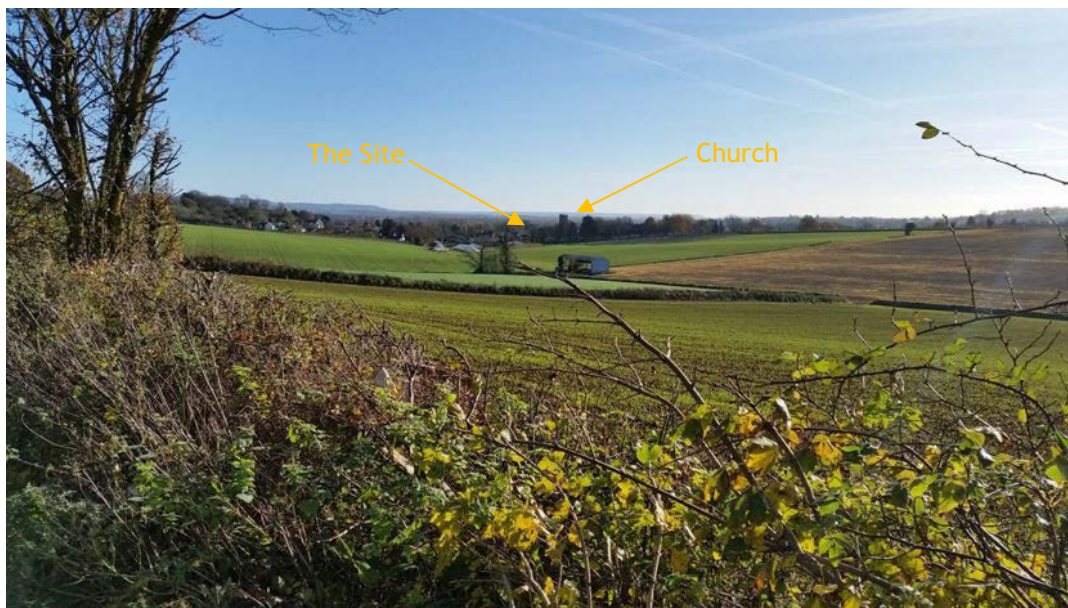
Plate 48. View from the Great Western Canal (Figure 2 No 43) from N (from Clark 2017 Plate PV4)
