Countess Wear Bridge
Exeter
Devon

Historic Building Recording

December 2016

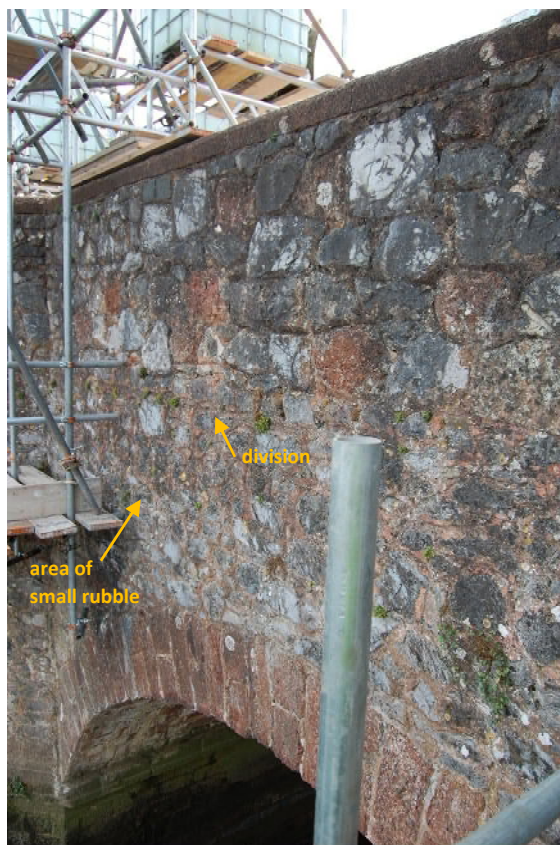
Plate 3. Arch between CW1 & CW2 (from NW)

- 4.4 In addition to the re-built parapet, a small strip comprising smaller rubble ran beneath the base of the parapet between CW1 and CW2 (**Plate 3**). This might relate to re-facing during reconstruction works, however it is quite different to the larger rubble pieces utilized for the parapet suggesting it might relate to an earlier episode of re-facing or repair.

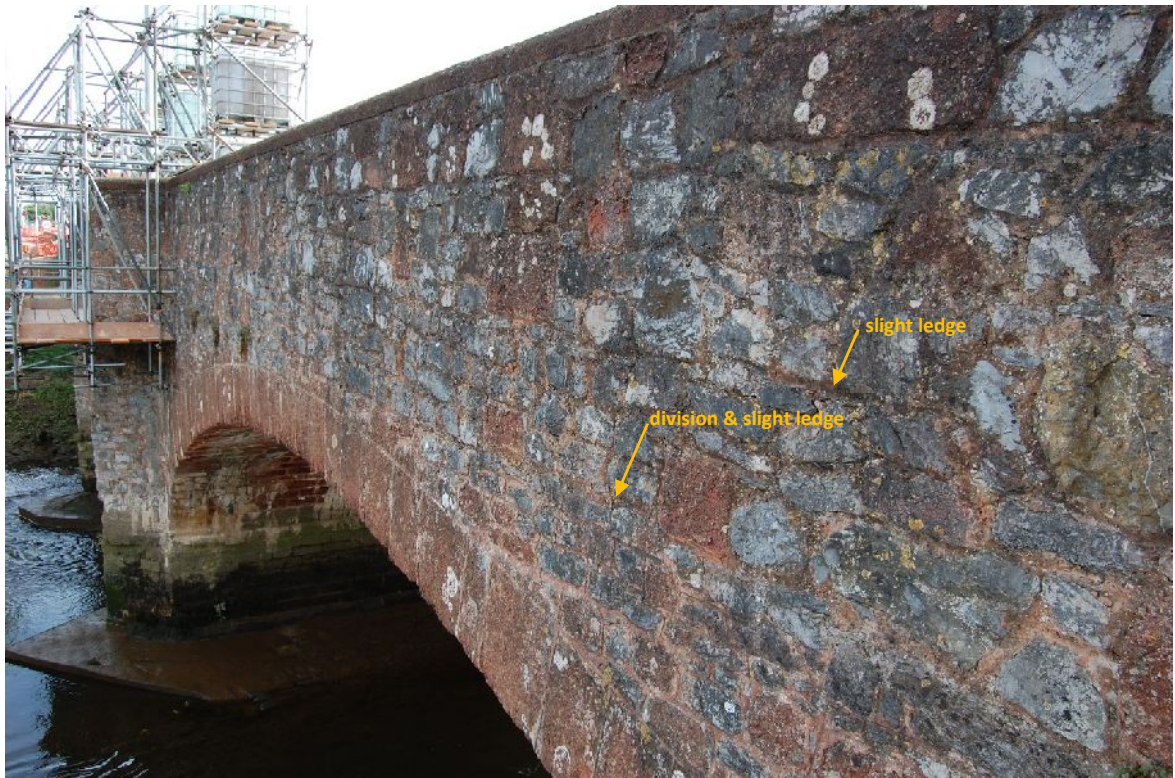
Plate 6. Main wide arch between CW3 & CW4 (from NW)

- 4.3 The masonry above the wide arch but beneath the re-built parapet differs in character to the other arches, containing fairly regularly spaced red sandstone blocks in addition to the grey limestone which dominates the 18th century rubble facing throughout the remainder of the bridge (**Plates 6 & 7**). This is indicative of an earlier phase of re-facing.
