# Countess Wear Bridge, Exeter, Devon

An Archaeological Programme of Works: Desk-Based Assessment and Historic Building Recording

**COAS reference:** COAS/SBR/12/CWE

March 2013

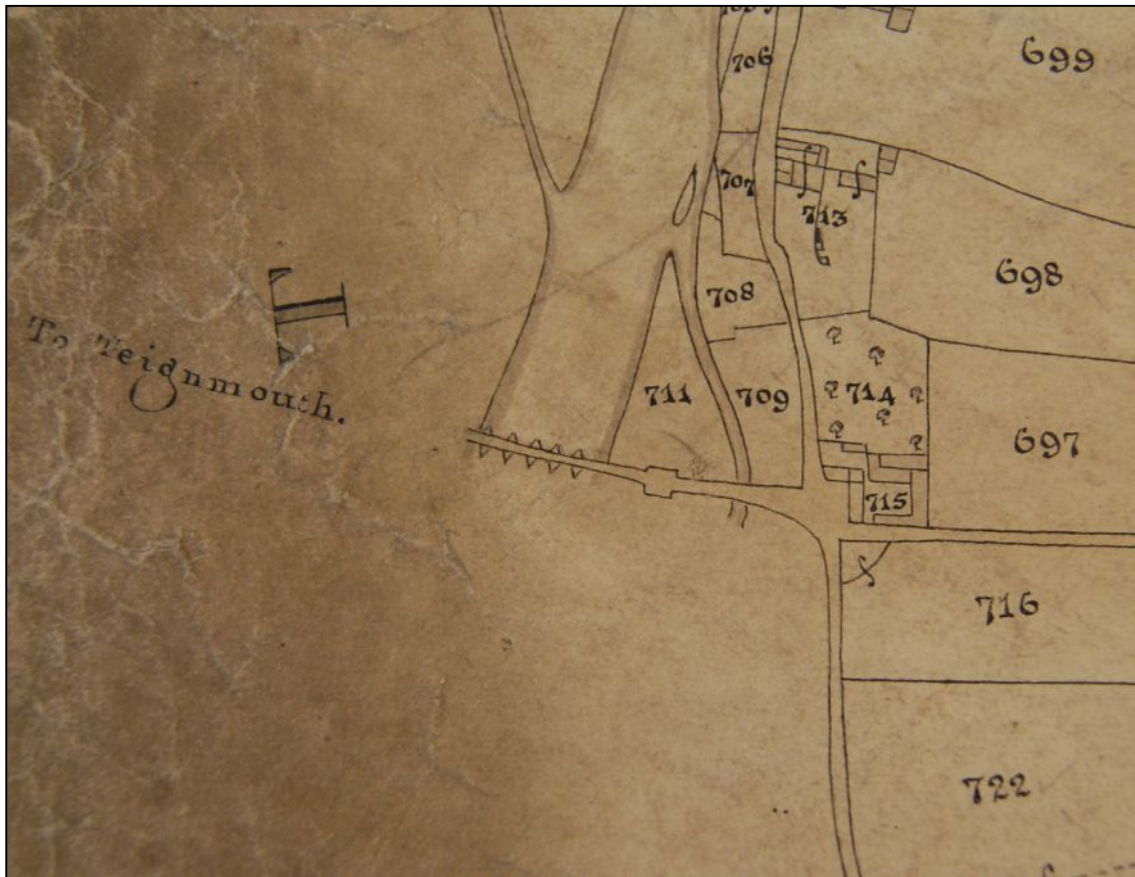
Plate 1. Topsham Tithe map, 1840 showing Countess Wear Bridge

- 3.5 The Topsham tithe map of 1840 shows Countess Wear Bridge spanning the River Exe and extending across the leat on the north-east side of the river. The five triangular cutwaters are apparent with a wider, rectangular section between the river and the leat above plot 711 (Plate 1). The 1880, 1905 and 1930's 1:5000 OS maps indicate that no significant alterations were carried out during this period.

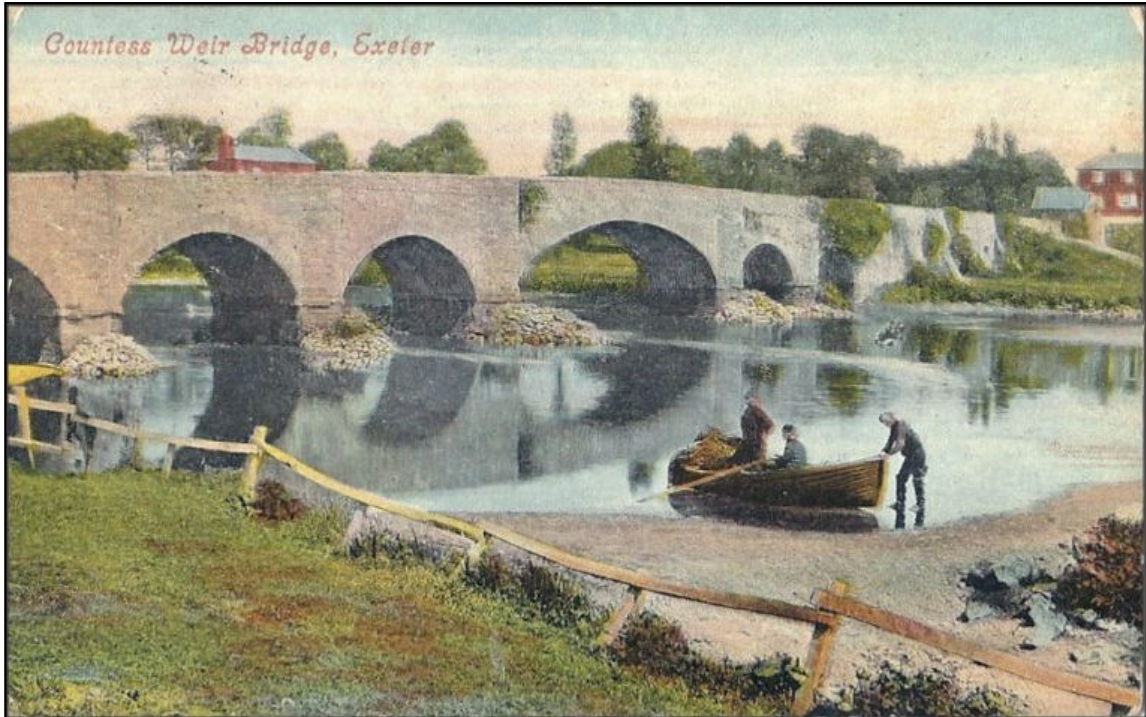
Plate 2. Postcard dated to the early 1900's (DHC/64/16)

- 3.6 Two watercolour postcards dated to the early 1900's (Plate 2) and to 1904 (Plate 3) depict the downstream (south-east) elevation prior to the extension of this side of the bridge in the 1930's. The triangular cutwaters rose to the top of the parapet and the supporting tapered buttresses supporting the bridge on the eastern bank are also visible. Piles of pebbles or stones obscure the lower courses of the cutwaters. Almost the entire width of the bridge span across the River Exe is shown on the postcards, including the three western segmental arches, the wider central elliptical arch and the two eastern segmental arches.

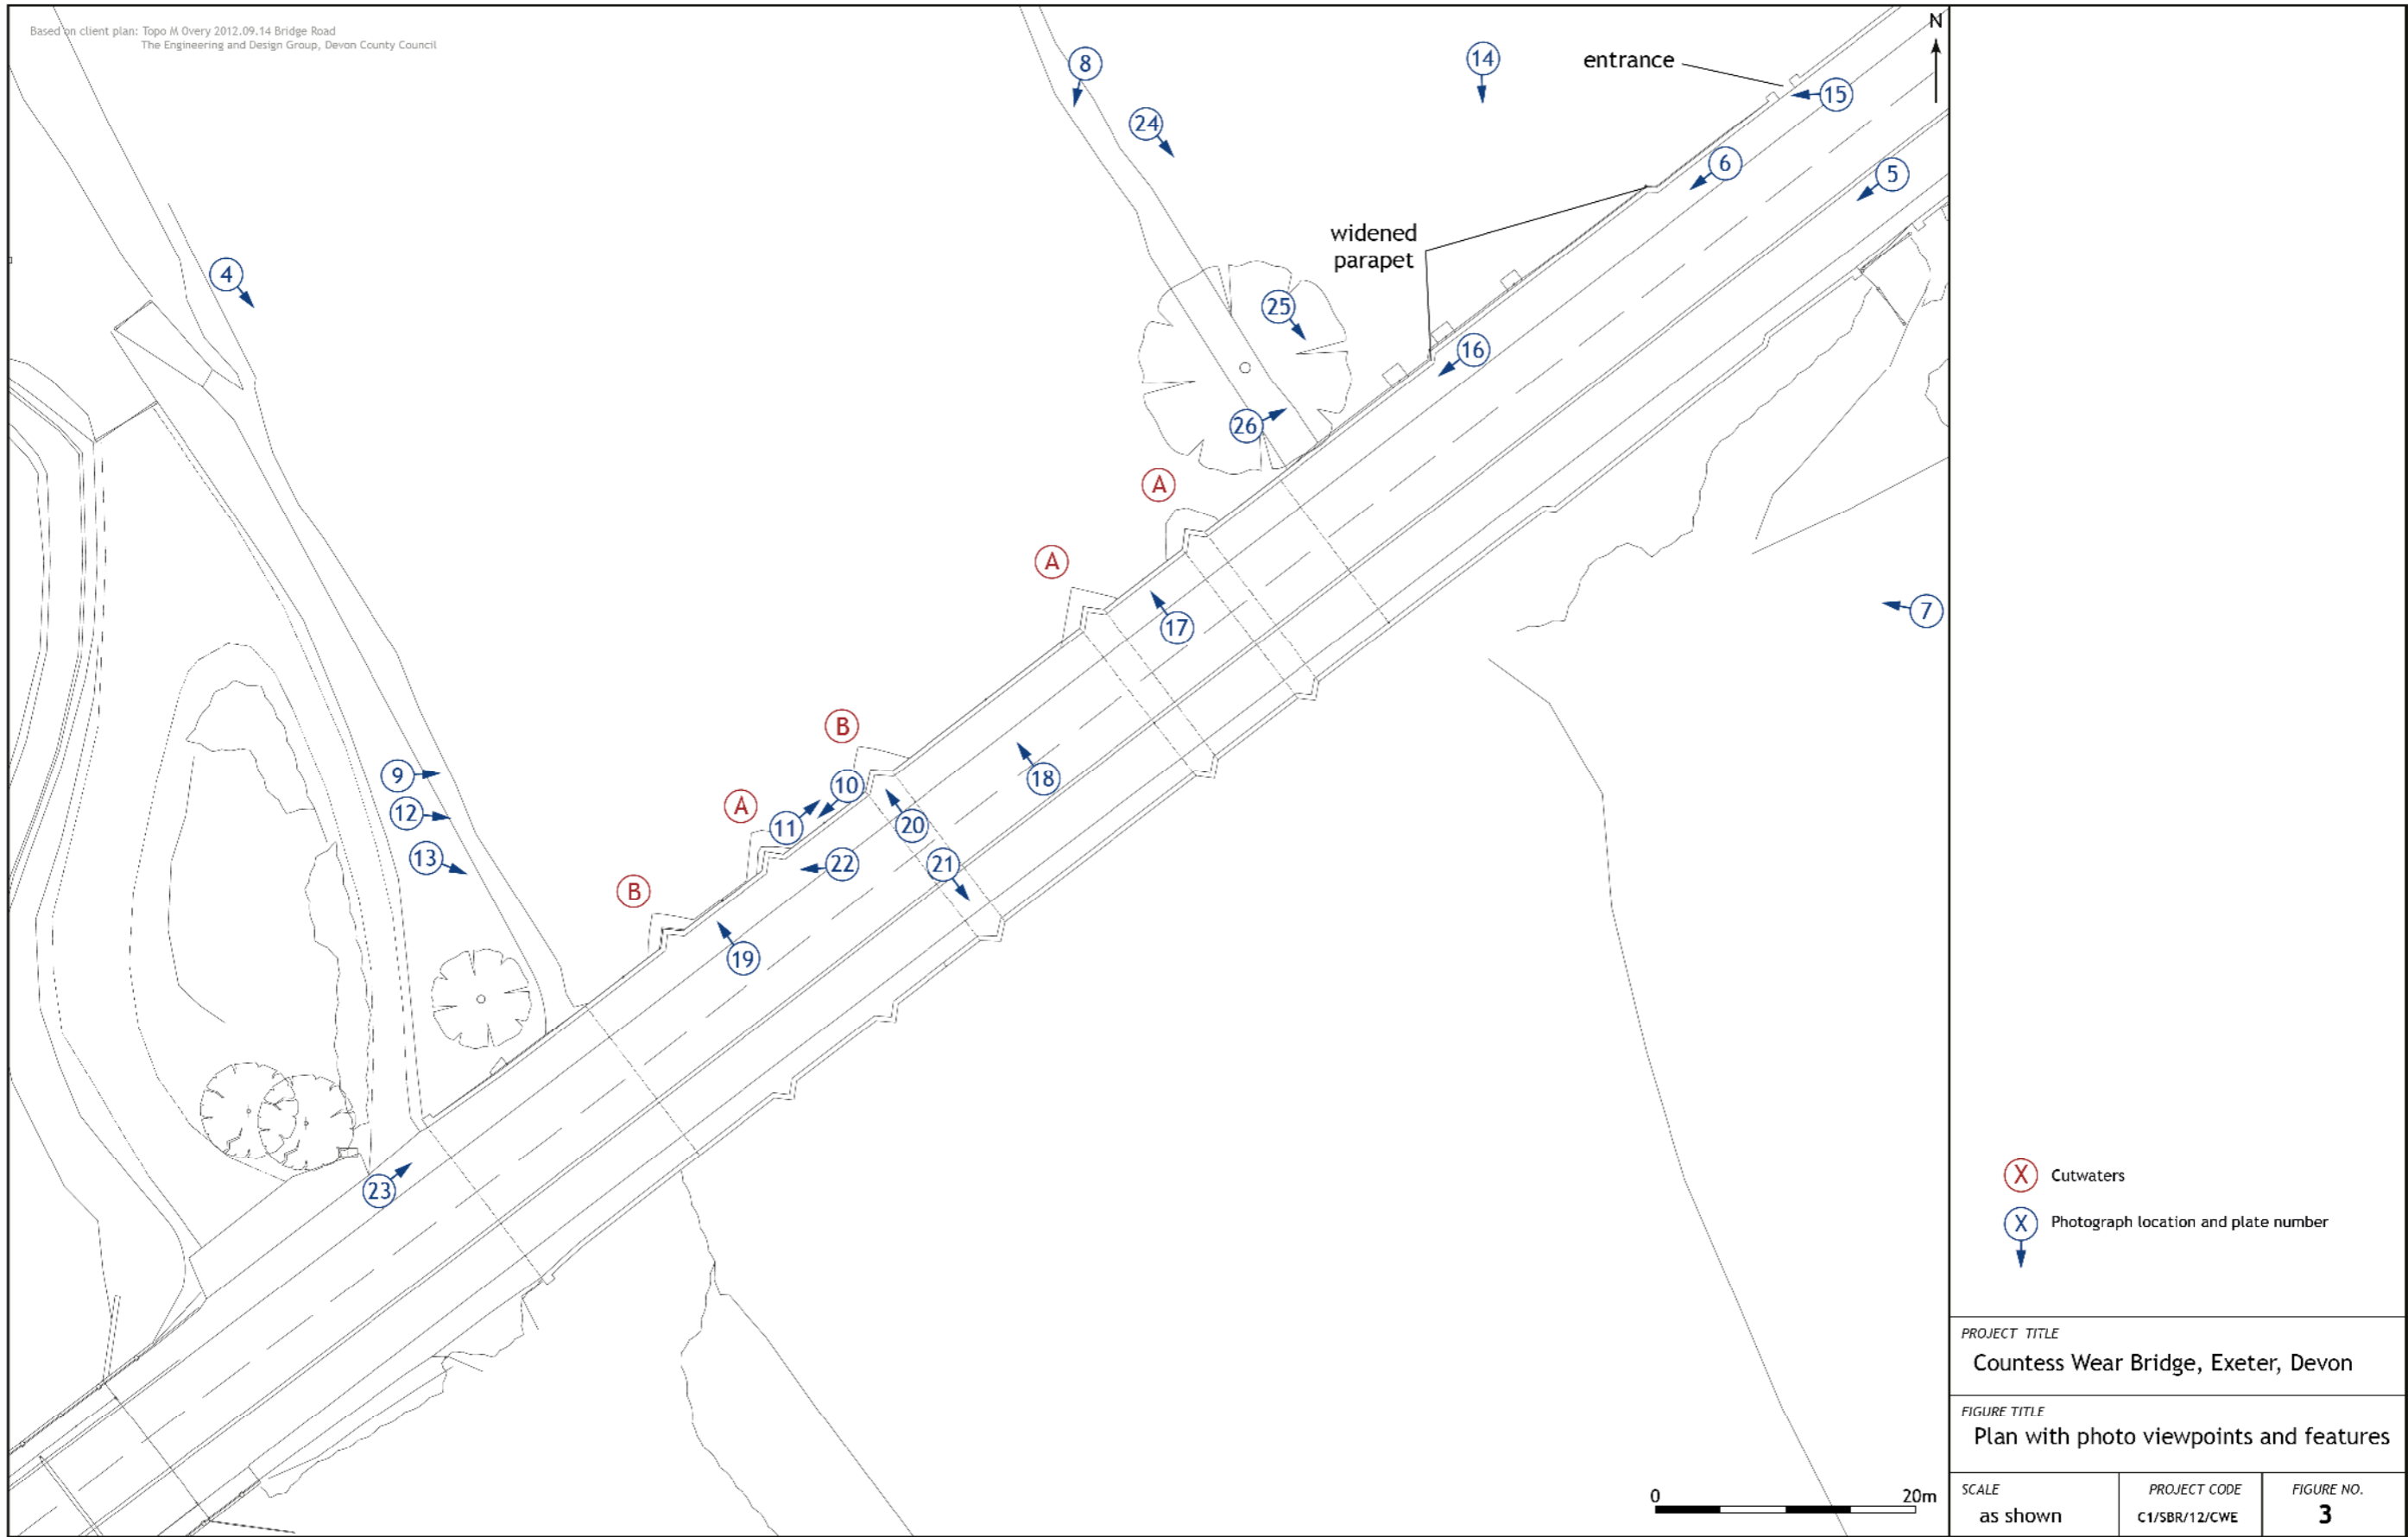
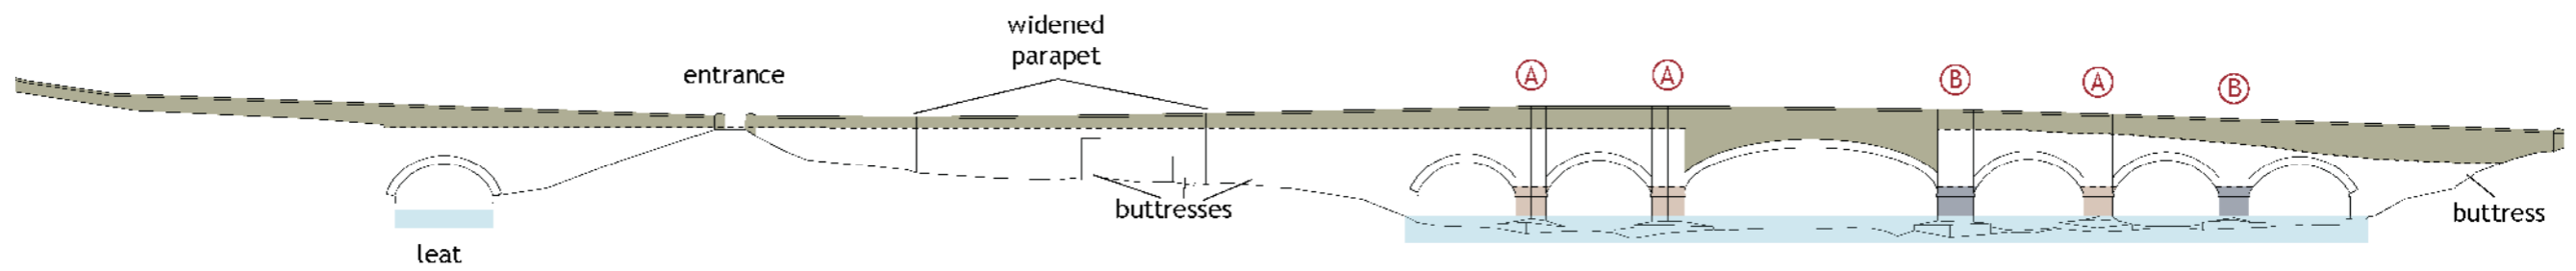
SCALE	PROJECT CODE	FIGURE NO.
as shown	C1/SBR/12/CWE	4

- Cutwater
- Re-faced cutwater
- 1770
- 1935-38
- Water level

FIGURE TITLE  
 Upstream elevation (north-west)  
 with approximate phasing

- 5.3 At the time of the survey the water level was c.1.5m below the springing of the bridge arches. The cutwaters were visible for seven courses below the stringcourses; comparisons with the elevation drawing (**Figure 4**) supplied by the client reveal that this was close to the level of the wide foundations which were submerged at the time of the survey. The bridge is faced with random rubble dominated by Devonian limestone (A Building Stone Atlas of Devon, 8) with smaller quantities of red sandstone. A few blocks of red granite were also identified, the large milky-white feldspar crystals suggestive of Dartmoor Granite (*ibid.*, 13). The cutwater piers are faced with a lighter coloured stone; the HER records states this is sandstone however the fabric could not be clearly identified during the course of the survey.

- 5.5 Of the five cutwaters, three have been labelled Type A (see **Figures 3 & 4**) and appear to retain original fabric (**Plate 10**). The facing comprises regular light-coloured ashlar for the stringcourse, the two courses above the stringcourse and the seven courses visible beneath the stringcourse. The remaining two cutwaters have been labelled Type B (see **Figures 3 & 4**) and have been re-faced with smaller ashlar for the stringcourse, the two courses above the stringcourse and the seven courses visible beneath the stringcourse (**Plate 11**). This stone is laid in a more regular fashion than for the Type A cutwaters, with a distinctly fresher and more modern in appearance. Between the two courses of ashlar above the springing of the arches and the base of the 1935-38 parapet, all five cutwaters are faced with random limestone rubble with larger more regularly shaped limestone blocks employed for the angle of the triangle (**Plate 12**).

- 5.6 The spandrels of the small arches and the area just above the arches appear to be entirely faced in random limestone rubble (see **Figure 4** and **Plates 9, 12 & 13**). The spandrels and masonry surrounding the wide elliptical arch incorporate red sandstone (**Plates 9 & 12**). No doubt this relates to the 1935-38 remodelling which is reflected in a distinct change along the entire elevation including the cutwaters. Precise measurements could not be obtained as close inspection of the elevation was not possible, nevertheless the change in construction was estimated at c.1.5m below the parapet coping (see **Figure 4** and **Plates 9-12**) becoming slightly lower above the western arch (**Plate 13**). The change in masonry continued in the elevation at the eastern end of the bridge, between the river and the leat (**Plate 14 & 26**). Above this level the masonry comprises a mix of limestone rubble mixed with red sandstone and some red granite rubble. Although the form of construction is random rubble, resembling the lower part of the elevation, the mortar joints were thinner, the stone size more regular and the masonry laid more neatly.

- 5.7 The soffits of the five narrower arches are constructed of two rows of red sandstone voussoirs comprising a fairly random pattern of alternating double headers and single stretchers (**Plate 12**). In contrast, the soffit of the wide elliptical arch has a single row of red sandstone voussoirs laid as single stretchers (**Plate 12**). The barrel arches appear to be faced with regular red sandstone ashlar (**Plates 8 & 12**). The narrow arch above the eastern leat could not be accessed however the elevation drawing shows this is identical to the other small arches (**Figure 4**).

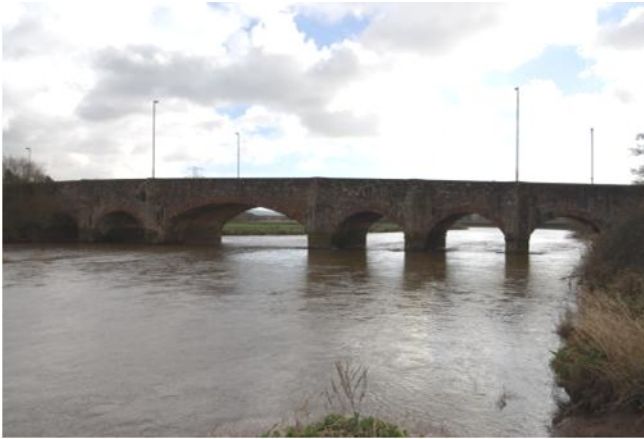
Plate 4. Upstream elevation (looking SE)

- 5.2 Recording of the upstream elevation (**Plate 4**) was mostly conducted from the south-western bank, the north-eastern bank being only partly accessible due to dense undergrowth and housing occupying the top of the bank. The modern road carries three lanes of traffic and two flanking pedestrian walkways (**Plates 5 & 6**). The downstream elevation relates to the widening of the carriageway between 1935 and 1938 and replicates the upstream elevation in form, dimensions and architectural style (**Plate 7**).

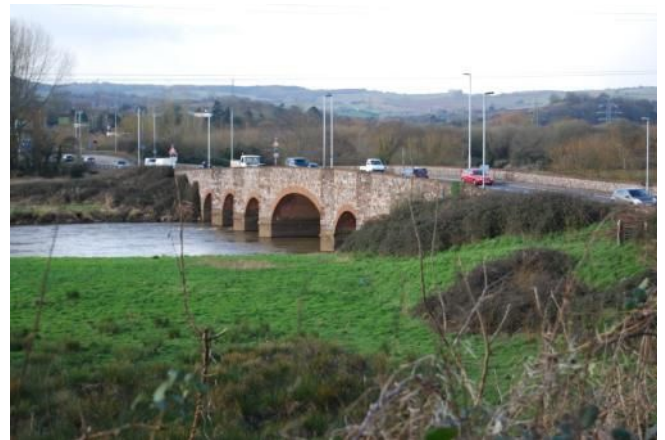
Plate 7. Downstream elevation (looking NWW)

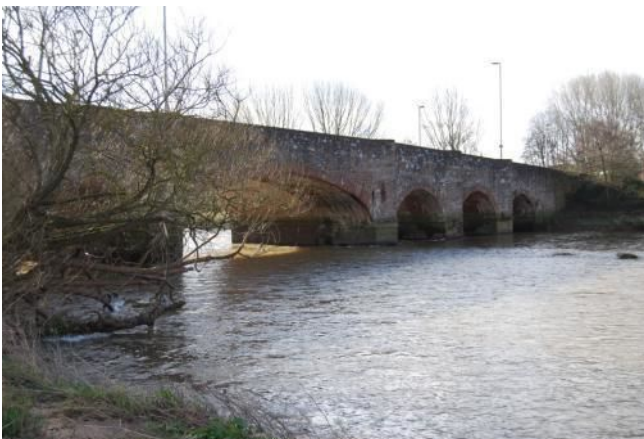
Plate 8. Upstream elevation (looking SW)

- 5.4 The eastern and western ends of the upstream elevation were obscured by dense undergrowth (**Plates 8 & 9**). Consequently the survey was restricted to observations of the main span across the River Exe with very limited observations at either end.

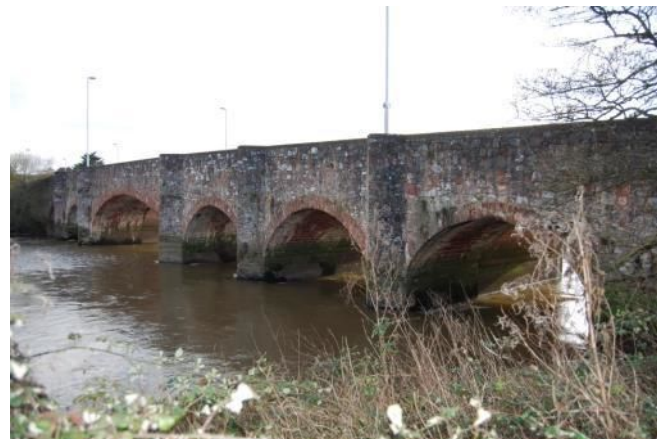
Plate 9. Upstream elevation (looking E)

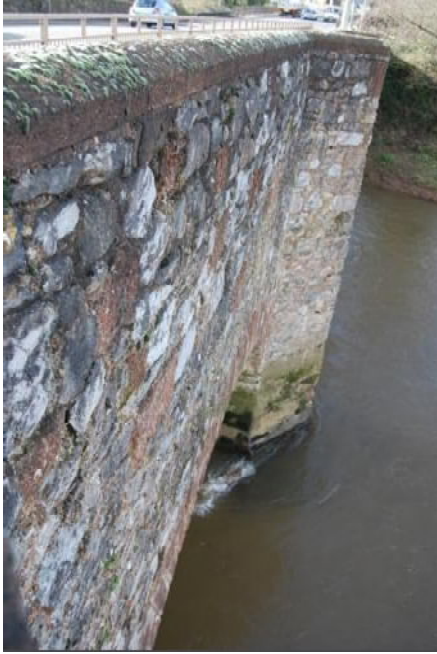
Plate 10. Cutwater Type A, upstream elevation (looking SW)

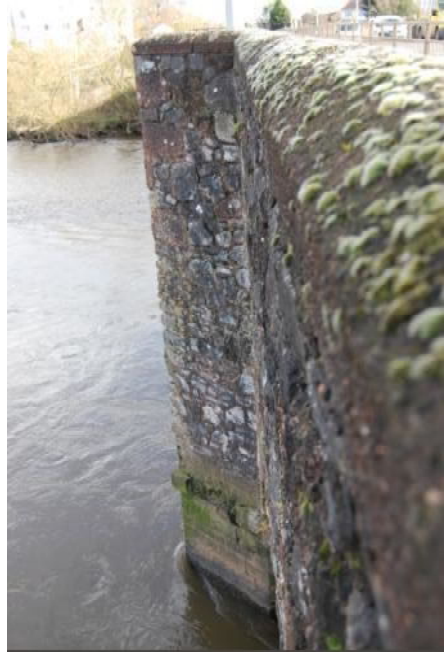
Plate 11. Cutwater Type B, upstream elevation (looking NE)

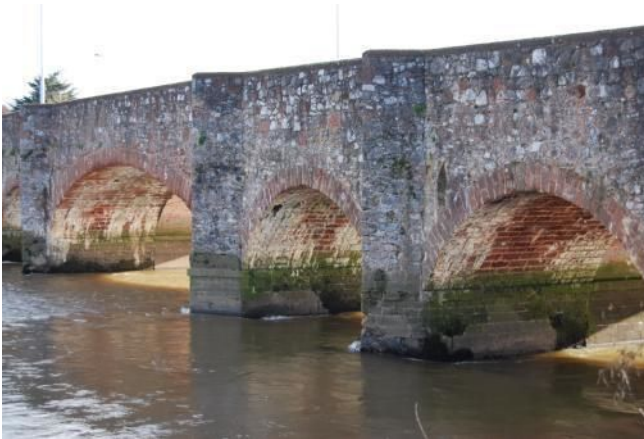
Plate 12. Cutwater Types A & B, upstream elevation (looking E)

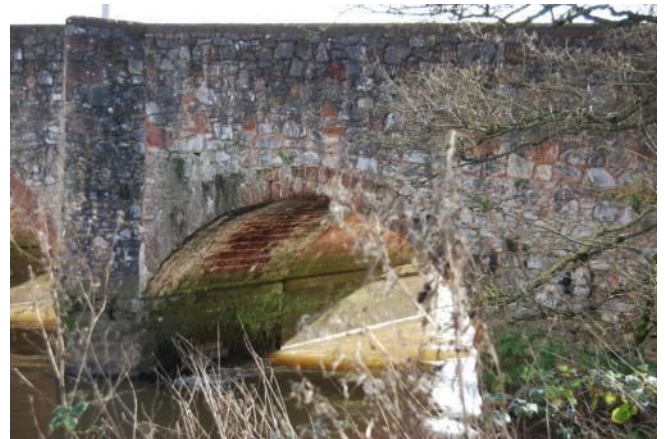
Plate 13. Western arch, upstream elevation (looking SE)

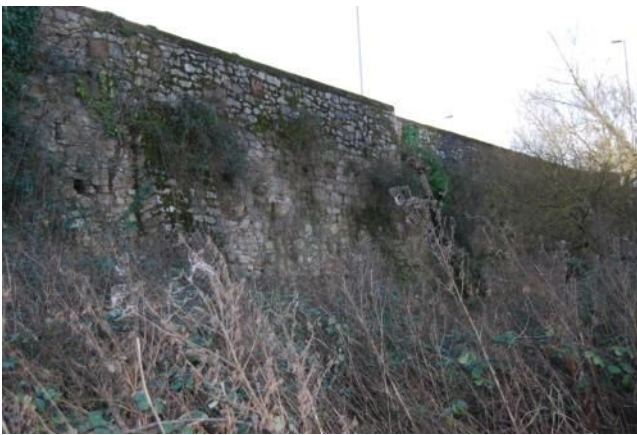
Plate 14. Buttresses at eastern end of upstream elevation (looking S)

- 5.8 One original supporting buttress at the western end of the elevation and three at the eastern end (**Plate 14**) could not be accessed due to dense undergrowth but the upper parts were seen to be constructed of light-coloured ashlar and rubble. Photographs supplied by the client following vegetation clearance show the buttresses in more detail, the slope of the buttresses continuing at the same angle to the ground (**Plate 26**).

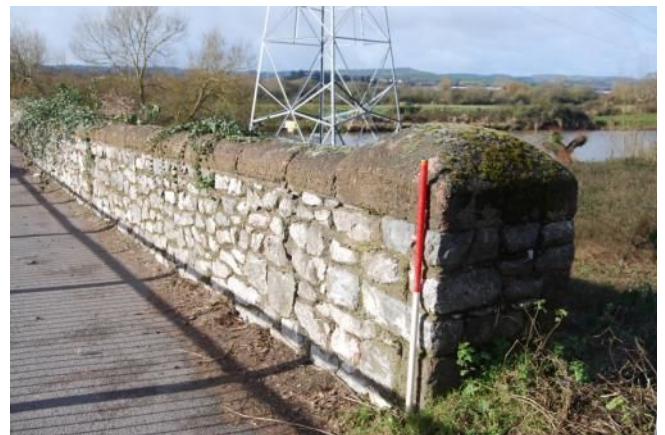
Plate 15. West side of entranceway, upstream parapet (looking W)

- 5.9 To the east of the easternmost buttress was a small entrance from which the riverbank was accessed although there is no formal path (**Plate 15**). The parapet continues north-eastwards on the other side of the entrance.

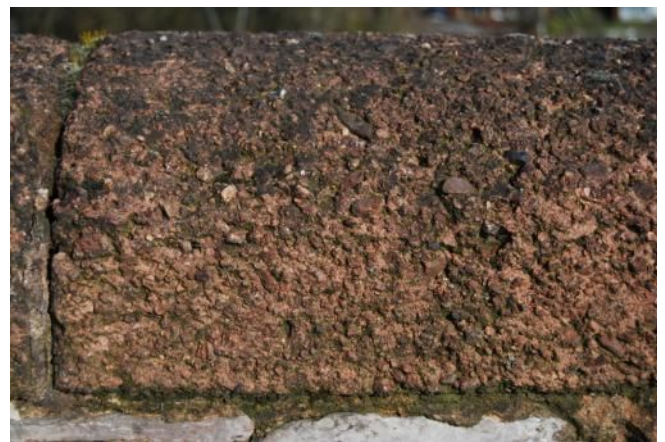
Plate 19. Red cement coping, upstream parapet (looking NW)

- 5.10 The inside of the parapet adjacent to the pedestrian walkway is of the same construction as the exterior, faced with random rubble comprising limestone, red sandstone and the occasional red granite (**Plates 16 & 17**). Widening of the parapet (**Plate 17**) may relate in part to the rectangular widened area shown on the 1840 tithe. In the centre of the upstream parapet is a backing stone for a plaque (**Plate 18**) which is no longer present; this presumably memorialised the remodelling of the bridge in 1935-38. The parapet is capped with red cement with red sandstone inclusions, chamfered on both sides (**Plate 19**); the coping is deteriorating and starting to flake.

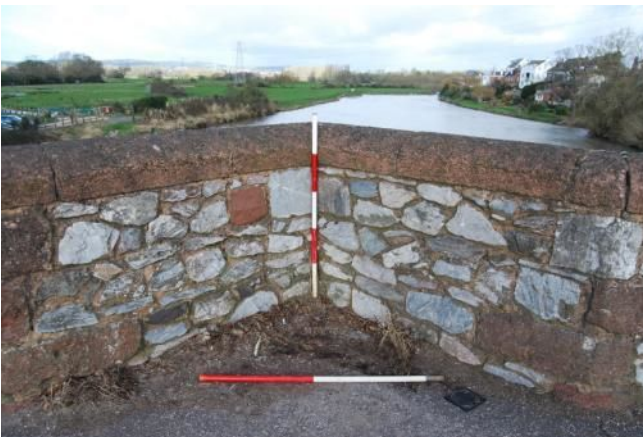
Plate 20. Refuge, upstream parapet (looking NW)

- 5.11 The parapet refuges are faced with the same material as used for the parapets (**Plate 20**) with red sandstone for the quoins (**Plate 22**), identical to the refuges on the downstream parapet (**Plate 21**). The south-western end of the upstream parapet curves out slightly (**Plate 23**) which is not evident from the modern architects plan.

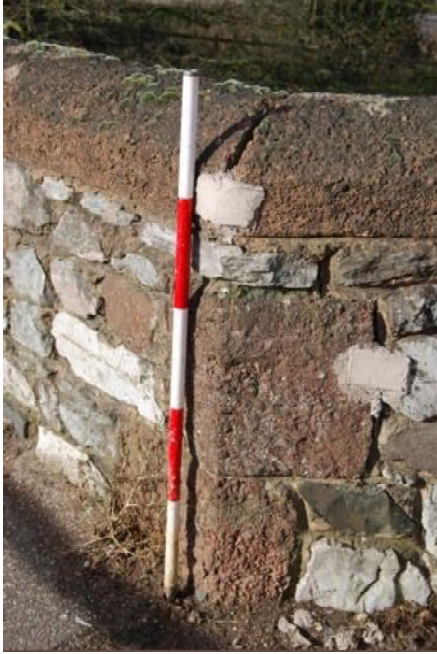
Plate 22. Quoin of refuge, upstream parapet (looking NW)

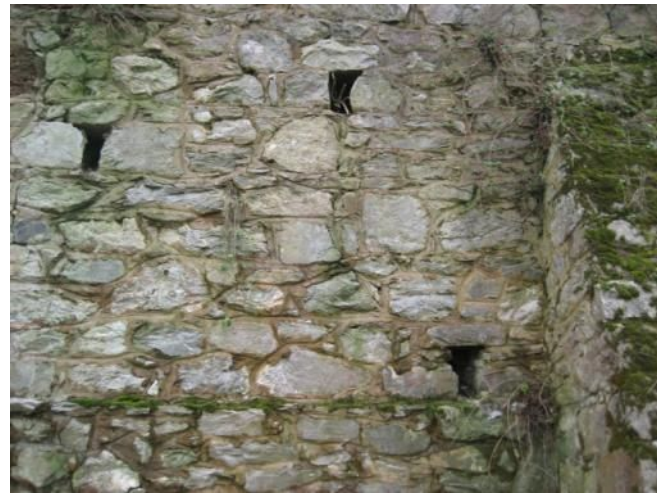
Plate 25. Voids in upstream elevation (looking SE)

- 5.12 Photographs provided by Ms Jackson show numerous rectangular voids in the stonework of the north-west elevation (**Plates 24 & 25**). These voids are original features and are staggered along the centre of the elevation at either end of the bridge suggesting they are associated with drainage.
