Maiden Castle
Dorchester
Dorset

Archaeological Monitoring and
Recording Report

March 2017

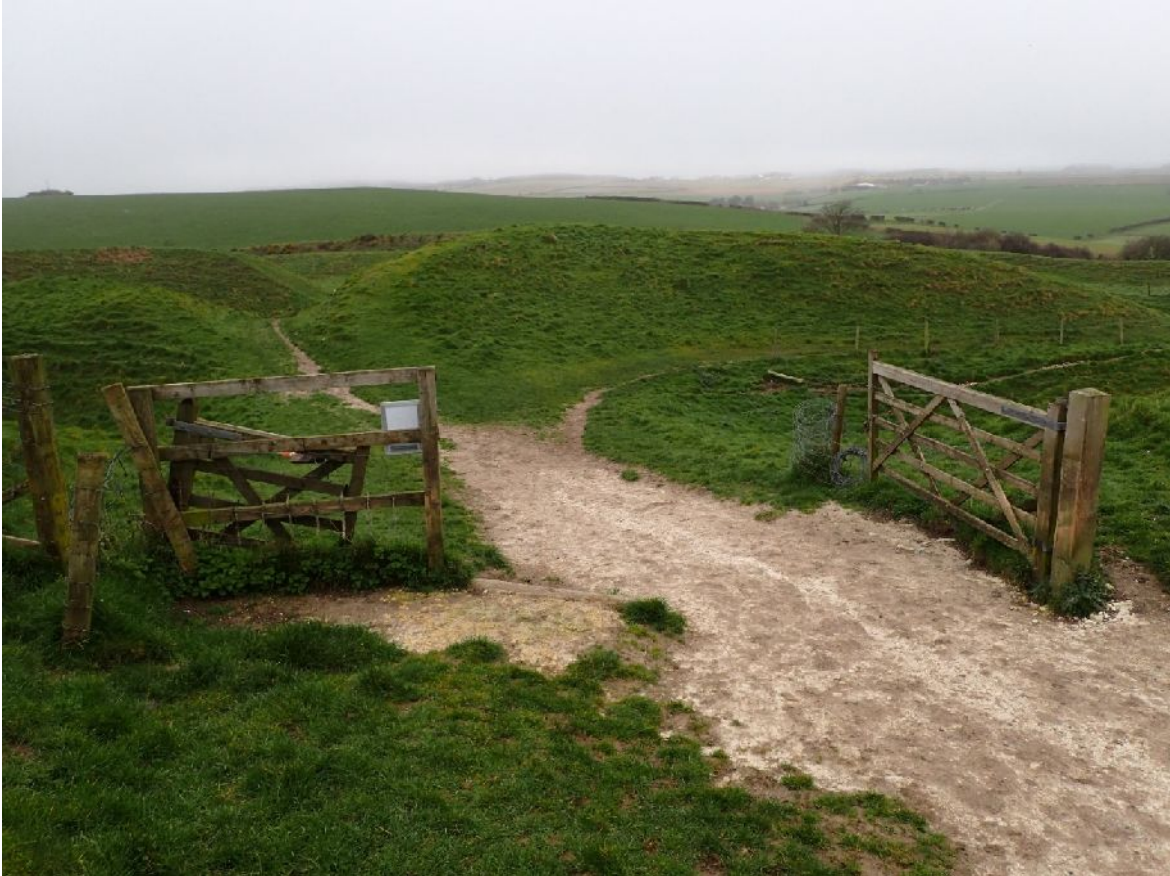
Plate 1. Gateway before work commenced (facing W)

- 4.1 Groundworks involved the excavation of a modern post-hole associated with the timber fencing and gates across the gateway at the inner western hillfort entrance (**Plate 1**) to facilitate the insertion of a replacement gate post. An area measuring c. 0.50 x 0.50m was excavated.

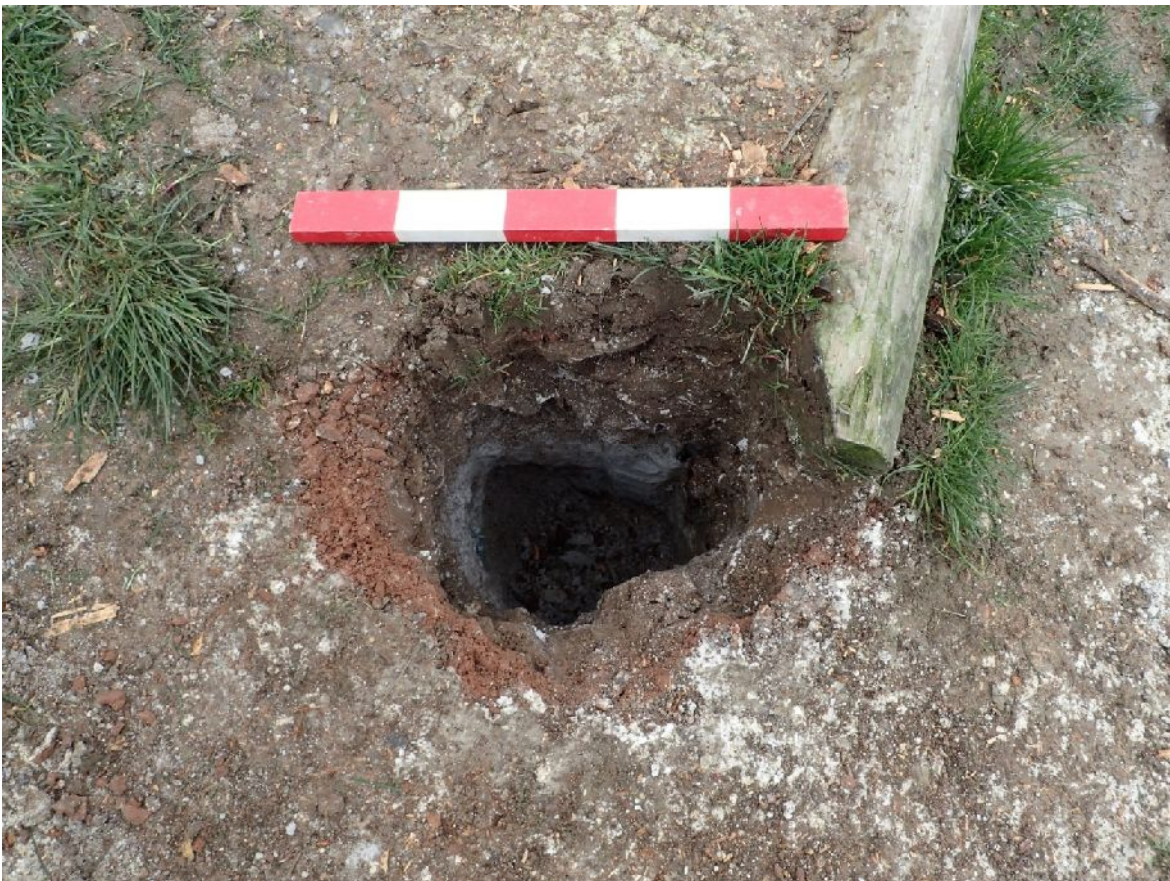
- 5.1 Observations revealed that the modern post-hole had been dug into the modern footpath surface. This comprised a cemented grey (7.5YR 5/1) flint gravel with frequent angular flint fragments (7-100) to a depth of 0.50m (**Plate 2**). This layer was directly situated above the underlying solid white (7.5YR 8/1) chalk natural (7-101) of the hilltop. This had been cut into by the post-hole to a depth of a further 0.50m. No archaeological features or deposits were observed, and a new timber gate post was inserted (**Plate 3**).

Plate 2. Profile of post-hole (facing S; 0.5m scale)

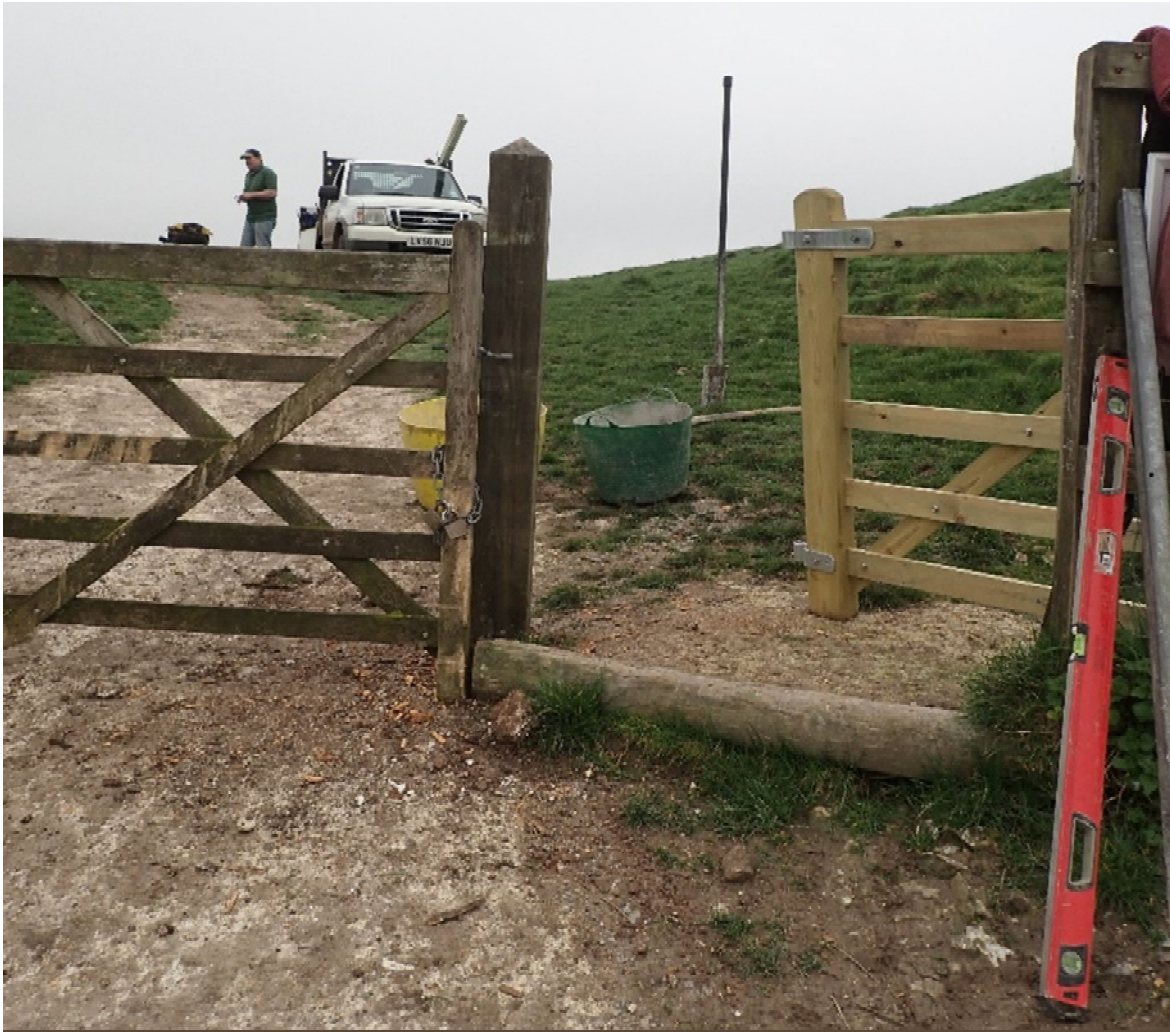
Plate 3. Gateway with new post (facing E)
