# Thorney Halt Structural Infilling Works Thorney Somerset

Historic Building Recording Report

March 2017, updated June 2017

Client project/scheme ref.	Thorney Halt Infilling Works (Bridge No. 4220303)
Planning Application ref.	N/A
Local Planning Authority	South Somerset District Council
Historic Environment Record ref.	37370
OASIS reference	contexto1-275799

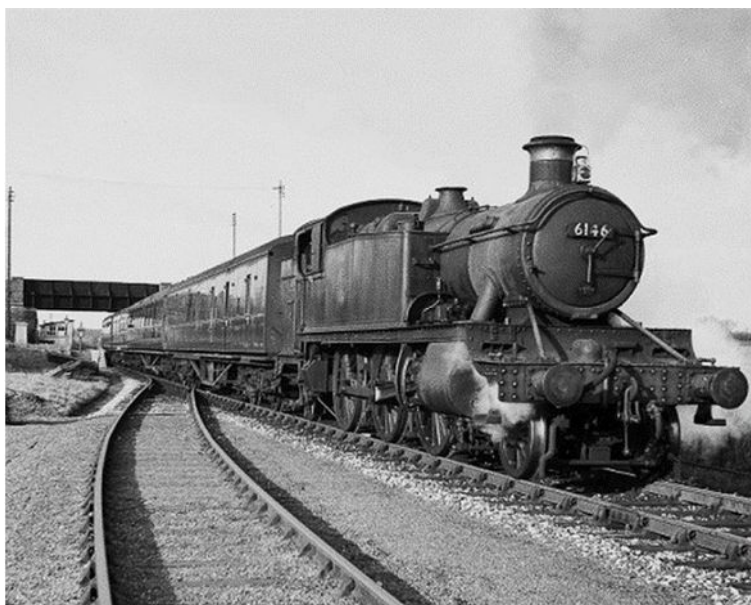
Plate 1. Thorney Halt 1962, looking N (photo by John Cornelius)

(Maggs 2007, 86). The platform was sheltered beneath the bridge (**Plate 1**), a flight of wooden stairs leading down from the north side of the bridge to the platform beneath, with a small office situated on the platform underneath the bridge (**Front cover**). To the south of the halt a siding served Nestlé's Dairy (for the Nestlé and Anglo Swiss Condensed Milk Company), opening in 1932 (*ibid.*, 87) (**Plates 2 & 3**). The line closed with effect from 15 June 1964, the last passenger trains running on Saturday 13 June (*ibid*) and goods traffic ceased on 6 July 1964. The southern part of the railway line was converted into a road in the 1980's, and connects Yeovil with the A303 to the south of Martock. Several bridges along the former railway line are recorded on the Somerset HER however they are all stone-built arched structures, often spanning cuttings through which the railway once passed.

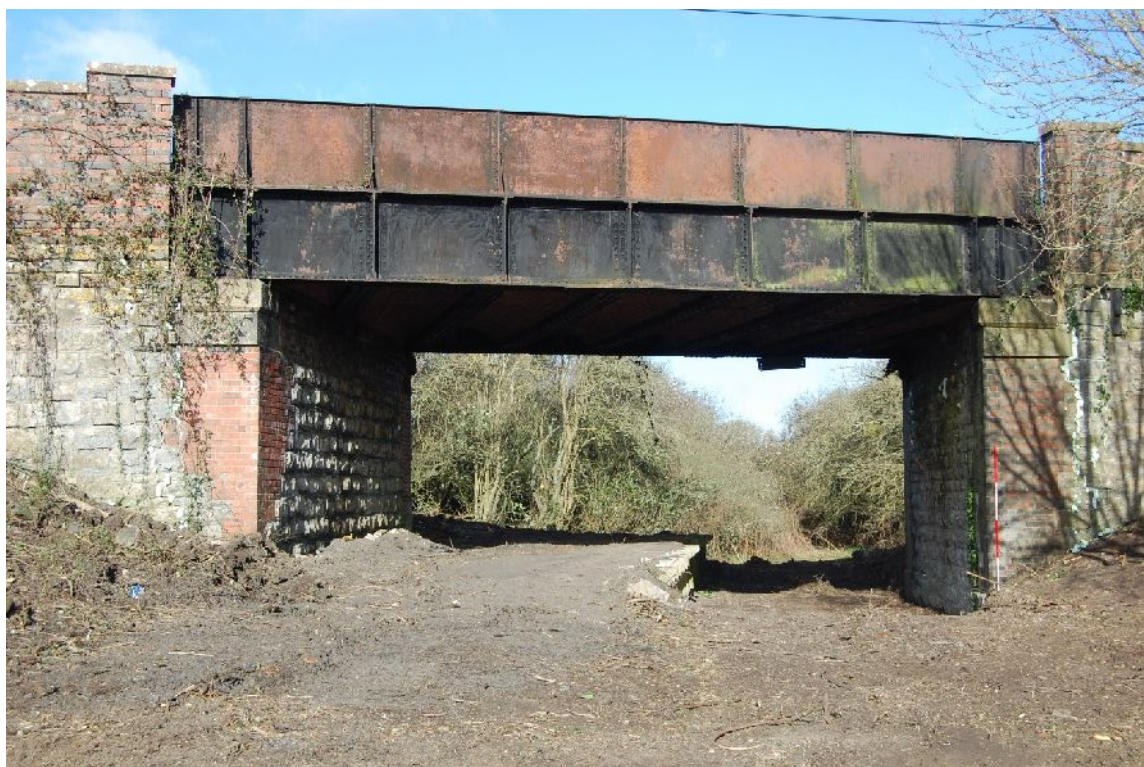
Plate 4. South elevation, looking NW (2m scale)

- 5.2 Thorney Bridge is constructed of a variety of materials, each type serving a purpose. The parapets above the bridge deck (flanking the road) comprise 8 panels of riveted steel measuring c. 1.30m in height, supported by exterior stiffeners consisting of pairs of angles and tapered gusset plates bolted to the top flange of the main beam (**Plate 4**). On either side of the deck, each parapet is flanked by a masonry pier and wall which continues for a short distance alongside the road. These are constructed of red and grey bricks laid as English bond (alternating rows of headers then footers) capped with concrete coping (**Plates 5, 6 & 7**). The original wooden gate that once provided access to the platform stairs remain entangled in dense vegetation on the north-west side of the deck (**Plate 6**). The strain on the bridge superstructure is evident from undulations in the tarmac of the deck and from gaps that have appeared between the steel parapet and the flanking brick piers (**Plate 8**).

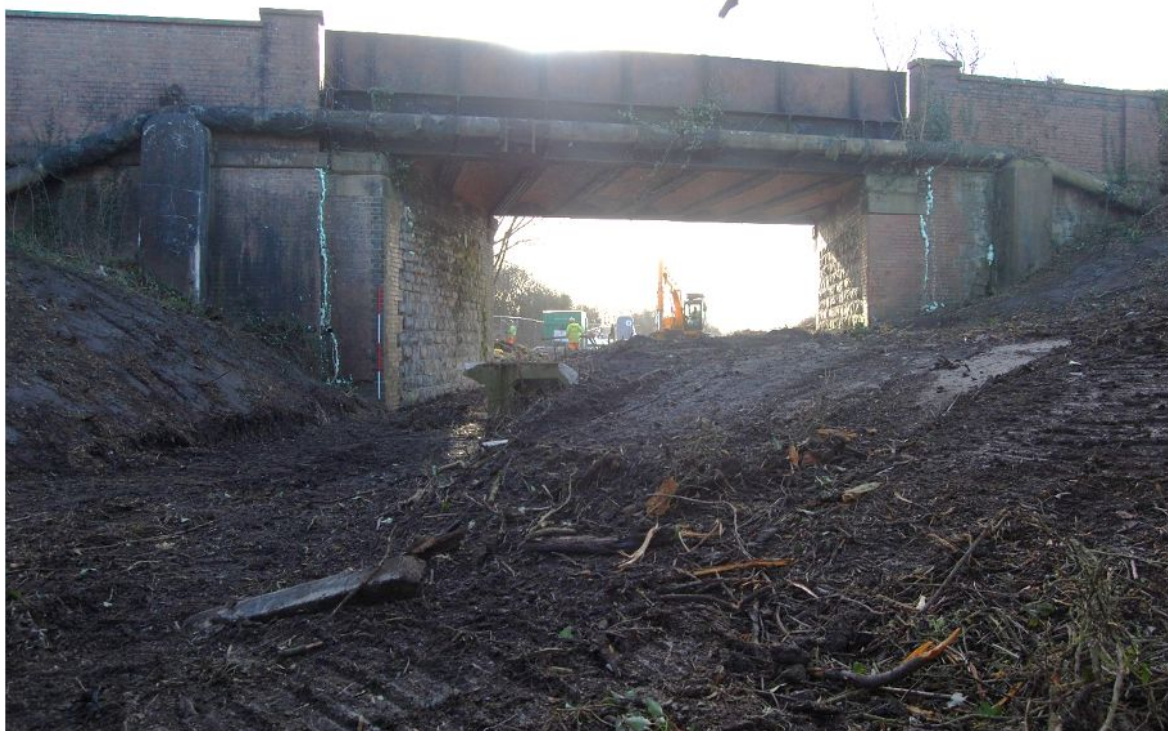
Plate 8. North elevation, looking SE (2m scale)

- 5.3 The steel panels of each parapet are situated above two main steel beams of riveted steel plate girders measuring 1.142m deep and spanning masonry abutments (**Plates 8 & 9**). The upper parts of the abutment quoins each comprise two monumental granite lintels, the upper ones chamfered at the edges and projecting slightly above the lower ones. Beneath the lintels, the quoins are faced with brick laid as English bond, although each one differs slightly in form and appearance. The quoins on the west side are almost entirely of red brick and have square profiles (**Plates 10 & 11**), while those on the east side are of grey bricks intermingled with red bricks and have curved profiles formed by rounded bricks (**Plates 12 & 13**).

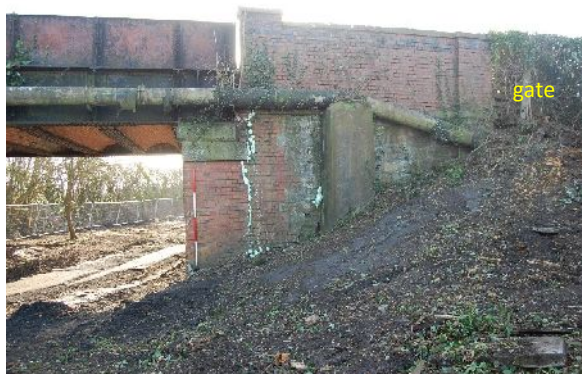
Plate 10. West side of north elevation, looking SE (2m scale)

- 5.4 Construction on either side of the abutments, up the embankments, is also variable. To the east side of the north-east quoin the wall is entirely faced in brick, separated from the brick parapet by a chamfered granite string-course (**Plate 12**). On the opposite side, the brickwork gives way to large coursed white lias rubble also with chamfered granite stringcourse above (**Plate 10**). Within the north embankments, two large concrete

buttresses with rounded tops adjoin the north elevation, supporting the service pipe (duct) which runs just above the bridge deck (**Plate 8, 10 & 12**). In the south elevation, the masonry of the embankment comprises coursed white lias rubble with chamfered granite string-courses above (**Plates 11 & 13**). The abutment walls are predominantly constructed of approximately equally sized large coursed white lias blocks, the edges of every block chipped off so that they appear to protrude (**Plates 14 & 15**). This gives way to the brickwork of the quoins and upper part of the walls, again constructed using English bond. At the top centre of each abutment wall is a monumental chamfered granite block, coinciding with the change in angle of the brickwork.

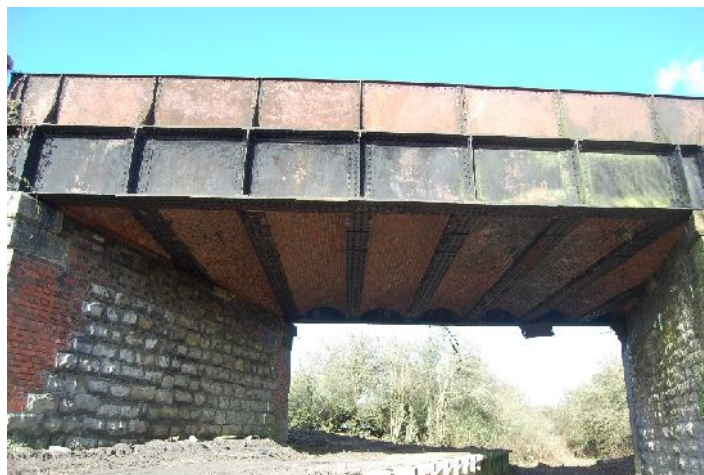
Plate 16. Underside & parapet, looking NW

- 5.5 The underside of the bridge deck is constructed of a series of semi-circular jack arches faced with red and some grey brick, separated by 6.02m long transverse beams faced with riveted longitudinal iron plates (**Plate 16**). The four central arches run through the entire width of the bridge, while the two arches on each side of the central arches are tapering, foreshortened by the bridge skew. The outer arches consist of a very narrow strip, while the adjacent arches start out as full width before narrowing where they coincide with the abutment walls, at which point the angle of the brick work becomes diagonal (**Plates 17 & 18**).

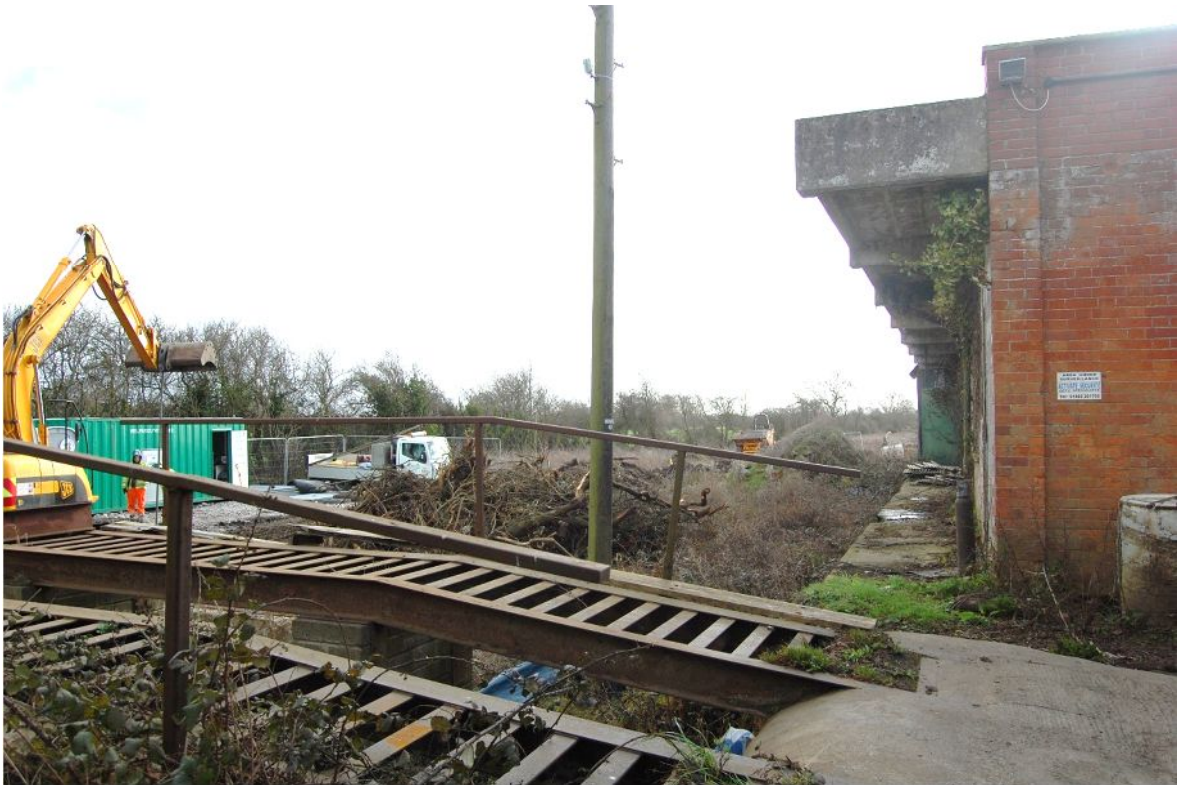
Plate 20. Former Nestlé building with platform, siding & loading ramp, looking SE

- 5.7 To the south of the bridge the former Nestlé building is extant, now used as business premises. The platform and over shelter of the building remain intact (**Plate 20**), complete with loading ramp on the north side of the building (**Plate 21**). Comparisons between the 1962 photograph (**Plate 2**) and an image taken from the same point on the bridge during the present survey (**Plate 22**), allow the location of the siding to be pinpointed on the east side of the former Nestlé building.

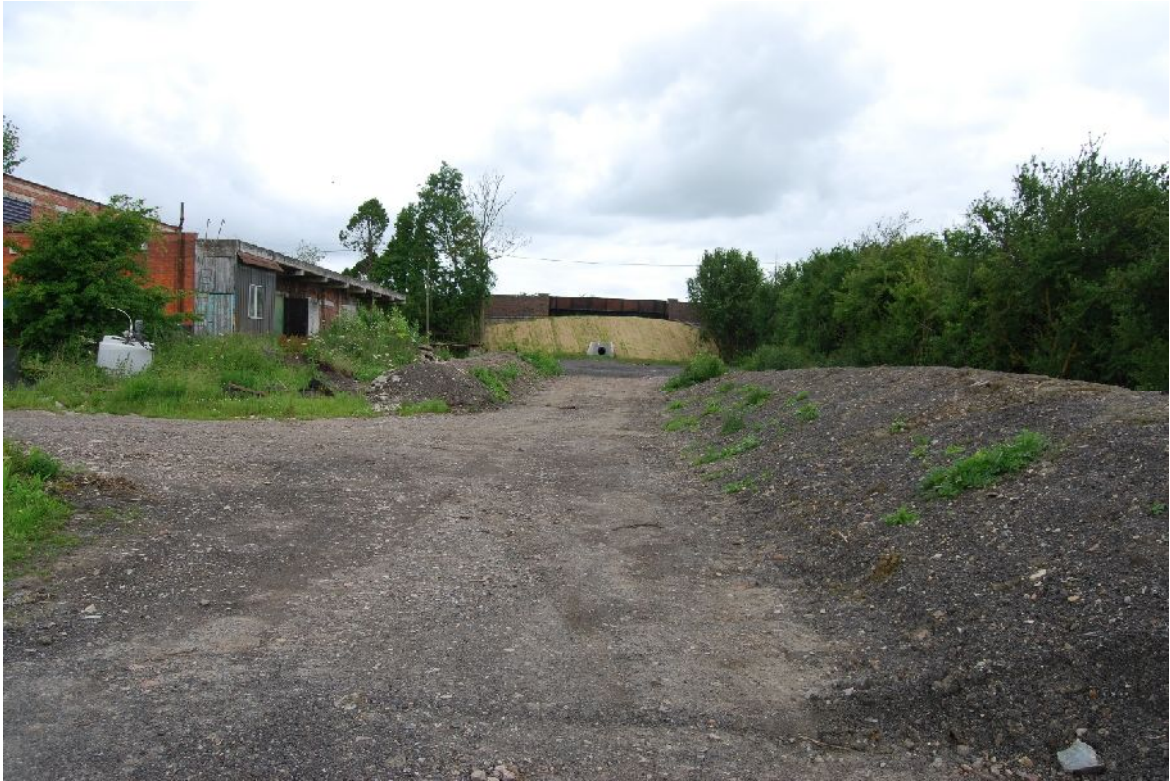
Plate 23. South elevation following infilling with former Nestle siding, looking NW

- 5.8 A photographic record of the completed works comprised photographs of the south elevation. The north elevation was previously accessible by passing beneath the bridge, with no access from the road. The juxtaposition of the former railway line, bridge and former Nestle siding remains intact (**Plate 23**). While the

stone abutments are now largely obscured, the most significant evidential element of the bridge, the iron parapet is largely visible with only the lowest part of the plates obscured beneath the bank (**Plate 24**). The brick parapets alongside the road stand above the level of the bank.
