Aller SPS Rising Main
Replacement
Aller
Somerset

Archaeological Monitoring and
Recording Report

March 2017

COAS project code: C1/AMR/17/ACS

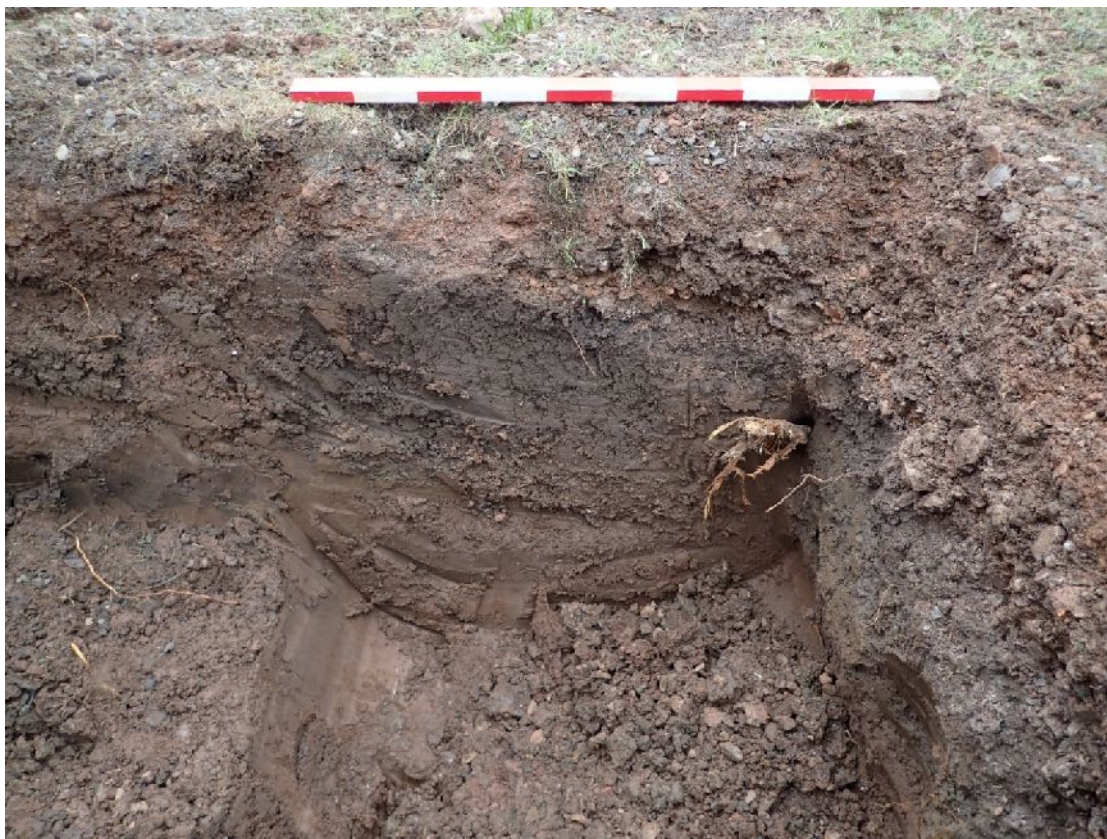
Plate 1. Profile 1 (facing E; 1m scale)

- 5.2 In Profile 1 (**Plate 1**) the topsoil (7-100) comprised a reddish grey sandy silt measuring 0.20m deep. This overlay a redeposited layer of reddish grey silty gravel (7-101), 0.40m deep. Under this was a redeposited natural red clay with occasional angular gravels (7-102), at least 0.60m deep. Profile 2 (**Plate 2**) was through a 0.40m thick layer of tarmac/hogging of brown mixed gravel concrete (7-200). Under this was alluvial red silty clay with occasional limestone fragments, which included occasional charcoal and shell (7-201), and was 0.50m deep. This was over a natural deposit of red clay with occasional limestone fragments (7-202), at least 1.0m deep. Profile 3 (**Plate 3**), was also covered with similar concrete (7-300), 0.40m thick, over similar red silty clay (7-301), 0.50m deep. This was over red clay with occasional lias fragments (7-302), and which exceeded 1.0m deep. In Profile 4 (**Plate 4**) the uppermost layer was a grey road make up with frequent angular stone fragments (7-400), which was 0.50m deep and over red clay natural (7-401) which was at least 0.50m deep.
