Land Between
Hainbury Farm and B315
Northover
Ilchester
Somerset

Archaeological Monitoring and
Recording report

July 2017

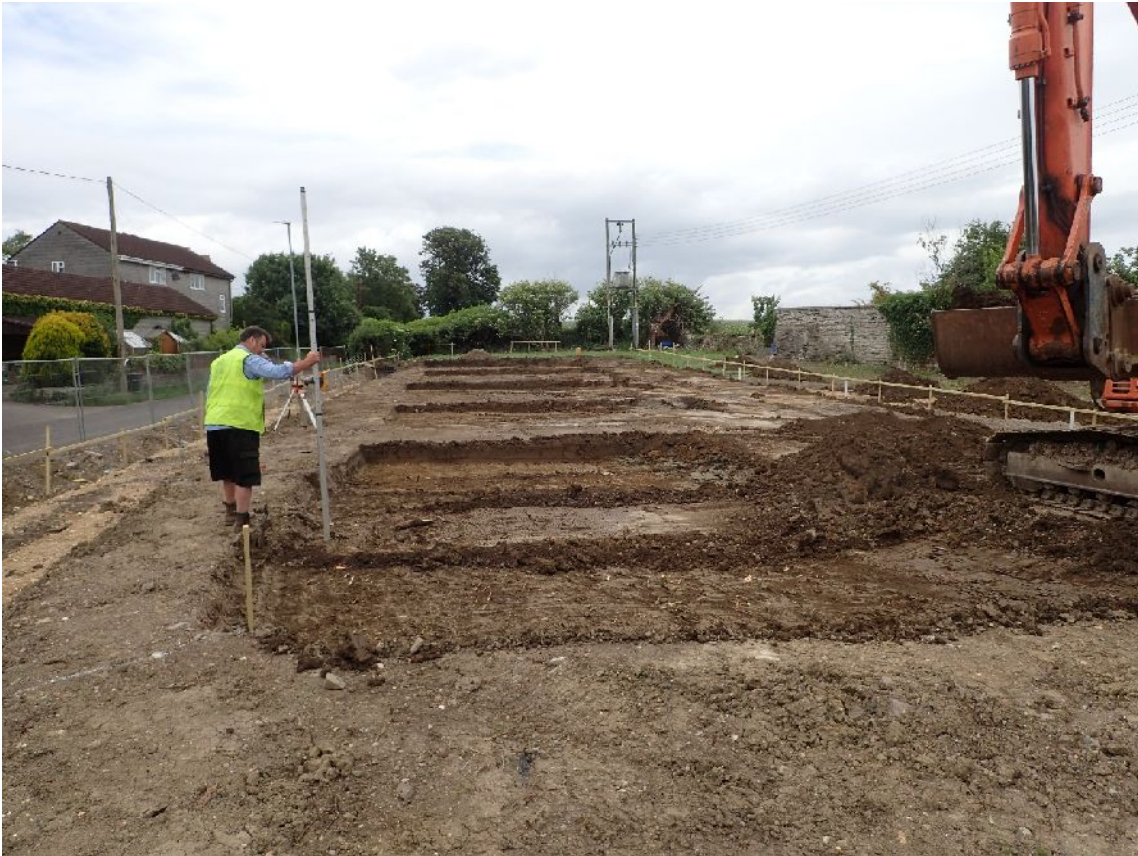
Plate 1. Working shot: excavation of terraces for house platforms (from SSW, no scale)

- 5.1 Ground reduction across the footprint for all five new buildings took place prior to the excavation of the foundation trenches. This largely involved the machine removal of residual topsoil and subsoil to varying depths up to c. 0.50m to create a series of terraces to serve as level platforms for the individual houses and accommodate a natural slope from north to south (**Plate 1**). No features/deposits were observed during this process. It was noted that very little topsoil was present prior to the reduction work and is likely to have been stripped away in the past.

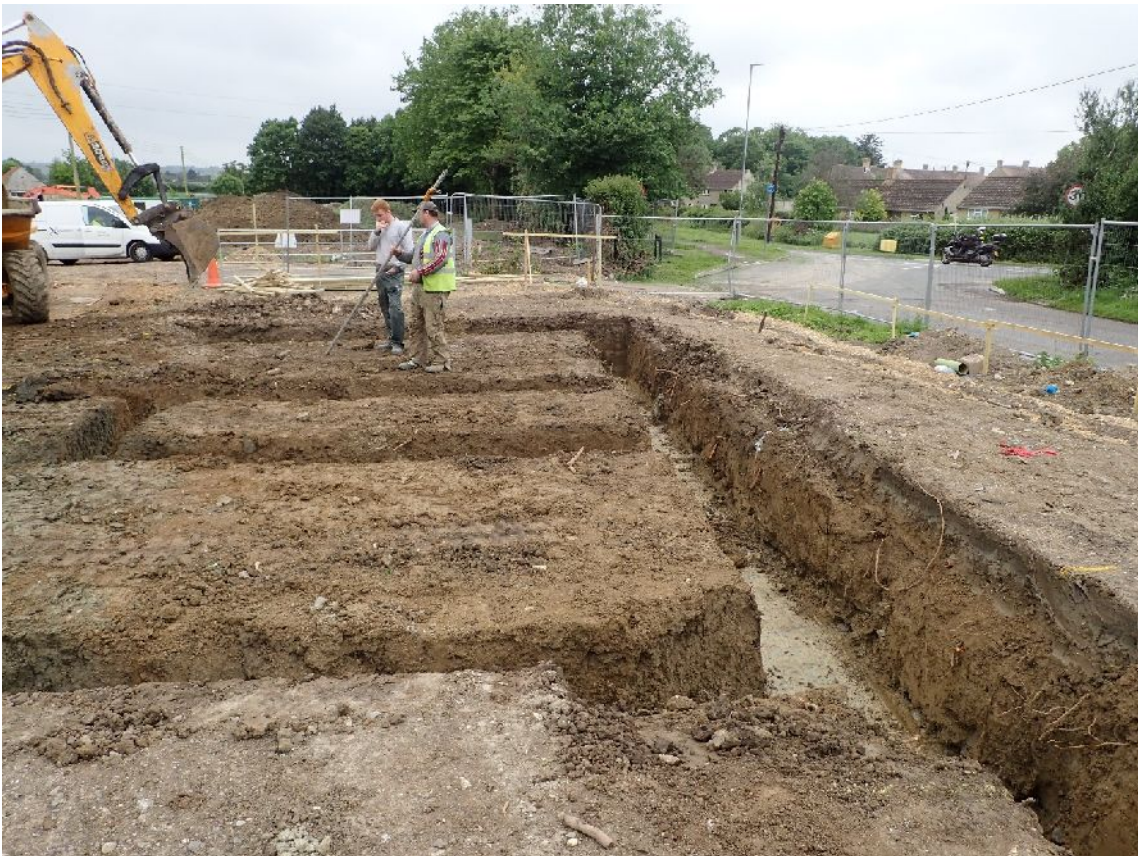
Plate 2. Working shot: excavation of foundation trenches (from N, no scale)

- 5.2 Standard strip foundation trenches (c. 1.00m wide and up to 1.20m deep) were then excavated by machine to accept concrete footings for all load bearing walls including external walls and selected internal partitions. A service trench was excavated along the western edge of the development area. The deposit sequence was similar across the Site and generally comprised a soft yellowish brown (10YR 5/6) silty clay (7-100) up to 0.80m thick, overlying a firm greyish brown (10YR 4/6) natural clay (7-101) which was excavated to a depth of c. 0.20m (**Plate 2 and 3**). No features/deposits were observed in any of the foundation trenches.

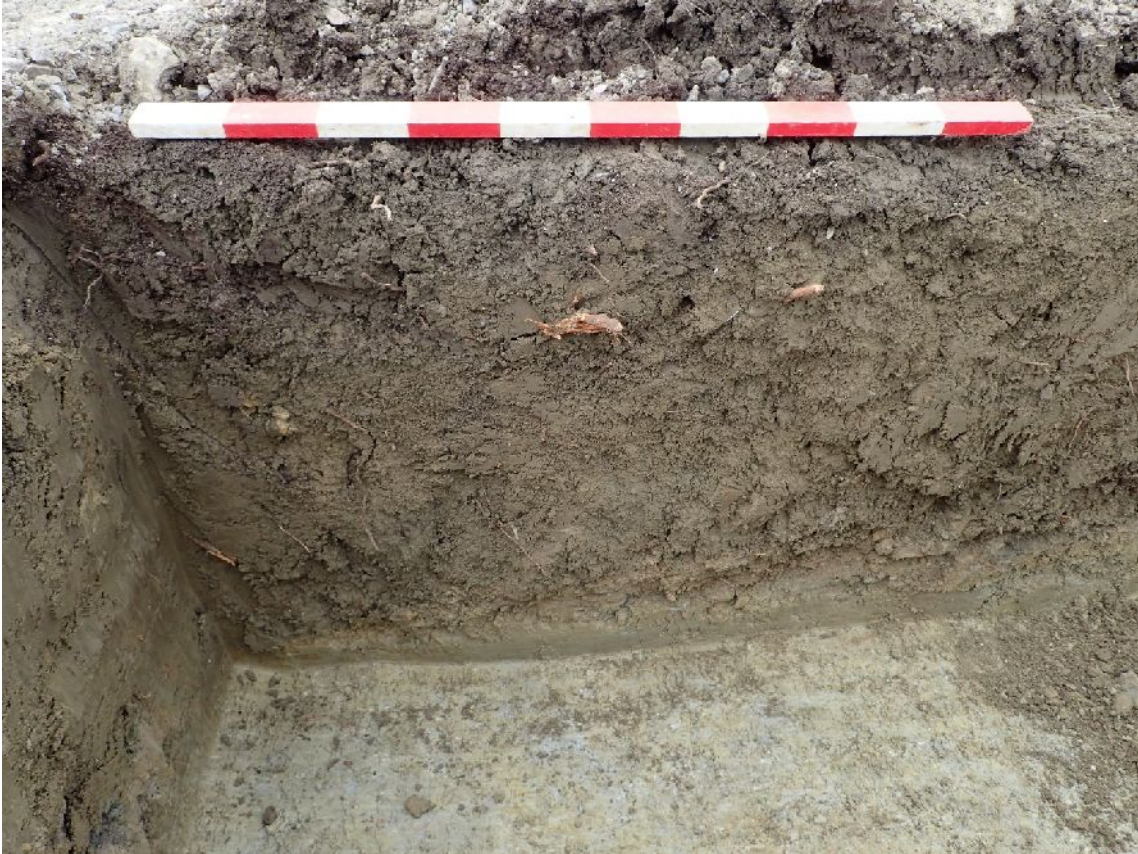
Plate 3. Profile of foundation trench (from SE, 1m scale)
