Devon County Council Historic Environment Record

Civil Parish: Membury		tional Grid Reference 3142 104424 (ST)	Number: (Leave blank)
Subject: Challenger Farm, Membury, Axminster, Devon Plan/Photo attached			Plan/Photo attached? Y
Planning Application no: 15/1768/FUL		Recipient museum: Royal Albert Memorial Museum	
OASIS ID: contexto1-295448		Museum Accession no: RAMM: 17/53	
Contractor's reference code: C1/AMR/17/CMD		Dates fieldwork undertaken: 08/09/17 and 10/01/19	
Description of works. Context One Heritage and Archaeology (C1) carried out an archaeological investigation as a condition of granting planning permission for the construction of an agricultural dwelling at Challenger Farm (Figure 1). In the event, the dwelling was constructed up to ground floor level without monitoring and recording having taken place. Following consultation with Stephen Reed, Senior Historic Environment Officer, DCC, it was agreed that three small compensatory trenches would be cited in areas undisturbed by the groundworks. The trenches measured <i>c</i> . 5m long x 1.6m wide and were excavated archaeologically using a 360-degree tracked machine equipped with a toothless (grading) bucket.

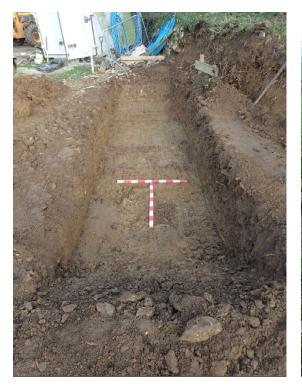
Plate 1. Trench 1 (facing N; 2 x 1m scale)

The topsoil in all three trenches was identical: 0 – 0.20m Topsoil (100) - Brown (7.5 YR 4/4) firm sandy silty clay with frequent angular chert fragments <0.20m			
The remaining stratigraphic sequence consisted of:			
Trench 1 (Plate 1) 0.20-0.60m Subsoil (101) - Strong brown (7.5 5/6) firm sandy silty clay with moderate angular chert fragments <0.20m

0.60m – >0.80m Natural (102) - Strong brown (7.5 5/8) firm sandy silty clay with frequent angular gravel <0.05m			
Trench 2 (Plate 2) 0.20-0.60m Subsoil (201) - Light brown (7.5 6/3) firm sandy silty clay with moderate angular chert fragments <0.20m

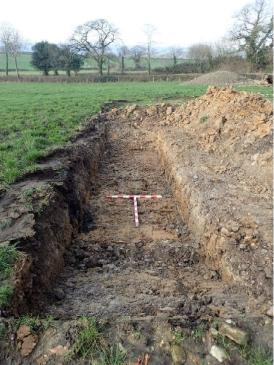
Plate 2. Trench 2 (facing W; 2 x 1m scale)

0.60m – >0.65m Natural (202) - Reddish brown (7.5 6/8) firm sandy silty clay with frequent angular gravel <0.06m and occasional angular chert fragments <0.30m			
Trench 3 (Plate 3) 0.20-0.60m Subsoil (101) - Strong brown (7.5 5/6) firm sandy silty clay with moderate angular chert fragments <0.20m

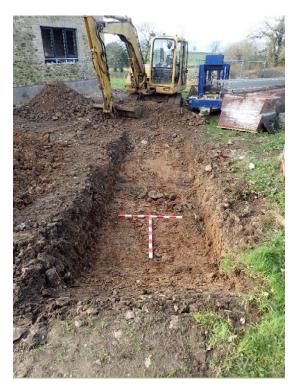
Plate 2. Trench 3 (facing W; 2 x 1m scale)

0.60m – >0.65m Natural (102) - Strong brown (7.5 5/8) firm sandy silty clay with frequent angular gravel <0.05m			
No archaeological features or deposits were observed and no artefacts or ecofacts were seen or collected.			
A plan as well as any other relevant drawings must be attached showing the location and extent of site, areas investigated and features exposed.			
Recorder: Tara Fairclough Context One Heritage and Archaeology.			Date sent to HER 28/01/19
