**98-100 Vauxhall
Street**

**Historic Building
Recording**

September 2017

HERITAGE IMPACT ASSESSMENT

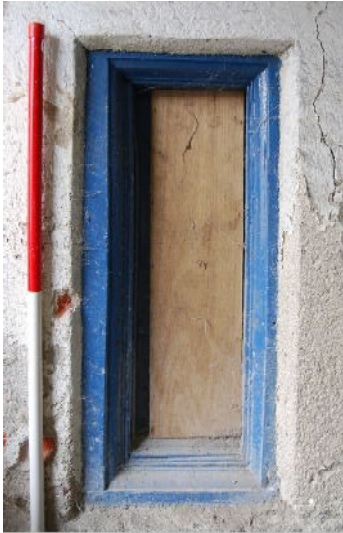
- 6.1 A 17th century stepped ovolo window single-light window was positioned within the stub of the north wall adjoining the 1920's frontage (**Plate 2; Figure 2**). The window had been reset within modern fabric (Humphreys 2004, section 3.11), although coursed rubble walling beneath the modern blockwork comprised coursed limestone rubble identical to Wall A and therefore indicative of historic fabric.

Plate 2. B1 north wall - 17th century window (from N)

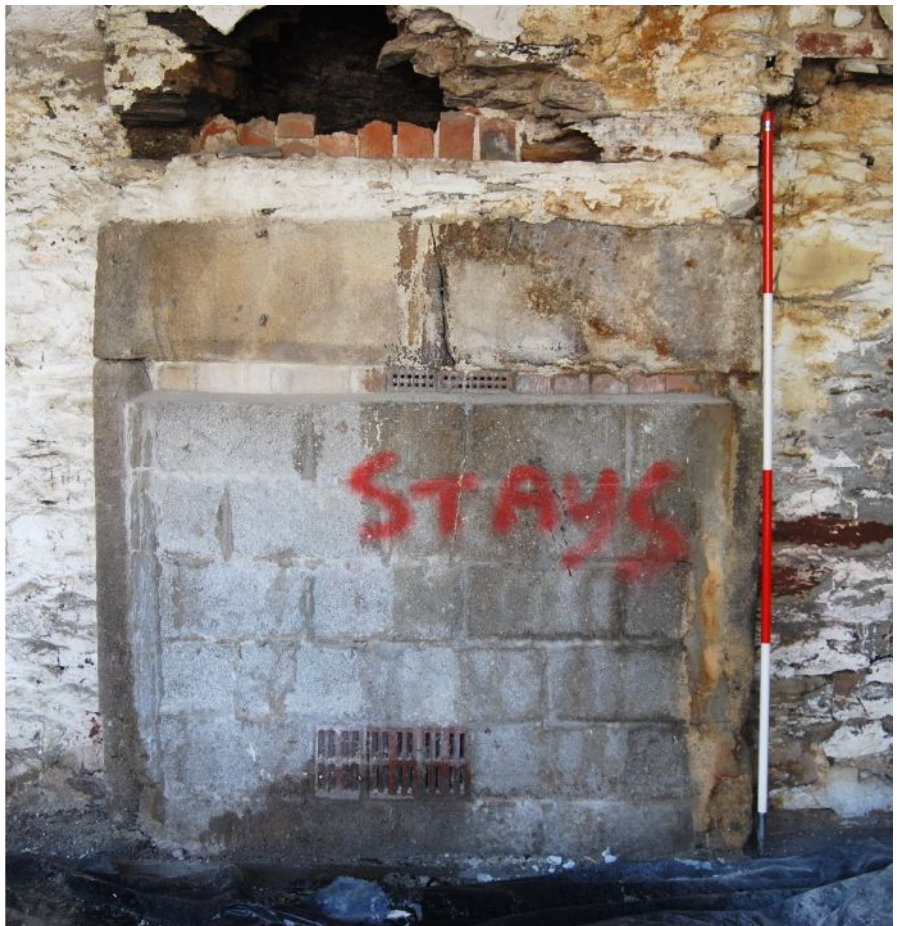
Plate 3. B1 Wall A - late 16th to mid-17th century fireplace (from N)

- 6.2 Within Wall A is a large fireplace with granite bressumer and granite jambs with deep straight chamfers (**Plate 3; Figure 2**). This has been dated as late 16th to mid-17th century (*ibid*, section 4.1). It has previously been noted that a plain wooden relieving lintel above the fireplace had been truncated on the west side, possibly where an opening (now blocked) had been forced through the wall (*ibid*, section 3.11). This postulated opening is of the correct dimensions to be a doorway and may have opened onto the space in front of the adjoining no. 96, which was set further back from the road as depicted on the 1st edition Ordnance Survey (OS) map. An alternative interpretation is a fireside recess, the re-built corner utilizing 19th century bricks.

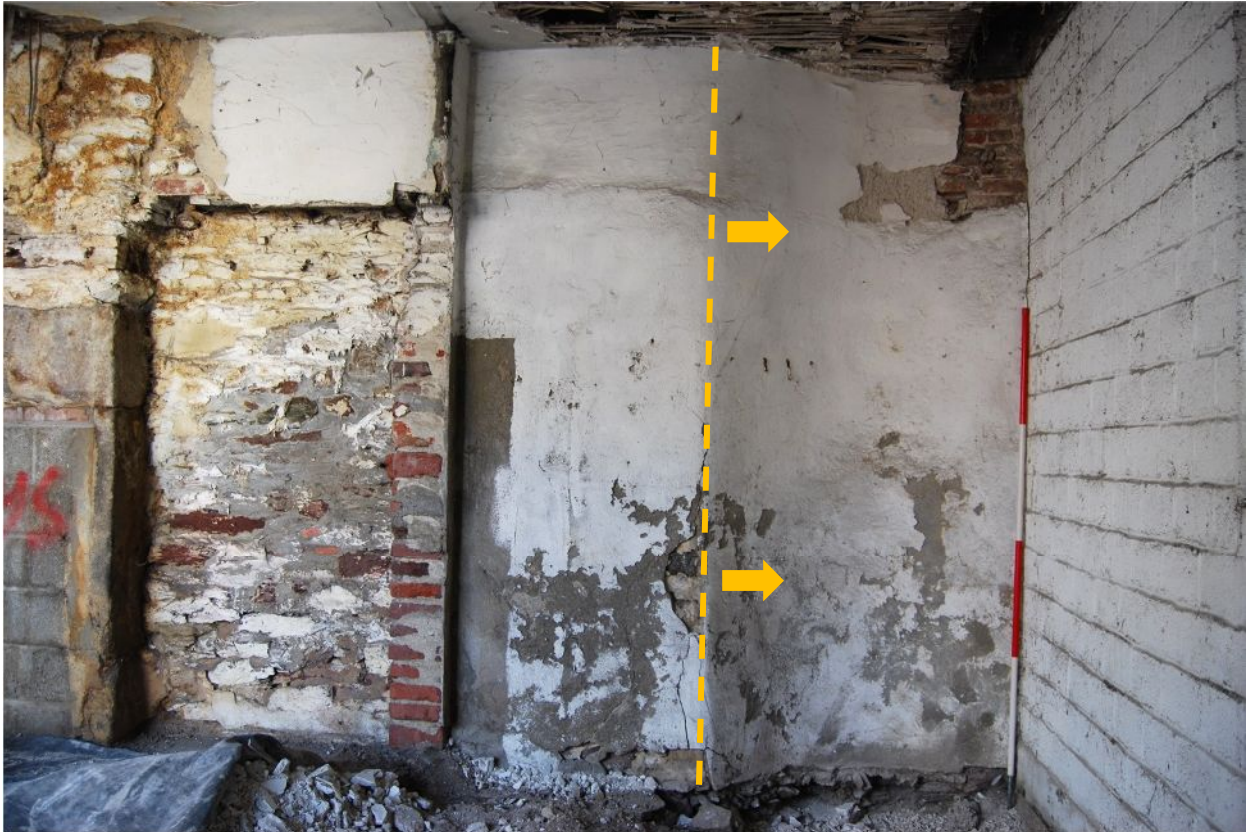
- 6.3 Immediately west of the fireplace and postulated recess, the south wall is slightly set-back before becoming concave in plan (**Plate 4; Figure 2**). This is thought to reflect the curve of a former stair turret subsequently truncated by the 1920's frontage, the junction between the old and new fabric rebuilt in brick (*ibid*.). The remainder of the wall was still rendered therefore construction materials could not be observed. Towards the east end of B1, and adjacent to the later stairs, the wall is also slightly concave in plan (**Plates 5 & 6; Figure 2**); this becomes more pronounced at first floor level and indicates the presence of another stair turret (see below).

Plate 4. B1 Wall A ground - 17th century stair turret at west end (from N)

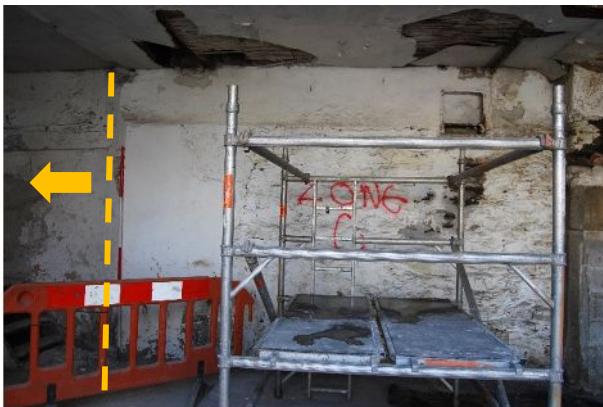
- 6.4 Where exposed, the fabric of the south wall comprised coursed limestone rubble (**Plates 3-7**). To the east of the fireplace the internal face of the wall is slightly set-back at a height of 2.25m from the modern ground surface. This would have created a sill upon which floor beams were suspended, and indicates the level of the original first floor. As such, the present first floor is c. 0.50m higher than the original floor. The east wall is similar in construction however it is not tied in to the south wall and has been suggested as being a 17th/ 18th century replacement of an earlier timber-framed internal wall (*ibid.*) for which no evidence was identified during the present survey. Given this wall aligns with the eastern projection of the stair turret it is considered more likely that the wall is the original east end of B1, even if it was constructed after the party wall (Wall A).

Plate 5. B1 Wall A ground - between 17th century fireplace & east end showing curve in wall (from N)

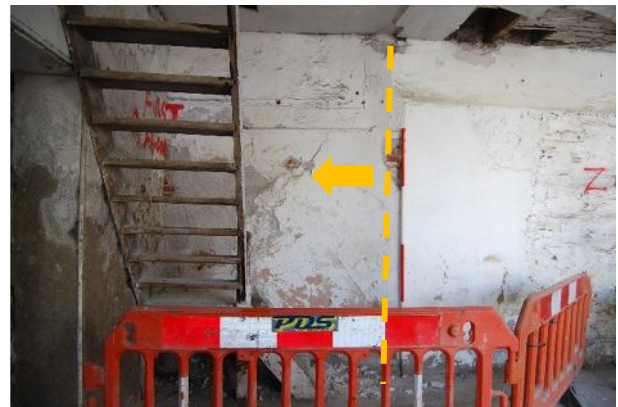
Plate 6. B1 Wall A ground - east end showing curve in wall (from N)

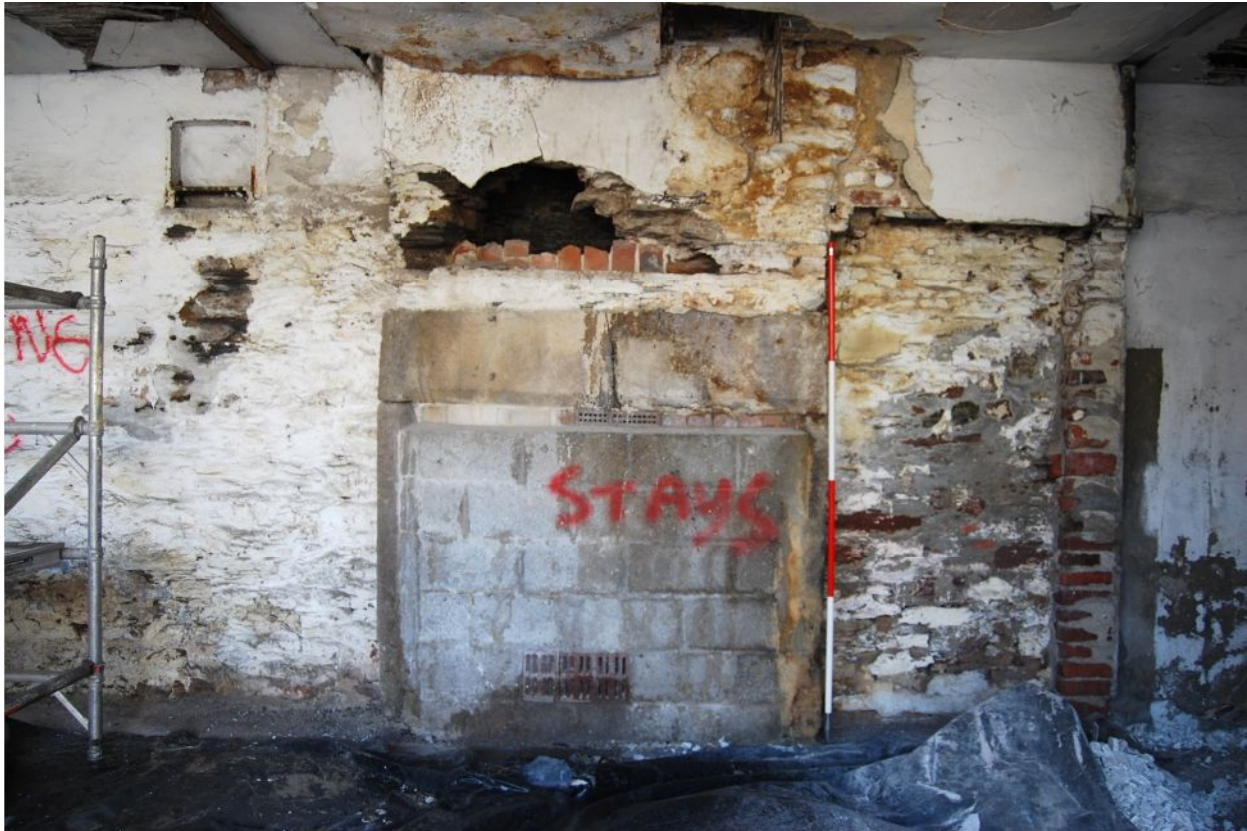
Plate 7. B1 Wall A ground – west end (from N)

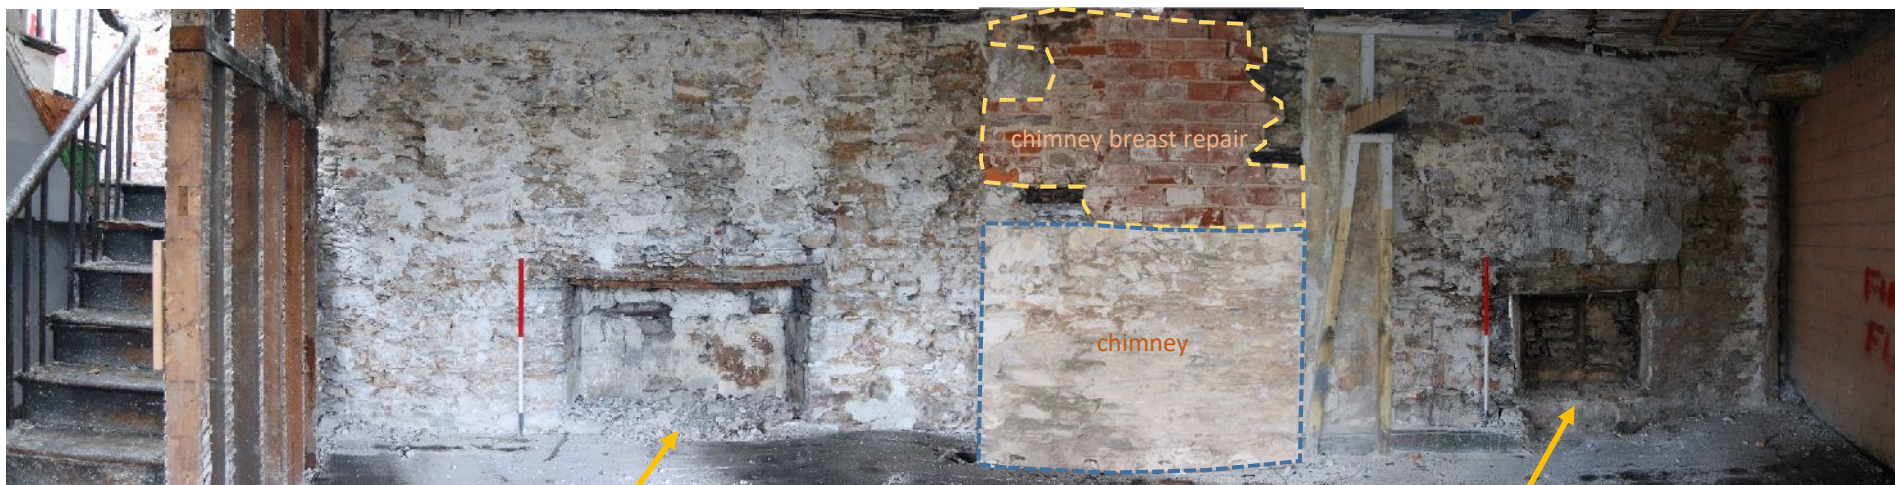
- 6.7 The eastern end of B1 was occupied by an ornate 19th century staircase positioned against a curved recess (**Plates 8 & 11; Figure 2**). The curve resembled the stair turret identified at the opposite end of the room, and was lined with thin Tudor-style bricks with several courses of limestone rubble above. At the approximate height of the present second floor the coursed rubble above the stair turret became flat and continued up to the roof line. The salient angle of the turret had been refaced in 19th century brick, perhaps associated with the insertion of the contemporary staircase.

Plate 8. B1 Wall A first floor

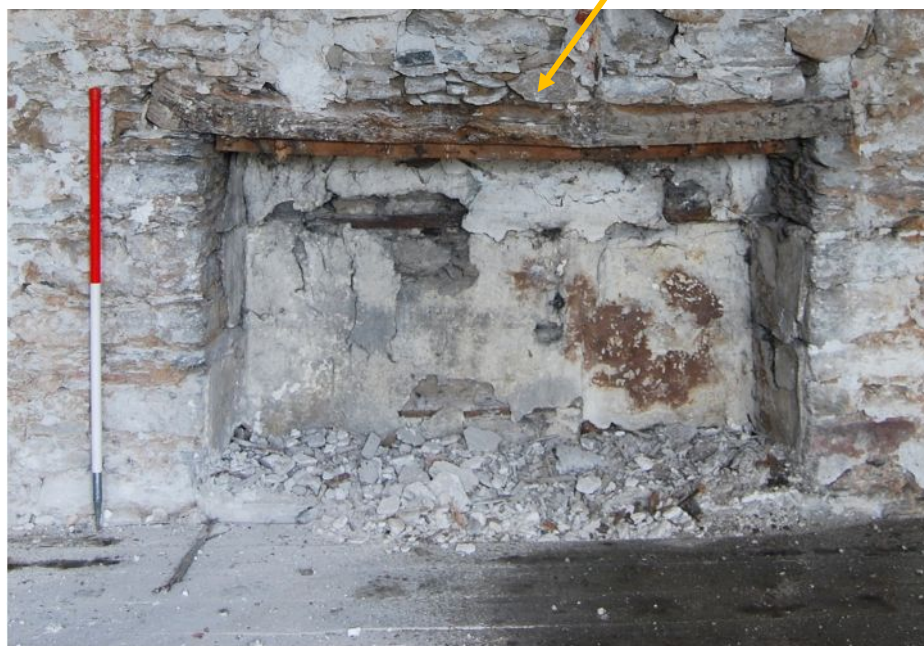
- 6.6 A previously concealed two-light single-splayed window was exposed in the slight curve of the western stair turret in the south wall (**Plates 9 & 10; Figure 2**). The wooden frame and timber lintel remained *in-situ* and had been blocked externally with small rubble, the outer sides of the splay measuring c. 1.10m apart. The glazing bar comprised a broad ovolo and fillet, a typical profile of the late 17th to early 18th century (English Heritage 2014, 15).

Plate 9. B1 Wall A first floor – blocked window

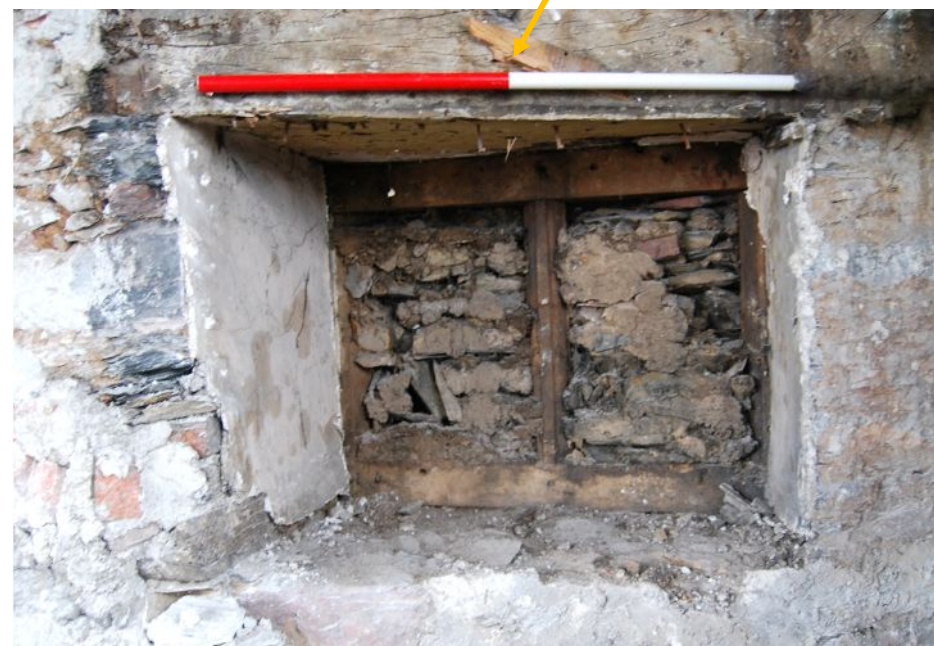
Plate 10. B1 Wall A first floor – late 17th to early 18th century window (from N)

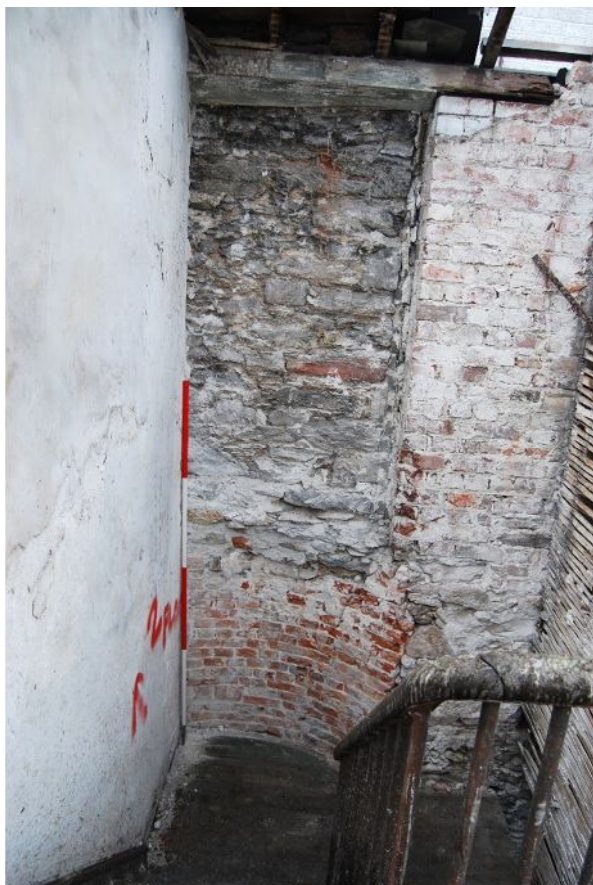
Plate 11. B1 Wall from second floor – stair turret (from N)

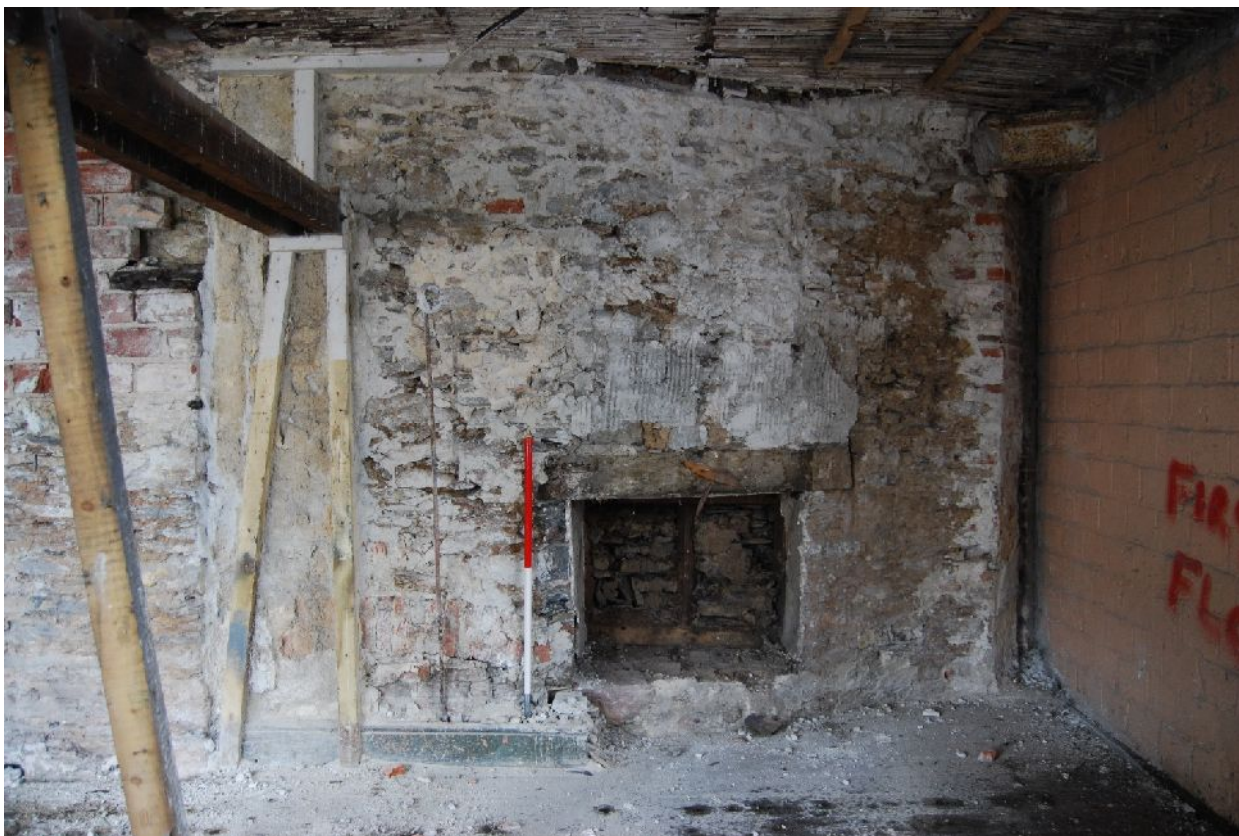
- 6.8 The exposed fabric of Wall A comprised coursed limestone rubble, with some modern brick patching to the chimney breast which continued upwards from the granite fireplace on the ground floor (**Plate 8**). The curved walling of the stair turret remained evident at the west end of the south wall despite modern interference, the curve starting on the east side of the late 17th to early 18th century blocked window and becoming more acute on the west side (**Plate 12**).

Plate 12. B1 Wall A first floor – west end (from N)

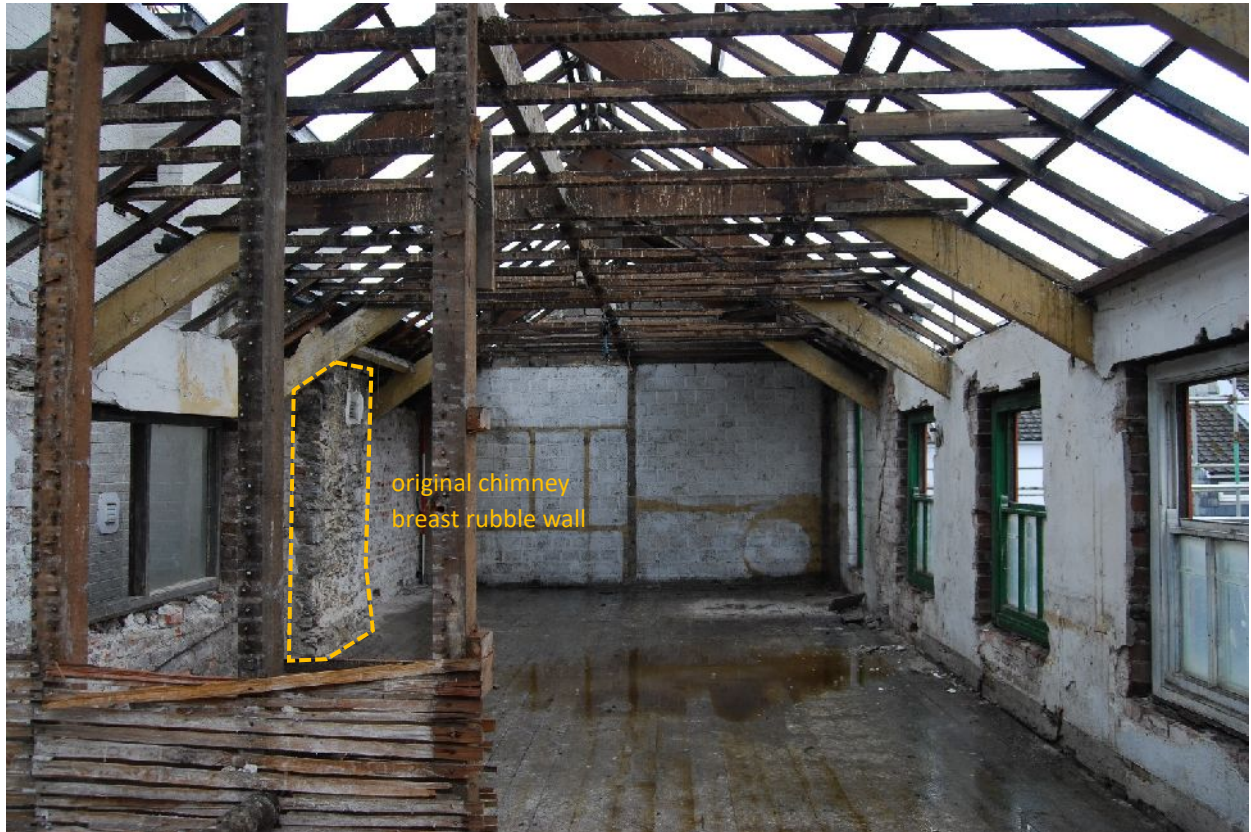
- 6.9 With the exception of the coursed rubble walling above the eastern stair turret and the chimney breast, which continued up from the ground floor, the remainder of the south wall was constructed in 19th century brick (**Plate 13**). The timber roof comprised bolted A-frames with half-lapped collars and apex, and together with the skirting boards and other features indicate extensive re-building and re-modelling in the late 19th century.

Plate 13. B1 second floor

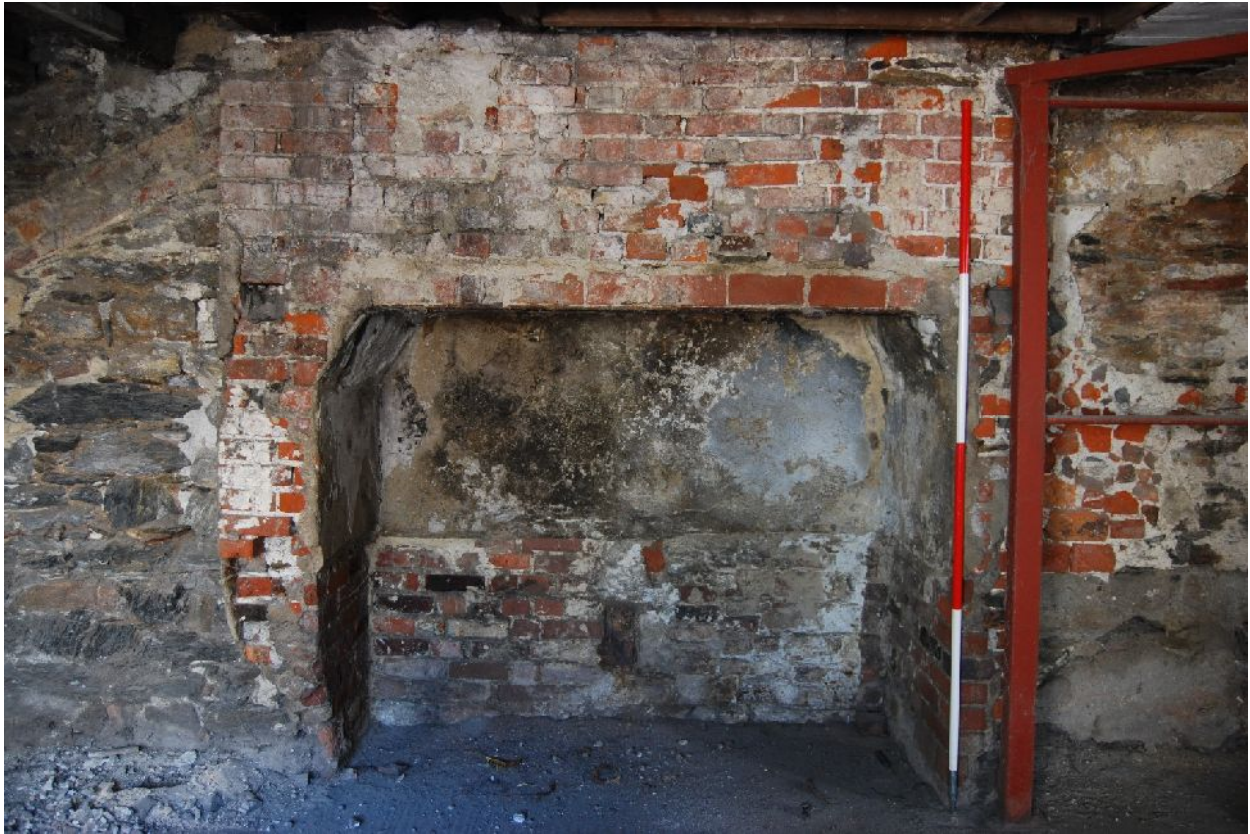
- 6.10 The room on the east side of B1 is clearly an addition (room 4 in SWA 2004 report), the coursed rubble walling of B1 forming the west wall. Some of the original coursed rubble walling of the south boundary is also visible, although it has been significantly altered by the introduction of a large brick fireplace in the 19th century (**Plate 14; Figure 2**). To the west of the fireplace is a diagonal band of brick (mostly laid as headers) rising towards the east at a c. 45-degree angle (**Plate 15; Figure 2**); it has been suggested that this related to a former stair (Humphreys 2004, 3.11). On the east side of the fireplace is another diagonal band of brick, this time mostly laid as stretchers and at a less acute angle of c. 30 degrees (**Plate 16; Figure 2**). This is thought to be a flue for a stove setting (now covered) in the south-east corner of the adjoining room (room 5 in SWA 2004 report). The partition between the two rooms is formed of timber studwork infilled with bricks, and is also 19th century (**Plate 17**).

Plate 14. B2 Wall A ground – 19th century brick fireplace (from N)

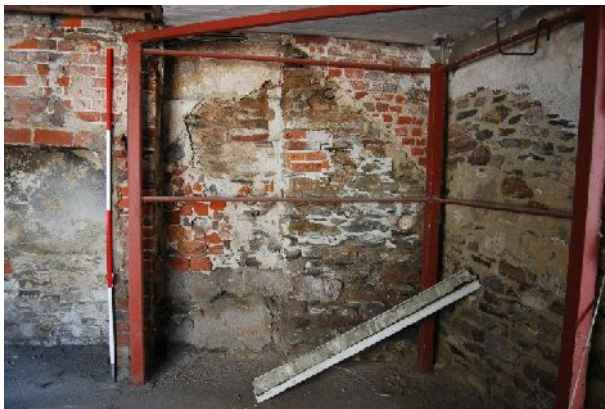
Plate 15. B2 Wall A ground – brick stair to west of fireplace (from N)

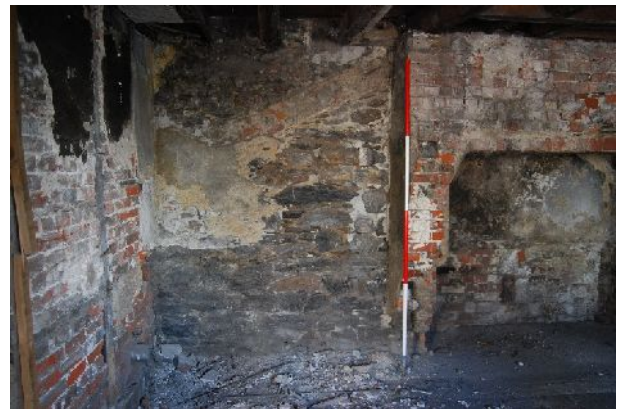
Plate 16. B2 Wall A ground – brick flue to east of fireplace (from N)

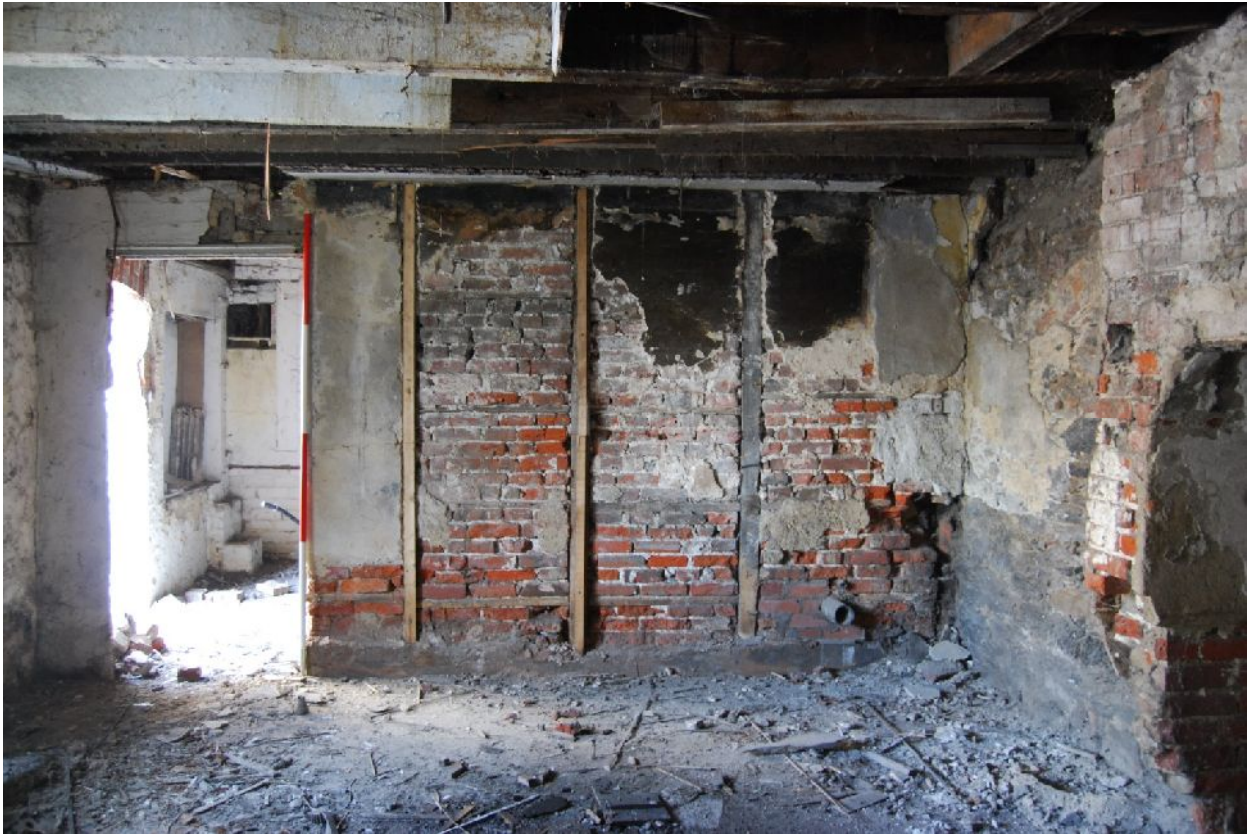
Plate 17. B2 ground – brick partition between rooms (from W)

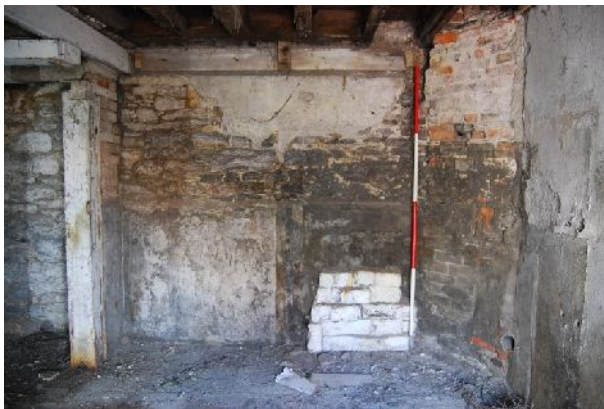
- 6.11 The south boundary wall in room 5 and the adjoining room 6 is of coursed limestone rubble (**Plates 18 & 19**). There is a large blocked opening in the east wall (**Plates 20**) of no. 98. Within the open courtyard, this wall contains the two 17th/ 18th windows with metal grills, one within a blocked doorway beneath a relieving arch comprising a row of header bricks above a row of stretcher bricks (**Plate 21**).

Plate 18. Wall A ground – rubble walling & stove setting across corner (from N)

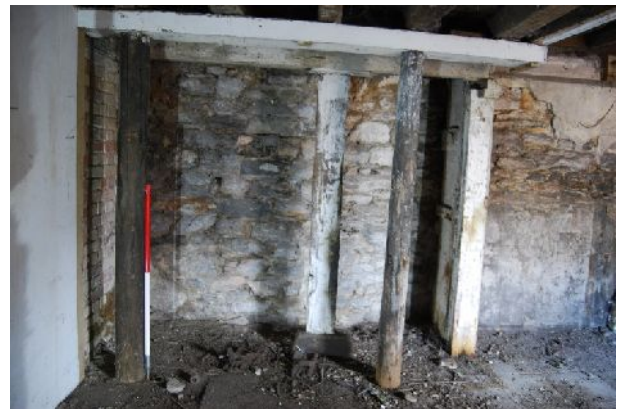
Plate 19. Wall A ground – rubble walling (from N)

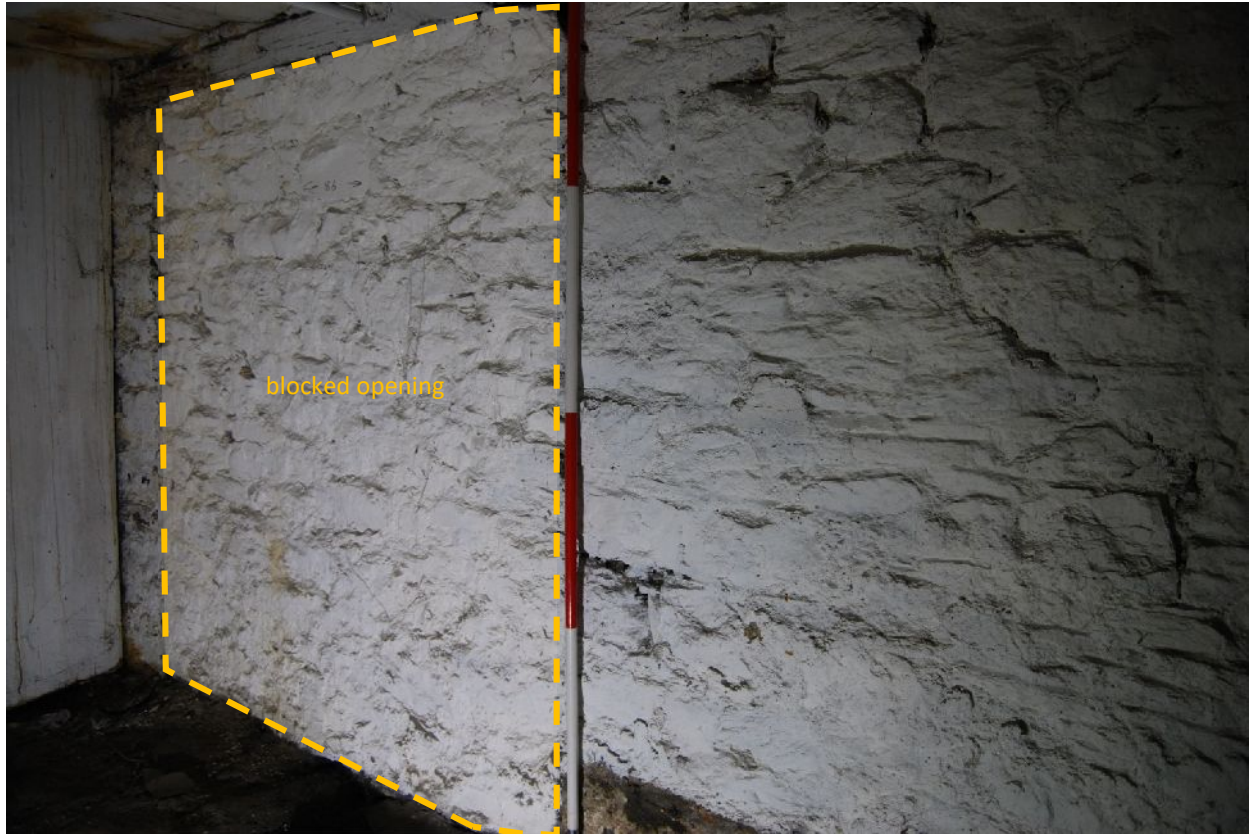
Plate 20. B2 east wall – rubble walling with blocked opening (from SW)

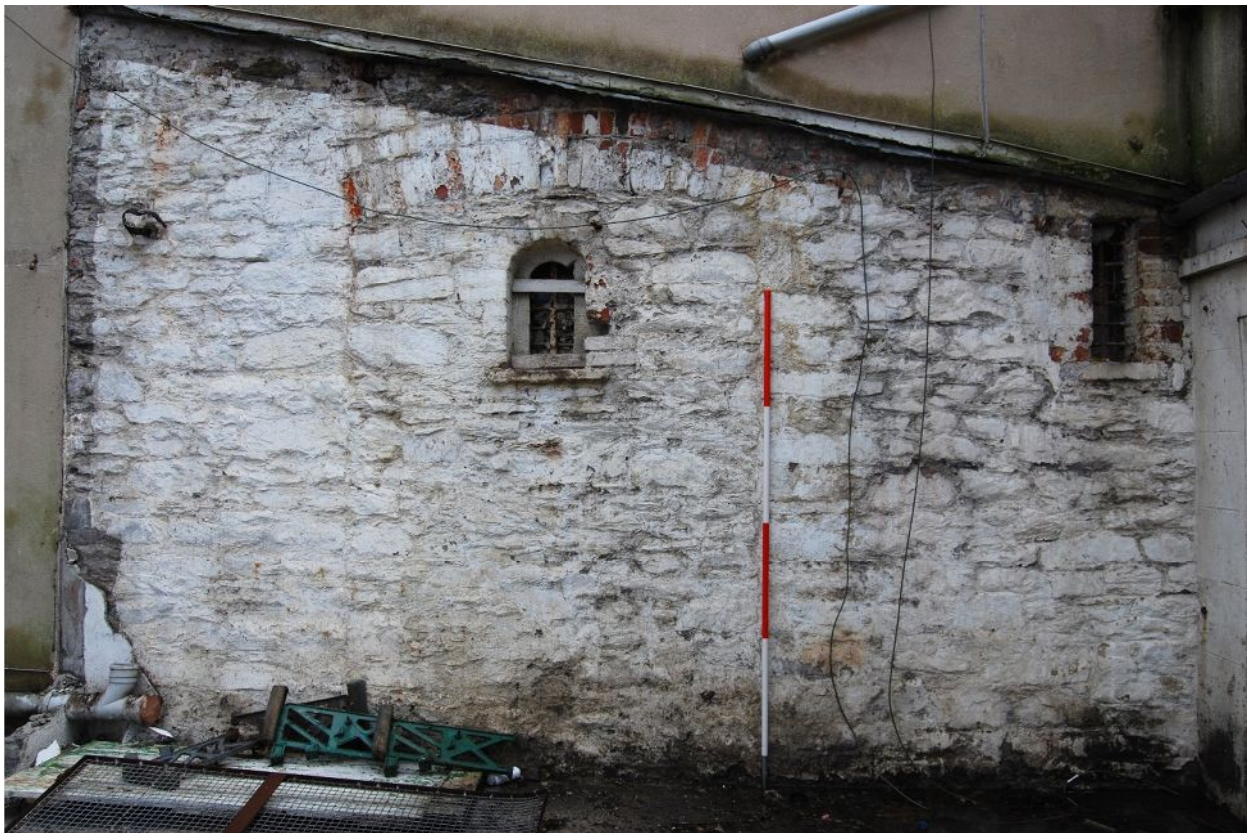
Plate 21. No. 98 east wall – blocked opening & two 17th/ 18th century windows (from W)

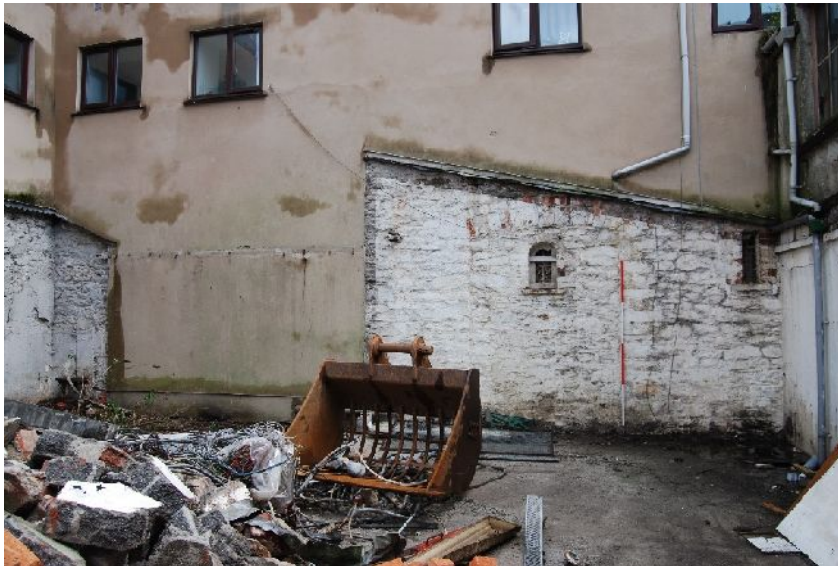
- 6.13 The SWA 2004 report depicts Wall B as possibly continuing up to the east wall of no. 98, although if this was the case they were clearly not keyed-in as there are no obvious scars on the latter. Also, the western return appears to be bonded-in (**Plate 22**) which makes the existence of an immediately adjacent wall unlikely. It is therefore argued that Wall B was either shortened before the construction of the east wall (supporting a pre- 17th/ 18th date) or always terminated here, which seems more likely given there is no obvious reconstruction work.

Plate 22. No. 98 east wall below Dolphin House with western return (from W)

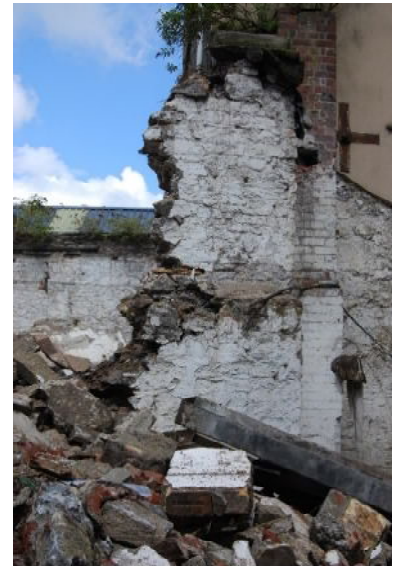
- 6.14 The wall was constructed entirely of coursed rubble lias, similar in character to Wall A forming the south boundary of B1 and B2 (**Plate 23**). The SWA 2004 report notes a change in build at first floor level; this relates to a narrowing of the wall as opposed to a change in materials or construction techniques. This is the same as the projection noted in Wall A, which would have supported beams for the first floor. As such, it seems more likely that the change in depth was intended to support a first floor as opposed to reflecting a different phase to the wall. These similarities provide the only clue that Wall B may have been contemporary with Wall A.

Plate 23. Wall B adjacent to western return from east wall below Dolphin House (from S)

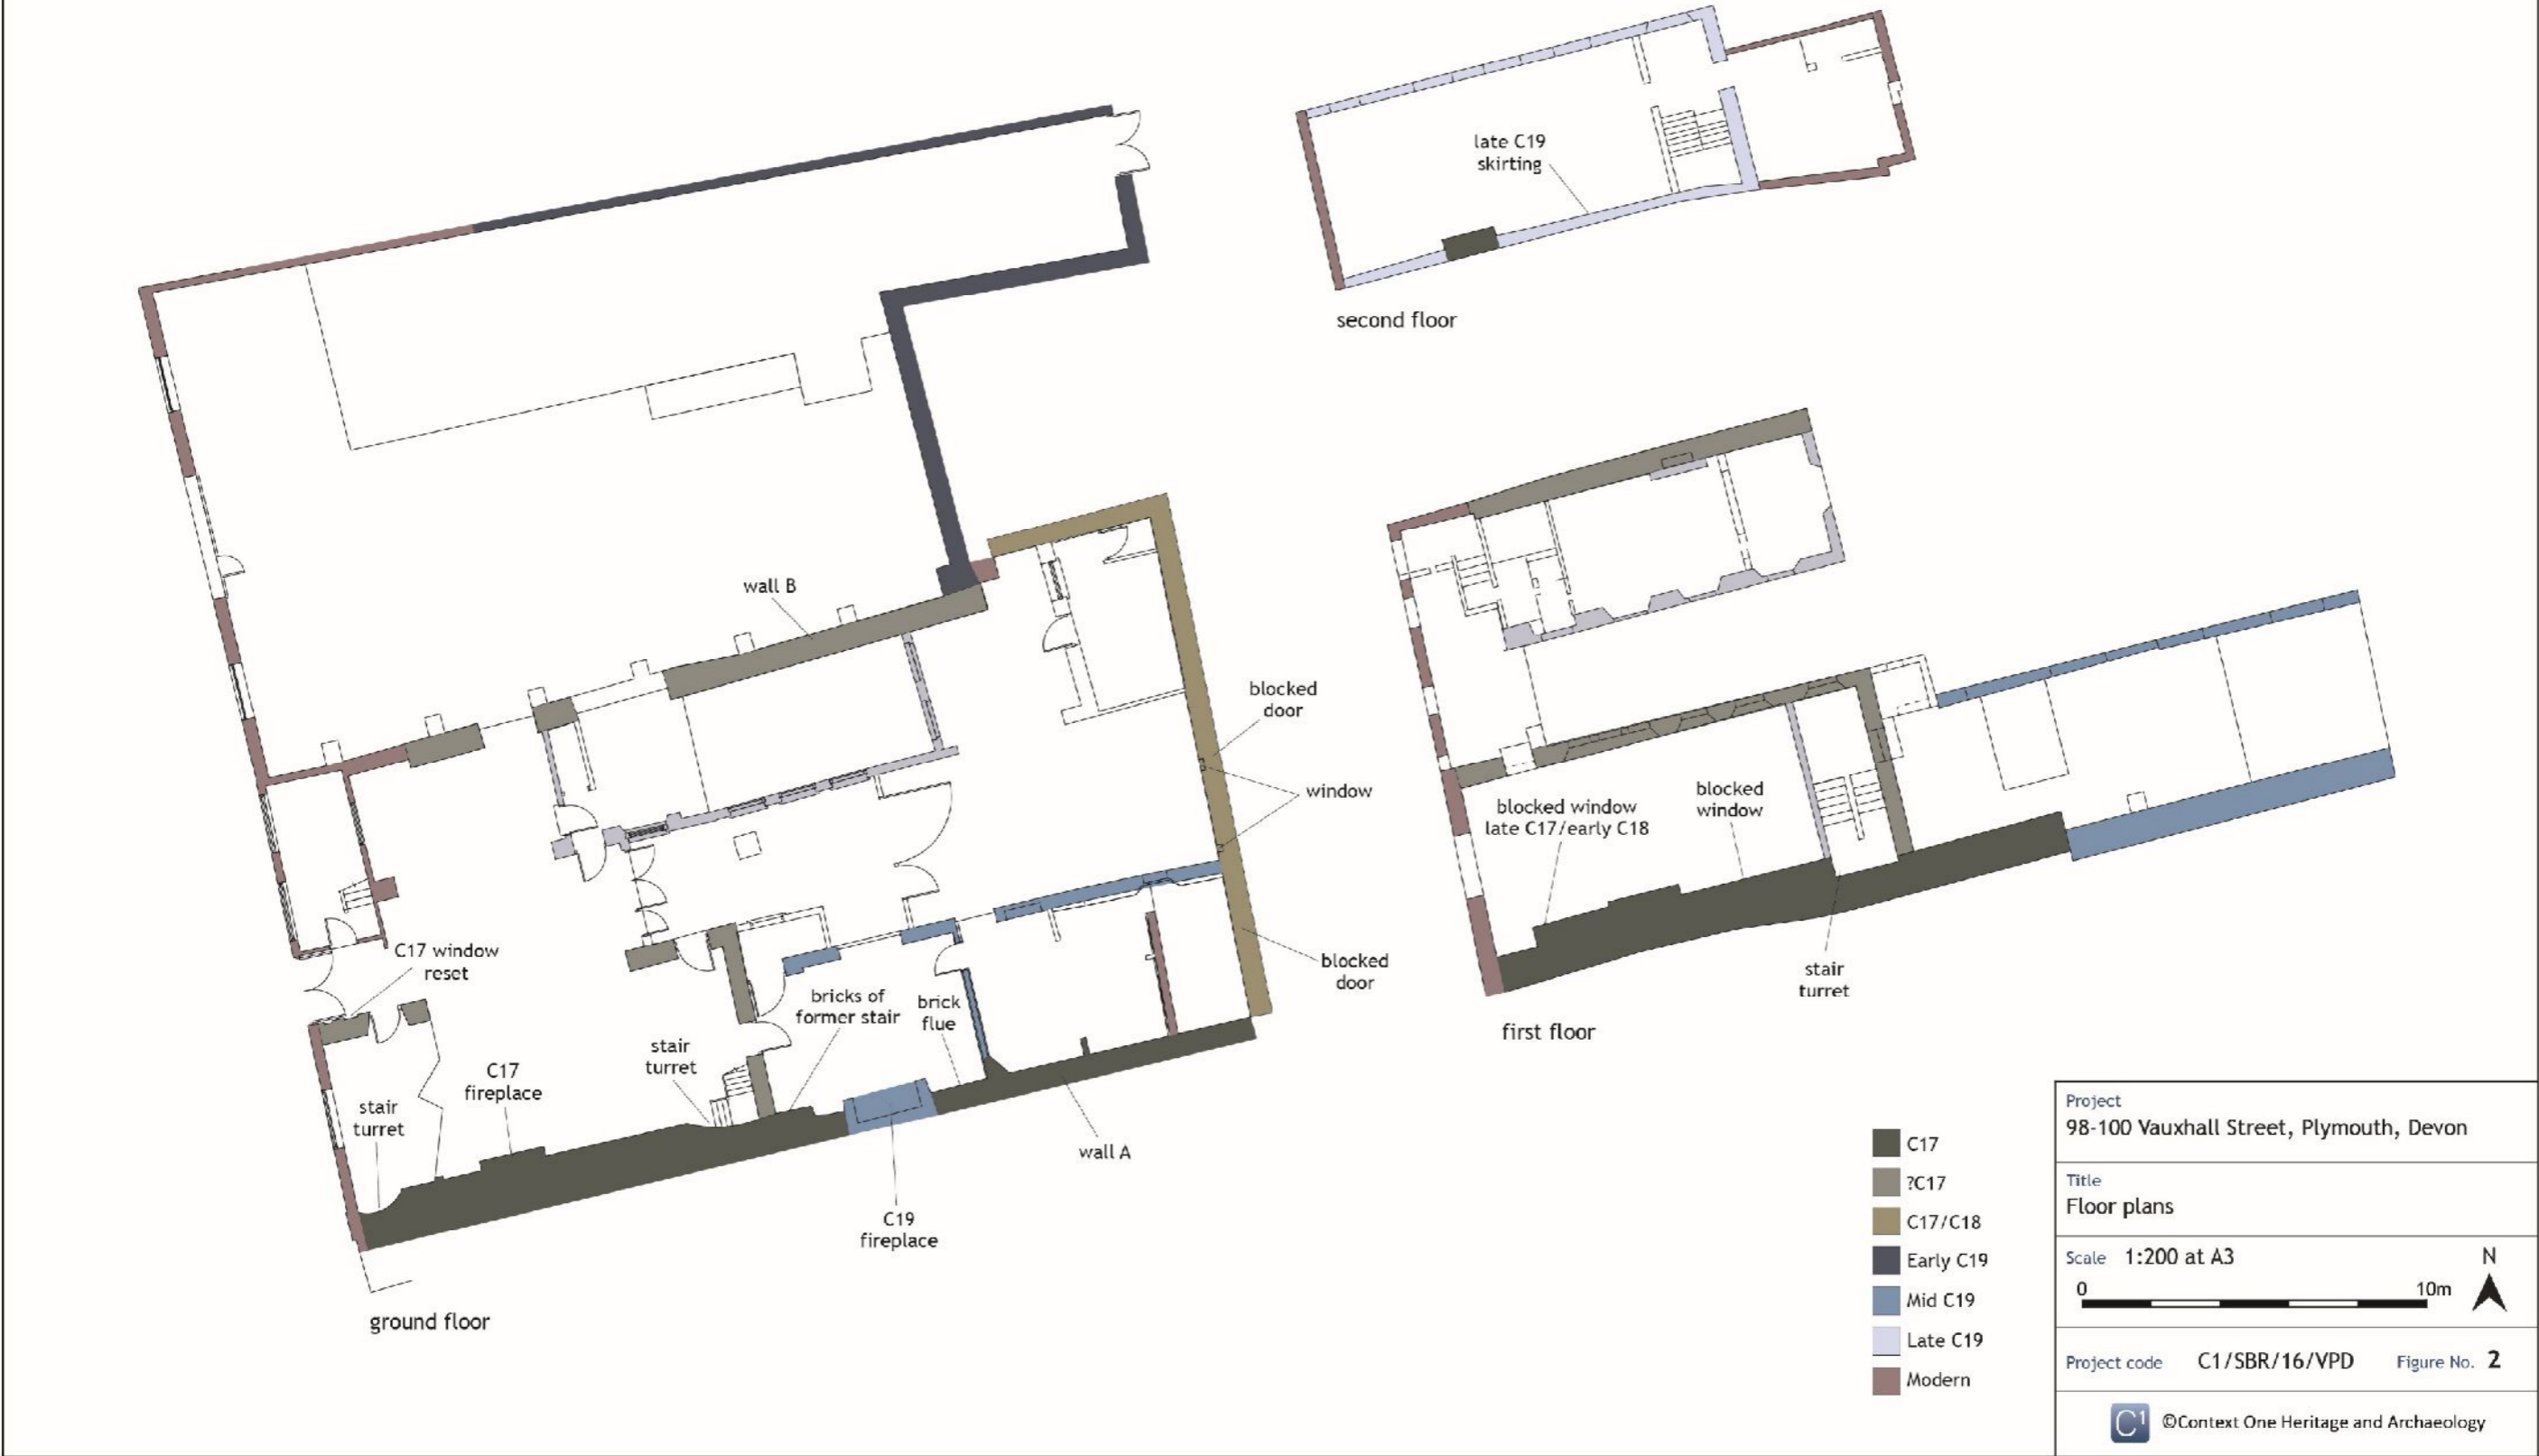
Figure 2. Phased floor plans

Based on client plan no.: 3703 - 01 REV A Site Layout Street Scene Elevation (As Existing)
 Charles Blake Associates Architecture
