Merricks Farm  
Middlezoy  
Somerset

An Archaeological Evaluation Report

October 2017

**C1 project code: C1/EVA/17/MMS**

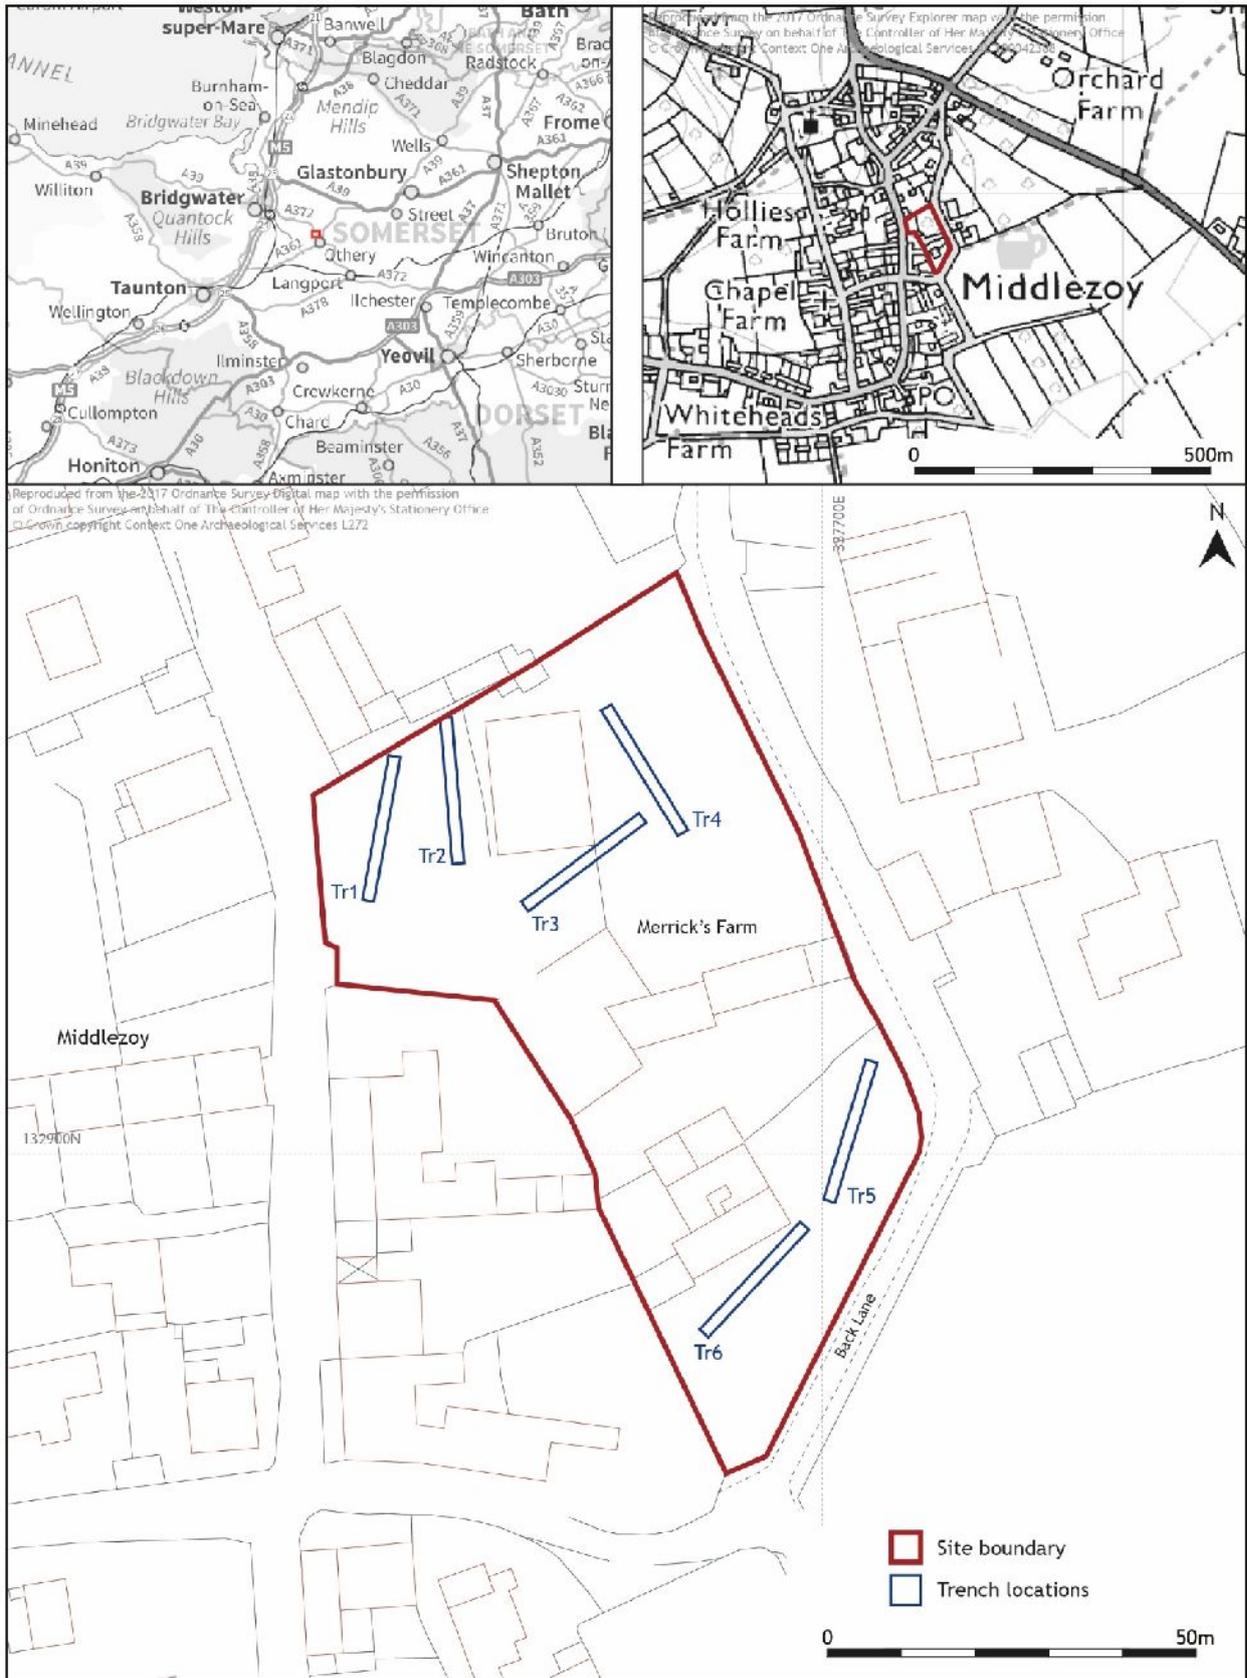
Figure 1. Site setting and trench locations

- 4.3 The archaeological evaluation consisted of six trenches, each measuring 20m long x 1.6m wide representing 4% of the proposal area. The trenches were laid out according to a pre-defined trench plan (see **Figure 1**) using Ordnance Survey (OS) co-ordinates with a TopCon GRS1 GPS unit.

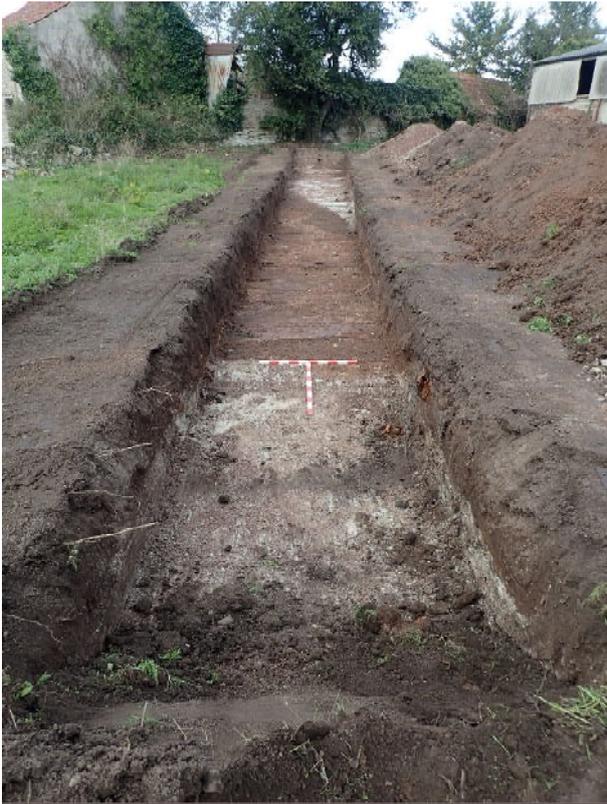
Plate 1. Trench 1 (facing NNE; 1m scales)

- 5.1 Details of the deposits encountered are given in **Appendix 1**. The six evaluation trenches are shown in **Plates 1-6**.
- 5.2 The topsoil in all six trenches was uniformly a dark reddish grey (2.5YR 4/1) silty sandy clay with occasional angular sandstone fragments (<0.05m). The topsoil varied between 0.25m and 0.40m depth in trenches 2-5, and 0.60m and 0.65m depth in trenches 1 and 6. The underlying subsoil in all cases was a dark reddish grey (2.5YR 4/1) silty sandy clay with occasional angular sandstone fragments (<0.05m), and varied between 0.30m and 0.40m depth in all trenches. The subsoil in all trenches overlay natural deposits of red (2.5YR 4/6) very degraded sandstone with frequent platy sandstone fragments (<0.10m).
- 5.3 No archaeological features or deposits were observed.
