Holy Trinity Church  
Newton St Loe  
Bath  
BANES

Archaeological Monitoring and  
Recording report

March 2018

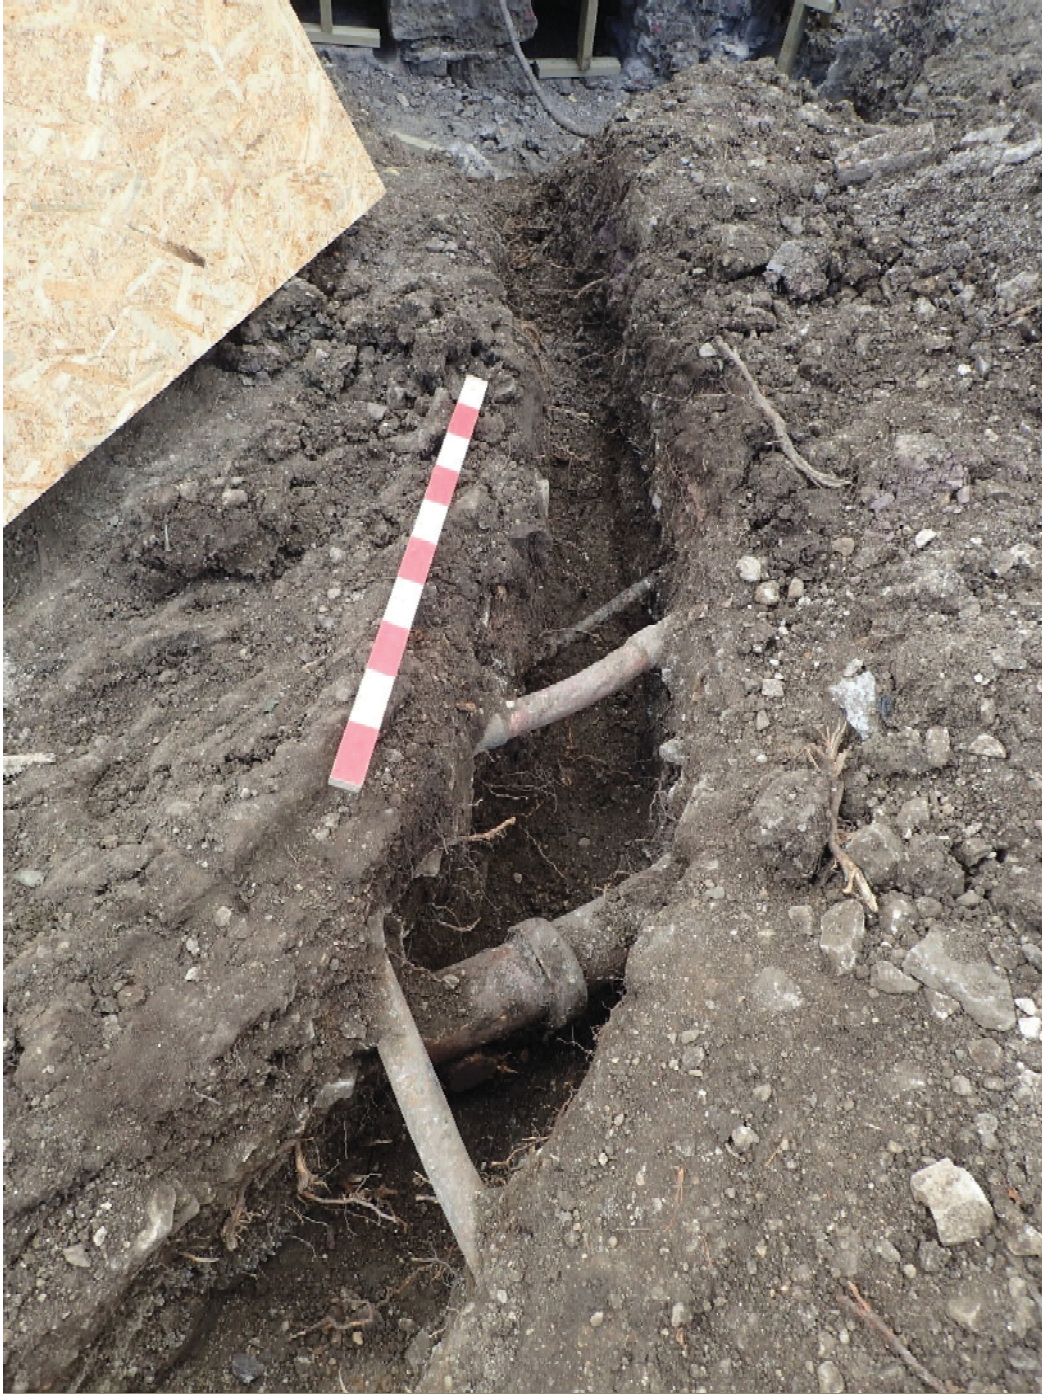
- 5.1 The excavation of the cable trench was observed over a distance of c. 25m (**Figure 1**). This only impacted the topsoil (100), which was a very dark brown (10 YR 3/2) friable silty sandy clay with frequent angular limestone fragments (<0.02m). The trench was crossed by other existing services and was much disturbed (**Plate 1**). No archaeological features or deposits were observed.

Plate 1. Electric cable trench (facing W; 1m scale)

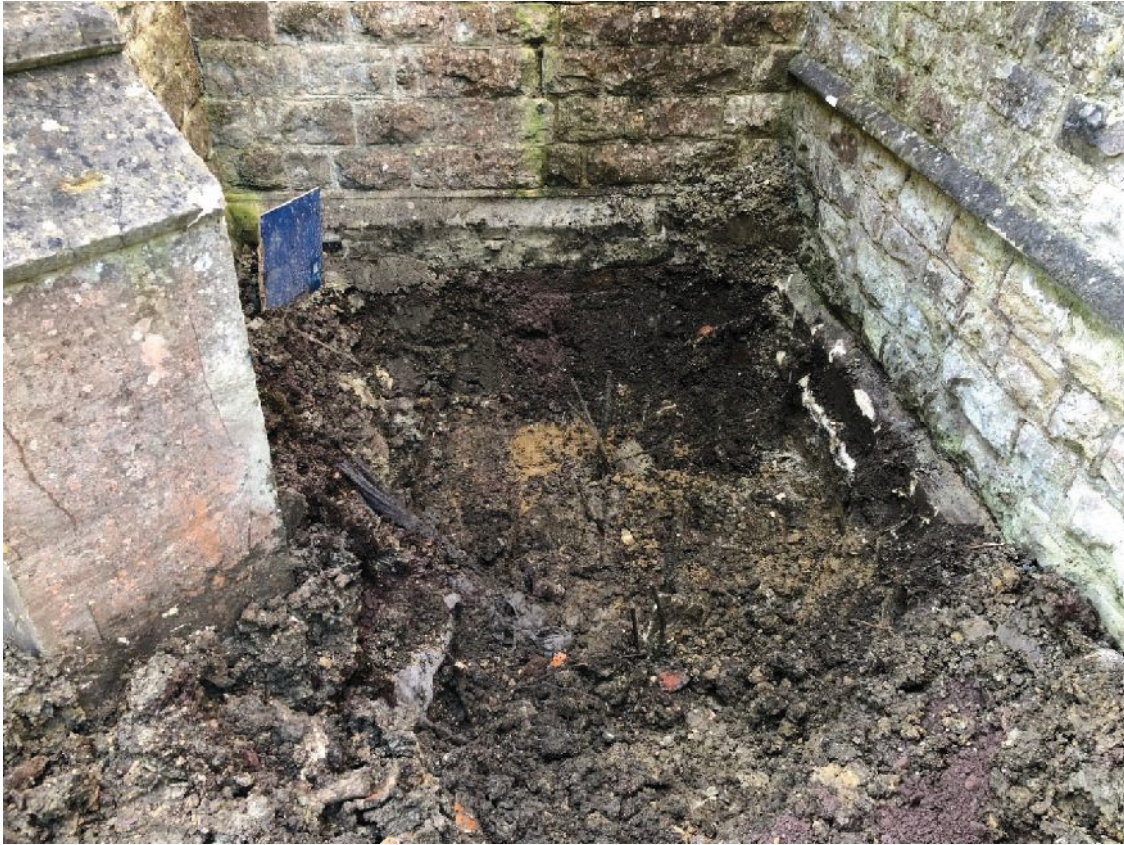
- 5.2 In the area of ground reduction around the vestry and north aisle wall, all of the groundwork excavation clearly showed that the works area has been significantly disturbed through a combination of the original vestry construction, later services and underpinning work (**Plate 2**). There was little cohesion to the deposit sequence in any of the excavation areas or test pits and it was only possible to confirm that the soils were clayey in nature. The homogeneity of the deposit sequence continued to at least the full depth of ground reduction and comprised fragments of ashlar, concrete blocks, clay water pipes pieces and, on the eastern side, some permeable membrane left from the previous underpinning works.

Plate 2. Deposit by the wall (facing S)

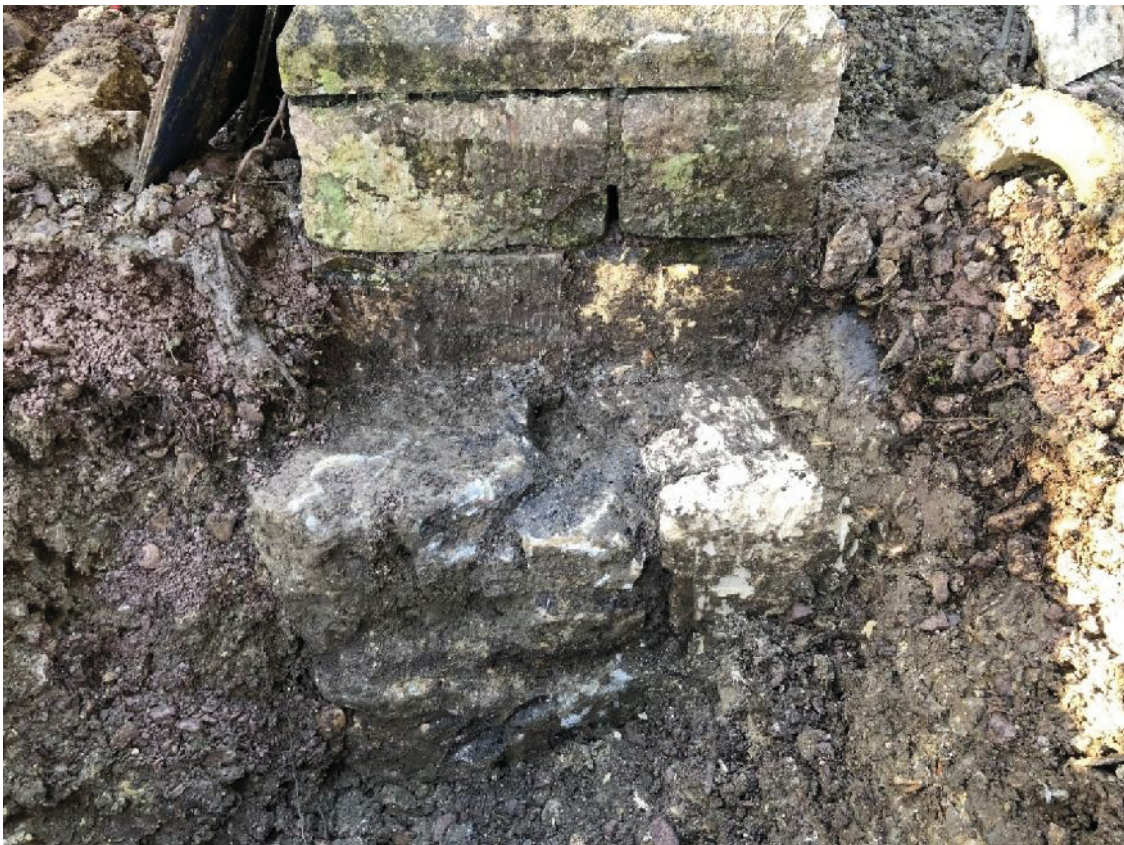
- 5.2 Excavation against the north aisle wall showed the foundation to be at least 0.55m below the lower course of the wall plinth and was similar for the foundation of the angled buttress on the north-east corner of the vestry (**Plate 3**). Here the foundation stepped out from the wall by approximately 0.28m. No archaeological features or deposits, and no evidence of burials were observed.

Plate 3. North-east corner buttress with projecting foundation (facing SW)
