BK331: Brook Farm to Fairwood House Westbury Wiltshire

Archaeological Monitoring and Recording report

November 2018

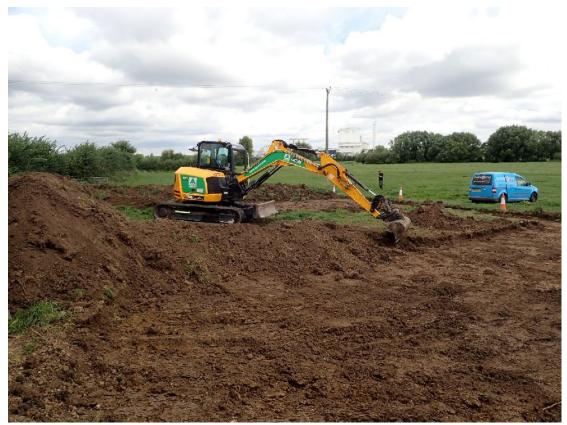
Plate 1. Site compound excavations (from S, no scale)

The machine excavation of topsoil across the compound area was monitored prior to being covered with permeable membrane and aggregate to form a temporary metalled. Excavation was carried out by an 8 tonne JCB slew with a 1.6m toothless grading bucket.

5.1 Four profiles of the deposit sequence were recorded during excavation of the open cut trenching (Profile 1) and drill pits (Profiles 2-4), (**Plates 1-2**). Overall, depths varied between 1m and 1.50m. The compound was

only soil stripped to a depth of 0.20m. The deposit sequence observed in Profiles 1 and 3 was identical. The topsoil (100) and (300) comprised a grey friable silty clay measuring 0.20m deep with occasional limestone fragments. This overlay a 0.30m deep pale brown firm subsoil (101) and (301) also containing occasional limestone fragments which covered >0.50m grey firm clay natural containing frequent limestone fragments (102) and (302). The topsoil (200) in Profile 2 was a very dark grey silty clay with occasional limestone fragments. This covered a light brownish grey firm silty clay subsoil (201) containing occasional limestone fragments. The natural geology (202) in Profile 2 matched that in Profiles 1 and 3. The deposit sequence in Profile 4 differed to that observed in the previous profiles. The topsoil (400) here comprised a very dark brown loam with frequent limestone fragments directly above a brownish yellow clay natural (401). No archaeological features or deposits were observed.

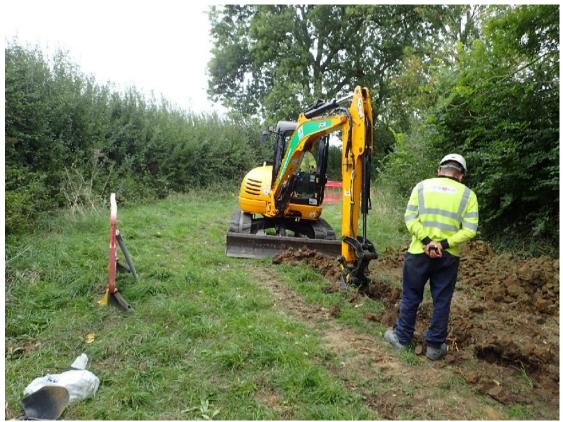
Plate 2. Working shot of open cut pipe trenching (from S, no scale)

Pipe trench excavations involved both the directionally drilled method and open cut trenching. Drill pits associated with the drilled pipeline were monitored together with three separate stretches of open cut trenching amounting to *c*. 0.50km. Excavation of the open cut trenching was carried out by a 4 tonne JCB slew equipped with a 0.30m toothed bucket.
