CK310: Berryfield
Rising Main Replacement
Melksham
Wiltshire

Archaeological Monitoring
and Recording Report

February 2019

Wessex Water plc

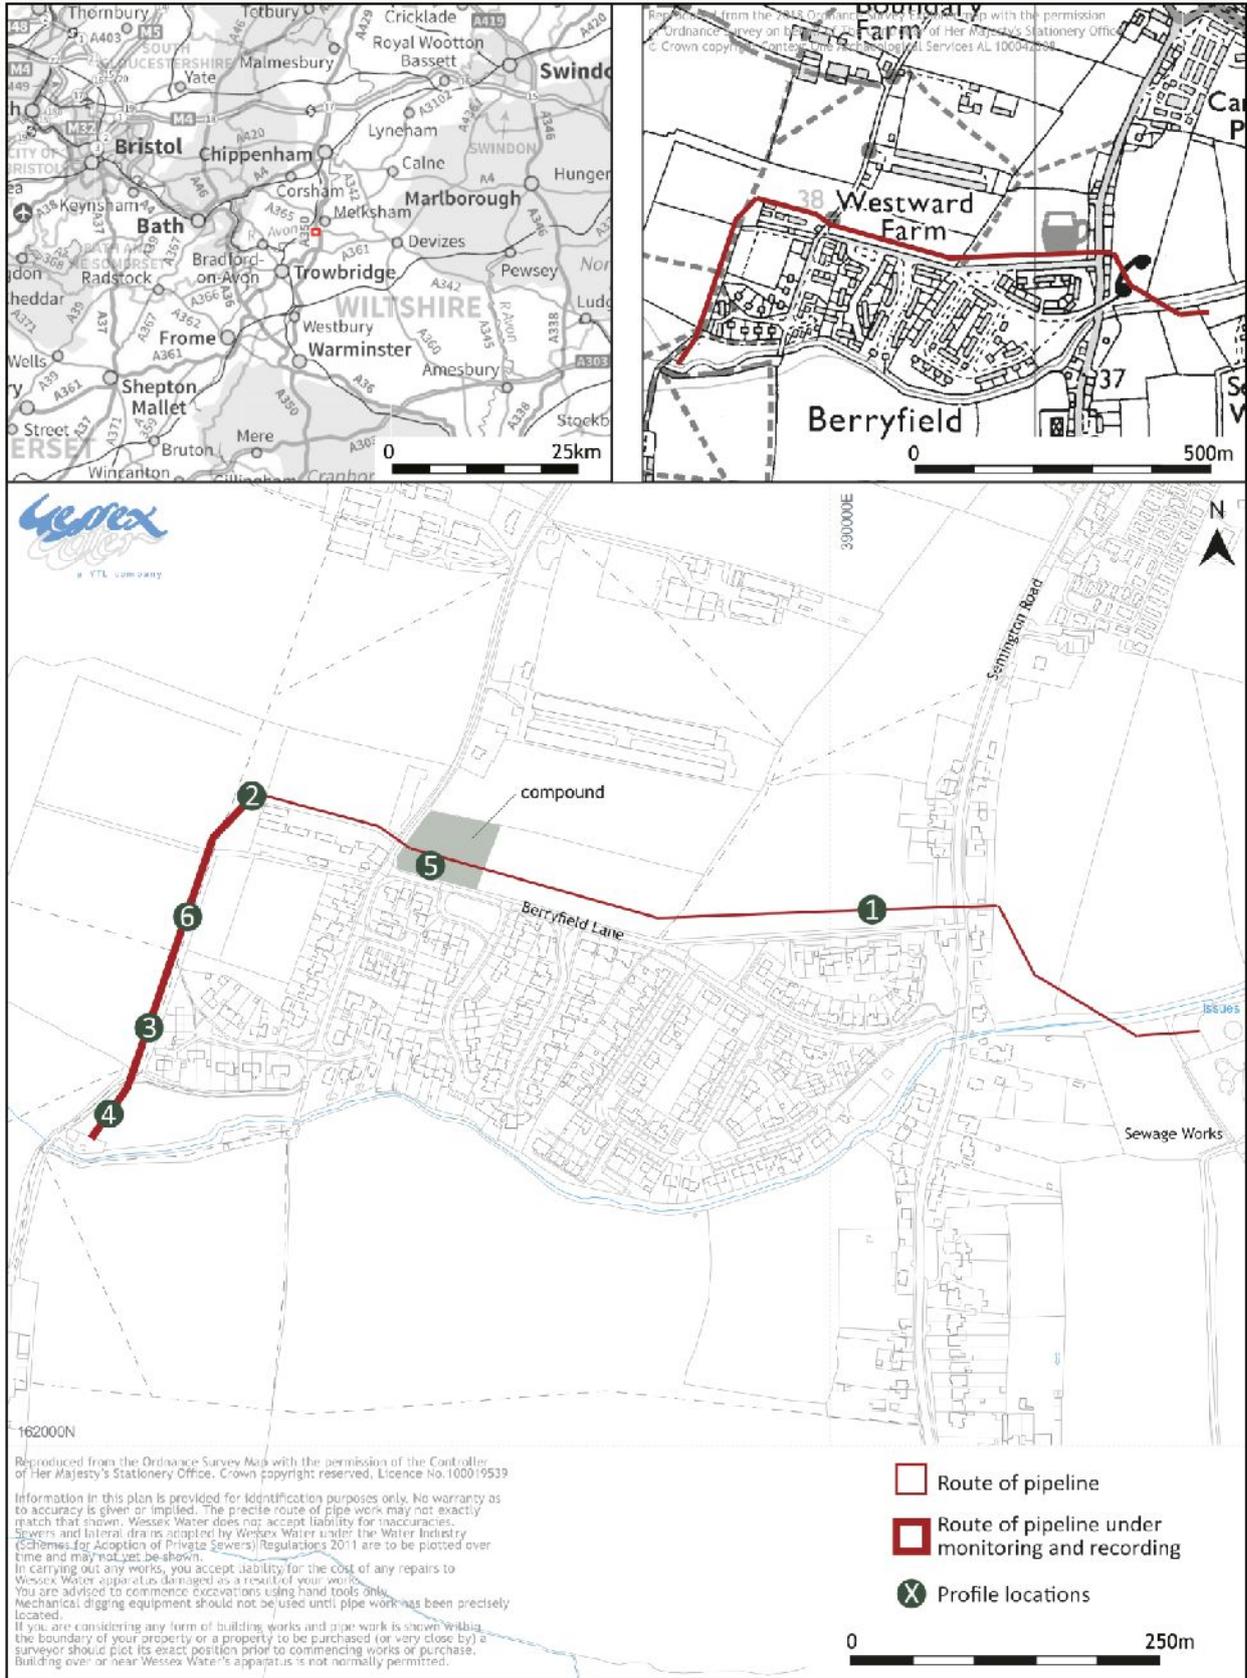
Figure 1. Site setting, route of pipeline and area subject to archaeological monitoring and recording

- 1.1 Context One Heritage & Archaeology (C1) carried out archaeological monitoring and recording during the construction of a new rising main at Berryfield, Melksham, Wiltshire (the 'Site') (**Figure 1**). The project was commissioned by Wessex Water plc (WW) under a Term Agreement with C1.

- 2.1 The pipeline route (NGRs: Eastern end, 390295 162343; Western end, 389531 162531; Southern end, 389398 162258) covered a linear distance of c. 1.15km and the east to west section ran from the sewage station, along the northern flank of Berryfield adjacent to Berryfield Lane and through agricultural land before turning south. The southern length of the route continued towards the pump house. Monitoring and recording was required along the easement of the western portion of the route, the area of a temporary compound and four drill pits for directional drilling (**Figure 1**). The route is situated on land that is c. 38m above Ordnance Datum (aOD) in the east, gradually falling to 35m aOD in the west. The recorded solid geology for the Site is Oxford Clay Formation – Mudstone with drift geology noted as River Terrace Deposits, 1 - Sand and Gravel (BGS 2019). The soils are characterised as freely draining lime-rich loam (CSAIS 2019).

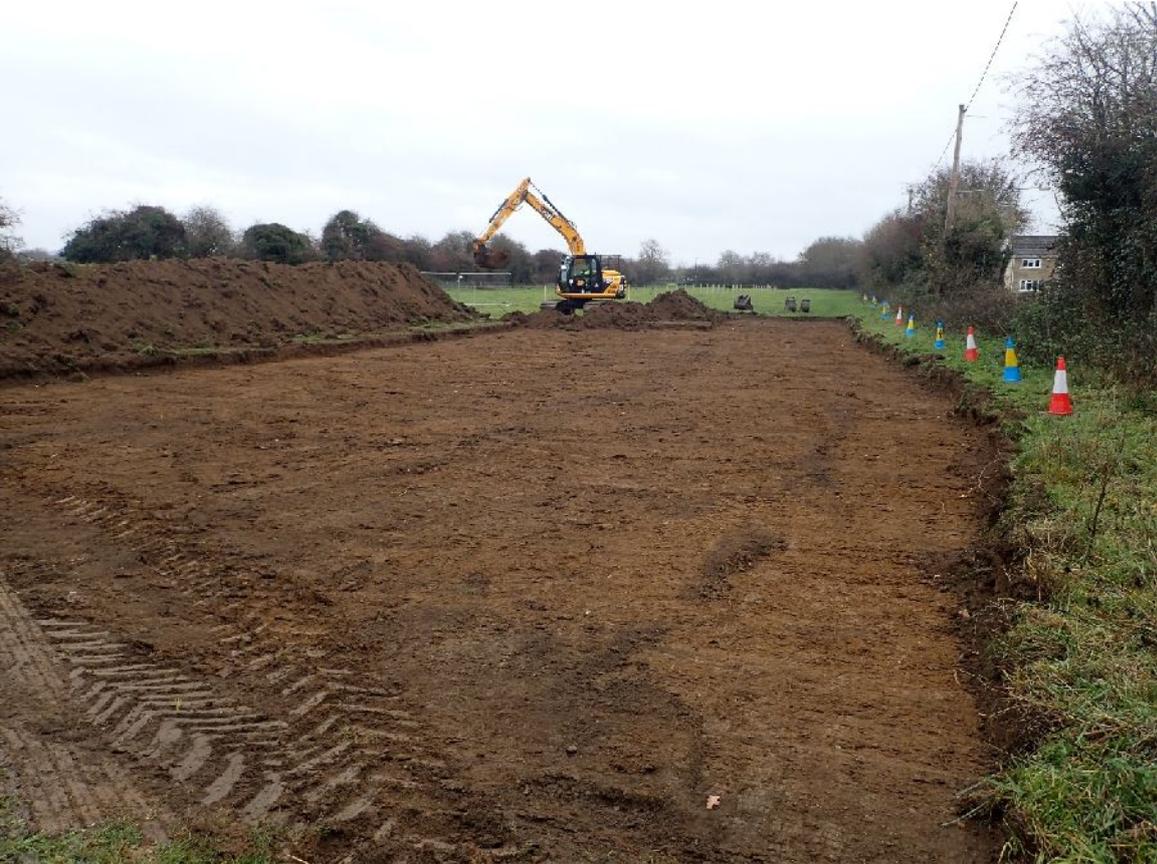
Plate 1. Compound (facing E)

5.1 Profiles of the deposit sequence were recorded in six locations during groundwork excavations, the compound, easement and four drill pits. The compound area (**Plate 1**) was only soil stripped to a depth of 0.30m. The easement for the pipeline (**Plate 2**) was stripped to 0.55m. The drill pits (**Plate 3**) were excavated to between 0.7m and 1.2m.

- 5.3 In the compound area, the topsoil overlay a similar subsoil (501) to that seen in most of the drill pits, a dark yellowish brown (10 YR 3/6) friable silty sandy clay with occasional angular flint and limestone fragments (<0.10m), in excess of 0.10m deep. The subsoil along the easement (601) was the same, but in this case, it was 0.20m deep and overlay natural deposits (602) of yellowish brown (10 YR 5/6) silty sandy clay with moderate angular flint and limestone. No archaeological features or deposits were observed.

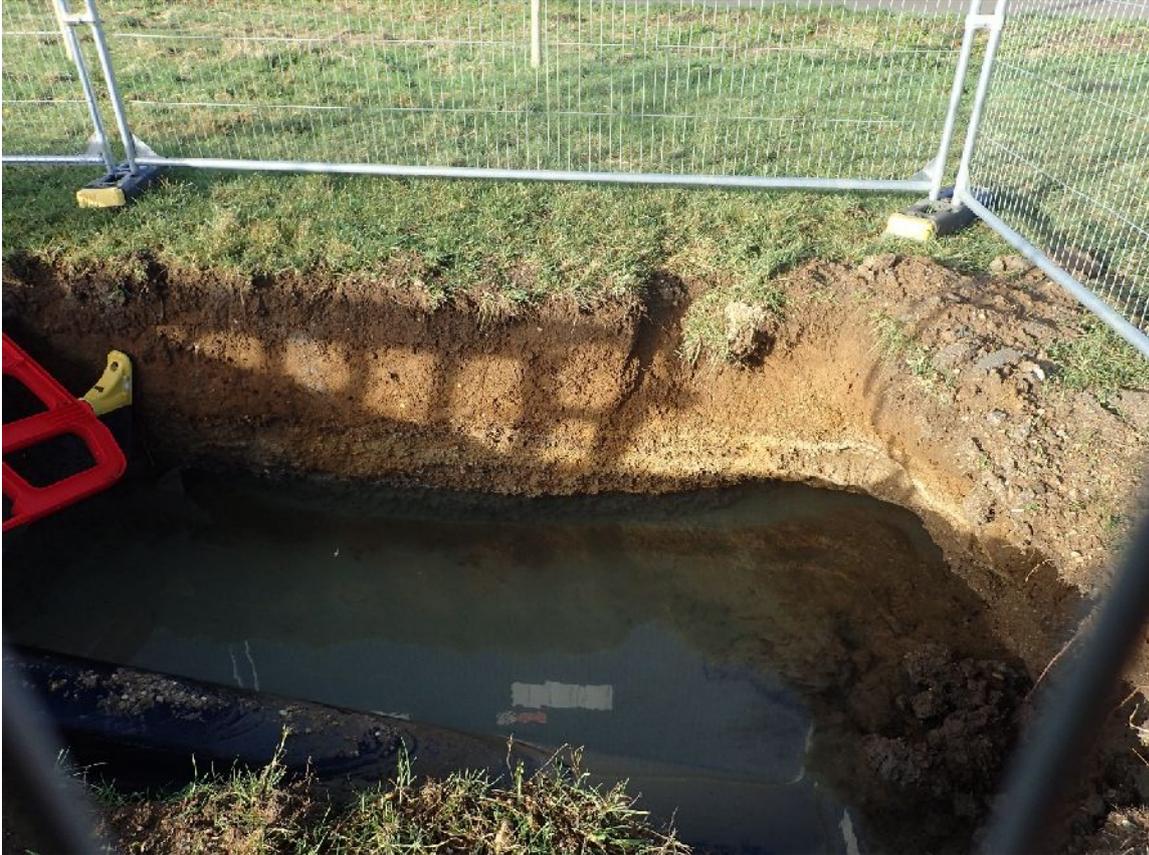
Plate 3. Drill pit 4 (facing SW)

- 5.2 The deposit sequence observed was very similar in all locations. The topsoil was the same, a very dark greyish brown (10 YR 3/2) friable silty sandy clay with occasional angular flint and limestone fragments (<0.10m). It was 0.20m deep in each of the drill pits and the compound, and 0.30m deep along the pipeline easement. In drill pit 1, the subsoil (101) was a grey (10 YR 5/1) friable silty sandy clay with occasional angular flint and limestone fragments (<0.10m), in excess of a meter in depth. In the other three drill pits, the subsoil (201), (301) and (401), was a dark yellowish brown (10 YR 3/6) friable silty sandy clay with occasional angular flint and limestone fragments (<0.10m), observed to be in excess of 0.5-1.0m deep. In drill pit 4, the subsoil was only 0.30m deep, and overlay natural (402) which comprised in excess of 0.50m depth of yellowish brown (10 YR 5/6) friable gravels with frequent angular sand and gravel.
