E7616: Great Chalfield Manor Melksham Wiltshire

Archaeological Monitoring and Recording Report

May 2019

# C1 project code: C1/AMR/19/CMW

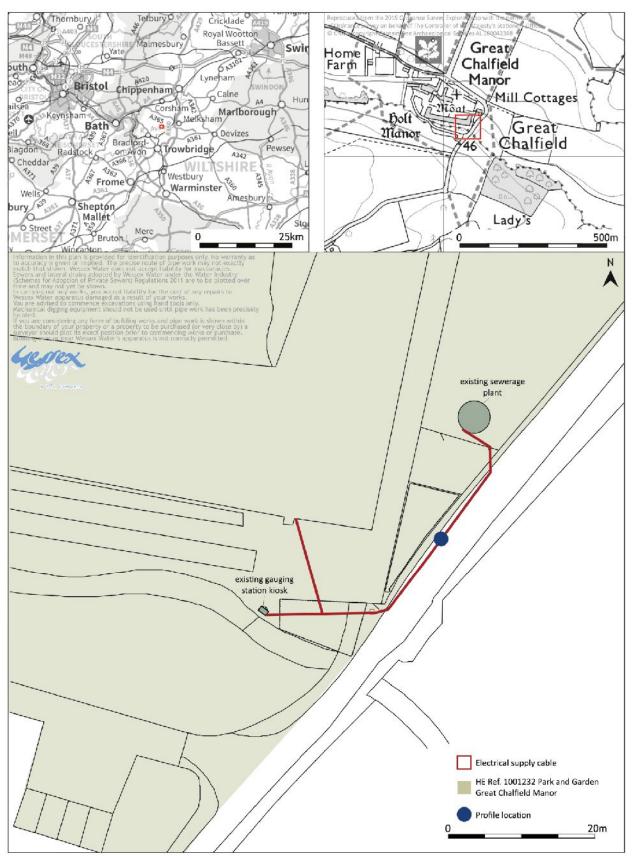
Figure 1. Site setting showing electrical supply cable route and profile location

- 2.1 The electrical supply cable trench (centred on NGR 386100 163100) covered a linear distance of *c*. 50m and was located towards the south-east corner of the Grade II listed Park and Garden of Great Chalfield Manor, which, itself is *c*. 4km west of Melksham. The cable ran for *c*. 5m south-east from an existing sewerage plant in the north at an adjacent property, beneath a boundary wall where a small kiosk will be constructed before turning south for *c*. 3.30m towards the road. The trench continued south-west along the roadside verge for *c*. 24m before turning west beneath the boundary wall once again. This section terminated at an existing kiosk *c*. 15m away and included a spur running north-west for approximately 15m (Figure 1). The trench was situated on land that is *c*. 50m above Ordnance Datum (aOD). The recorded geology for the Site is Cornbrash Formation Limestone (BGS 2019). The soils are characterised as shallow lime-rich soils over chalk or limestone (CSAIS 2019).

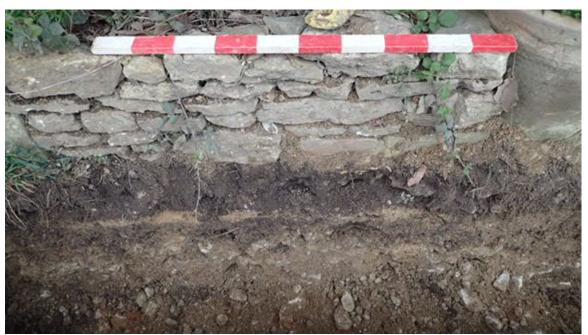
Plate 1. Profile 1 (facing NW; 1m scale)

- 5.2 A single profile representing the general deposit sequence was taken in the main cable trench (Figure 1; Plate 1; Appendix 1). This comprised topsoil consisting of a dark grey (10YR 4/1) soft silty clay with sparse angular limestone fragments (<0.05m), 0.20m deep. Lenses of mortar were also noted. This overlaid a subsoil of grey (10YR 5/1) compacted silty clay with common angular limestone fragments (<0.10m), more than 0.40m deep. Within the Registered Park and Garden, at the southern end of the scheme, the topsoil was observed in a narrow hand dug section of the cable trench leading to the existing kiosk (Plate 2). This consisted of black (10YR 2/1) soft silty clay with sparse angular limestone fragments (<0.05m), more than 0.20m deep. It had all the characteristics of a garden soil.</p>

- 5.3 No archaeological features or deposits were observed and no finds were collected.
