## Devon County Council Historic Environment Record

Civil Parish: Clyst Honiton	National Grid Reference SX 98946 93552		Number: (Leave blank)
Subject: Clyst House, Clyst Honiton, Devon  Plan/Photo attached? Y			
Planning Application no: 18/1177/FUL		Recipient museum: Royal Albert Memorial Museum	
Training repriorition for the first		, and the second	
OASIS ID: contexto1-343967		Museum Accession no: RAMM: 19/10	
Contractor's reference code: C1/AMR/19/CCD		Dates fieldwork undertaken: 26 March & 1 April 2019	
Description of works.			
Context One Heritage & Archaeology (C1) carried out archaeological monitoring and recording as a condition of planning permission for the conversion, extension and alterations to existing stables to create residential accommodation at the Clyst House, Clyst Honiton, Devon. Due to the close proximity to the medieval parish church it was anticipated that significant archaeological deposits might be present.			
The first phase of archaeological work was a desk-based appraisal of archaeological and historical data recorded within a 500m radius of the Site. Historic map regression identified the former stables as dating to the latter half of the 19th century.

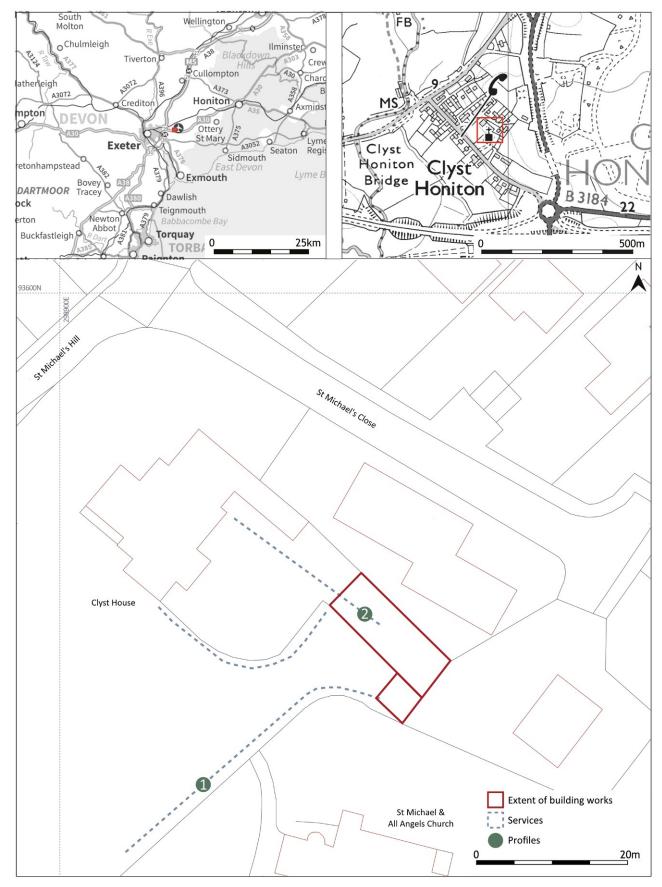
Figure 1. Site setting, development area and service trenches

Works to the building did not involve any below ground impact so the groundworks exclusively related to the excavation of service trenches ( <b>Figure 1</b> ). These were monitored for archaeological features/deposits. Representative profiles of the deposit sequence within the trenches were taken at two locations ( <b>Figure 1</b> , <b>Plates 1-2</b> ) and are described below:			
Profile 1 ( <b>Plate 1</b> ) 0 – 0.20m Topsoil Black (10YR 2/1) soft sandy silt loam with sparse rounded sandstone fragments. 0.20m - 0.60m Subsoil Dusky red (5R 3/4) friable sandy silt loam with common rounded sandstone fragments			
Profile 2 ( <b>Plate 2</b> ) 0 – 0.60m Topsoil/subsoil (beneath stables) Dusky red (5R 3/4) friable sandy silt loam with moderate rounded sandstone fragments			
No archaeological features or deposits were encountered and no finds were observed or recovered.			
It is likely that any archaeology which might have once been present is likely to have been removed by levelling associated with the present buildings on the Site.
