All Saints Church
Weston
Bath
BANES

AN ARCHAEOLOGICAL
EVALUATION

REPORT

July 2019

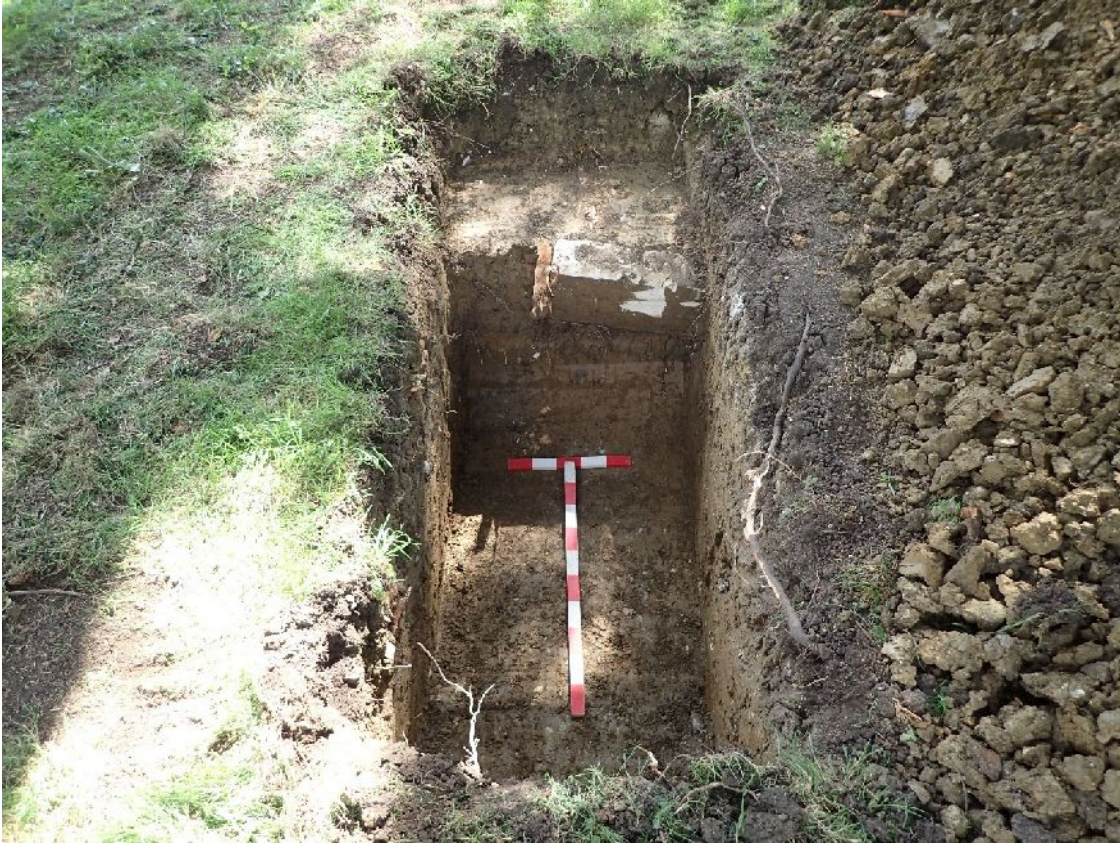
Plate 1. Trench 1 (1m and 0.50m scales; facing E)

- 5.3 In Tr 1 (**Plate 1**), a grave soil (102), 0.65m deep, was located beneath the subsoil. This was a yellowish brown mottled compacted clay with moderate amounts of small to very small stones, and mortar flecks. There were also occasional larger mortar lumps (<0.04m) and angular stone, and very occasional charcoal flecking. There was one relatively large fragment of stone measuring >0.55m long, 0.15m wide by 0.38m deep; this was similar to the stones seen in tomb F2 (see below). This deposit was similar to (201) in Tr2, which was situated directly beneath the topsoil (200), and was a greyish brown compacted clay, 0.28m deep, with moderate subangular stones (<0.05m), and occasional large stones (<0.30m) with some mortar flecking. The deposit contained some disarticulated human remains and coffin fittings. A mortar and clay deposit was also encountered in Tr 3, (302), and was 0.75m deep. This contained moderate amounts of small to very small stones; mortar flecks; occasional larger mortar lumps (<0.04m); some angular stone; and very occasional charcoal flecks.

- 7.4 A clay/mortar layer was observed in all three trenches. This is likely to be related to the construction debris/landscaping resulting from the adjacent early 20th century extensions to the church. This disturbance is probably the reason the tomb in Tr3 was covered with soil and why an isolated grave kerb stone was encountered in Tr1.

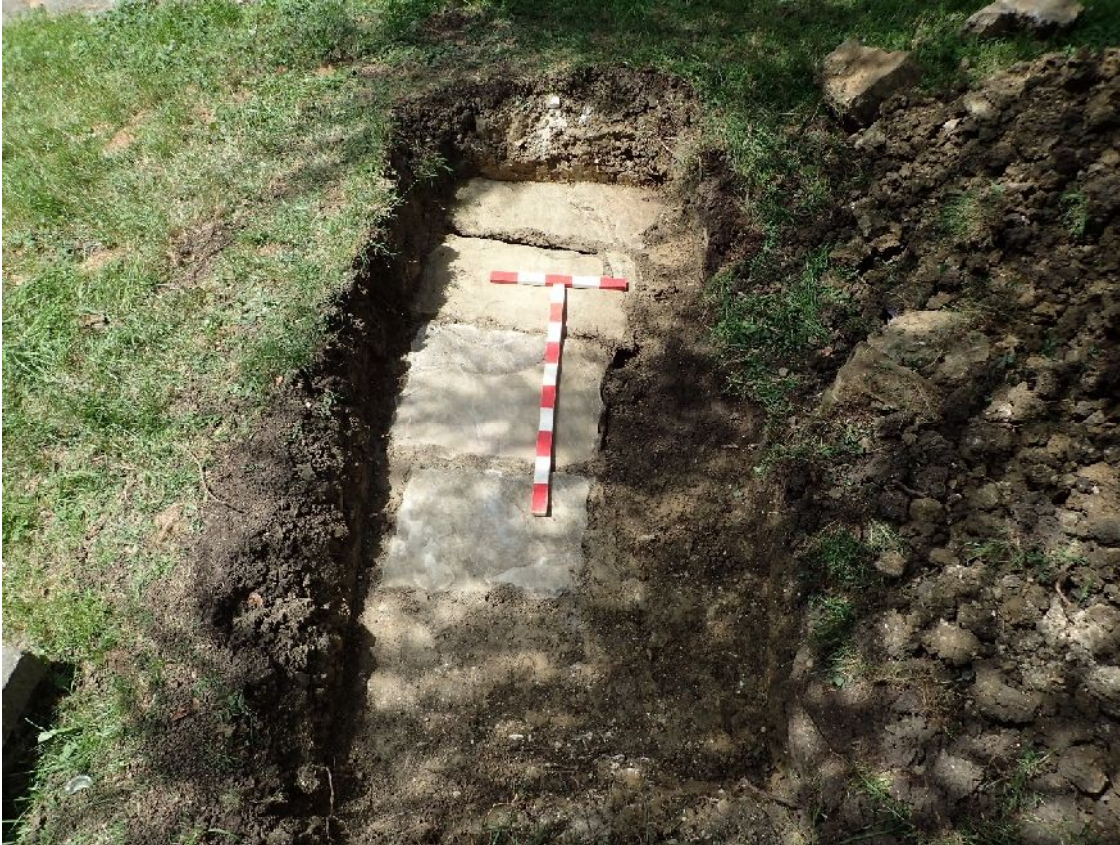
Plate 2. Trench 2 (1m and 0.50m scales; facing W)

- 5.4 Structures were encountered in Tr2 and Tr3. In Tr2, this comprised a brick-lined void with a stone cap which tapered in plan feature (F1(202)) (**Plates 2 & 3**) that gently tapered from west to east. The stones measured up to 0.80m long and 0.60m wide and were orientated west-north-west and east-south-east. The stones were laid in a line and appeared to cap a brick lined cavity below. On closer inspection, utilising a camera inserted into the space beneath the stones, the cavity appeared to be a narrow space between two brick walls, which appeared to taper towards the east (**Plate 4**). The south wall seemed to lean away to the south and it is possible that it represents the outer wall of a tomb. If this is the case, the north wall may represent another outer wall of a second tomb, and what can be seen beneath the stone slabs is the void between two brick tombs, with possibly one or both of them being arched. F2 (303) (**Plates 5 & 6**) was a stone tomb constructed of Bath stone and orientated roughly east-west. There did not appear to be a construction cut for this feature and it appeared that the tomb was covered over by landscaping layers associated with the late 19th century and early 20th century extensions to the church.

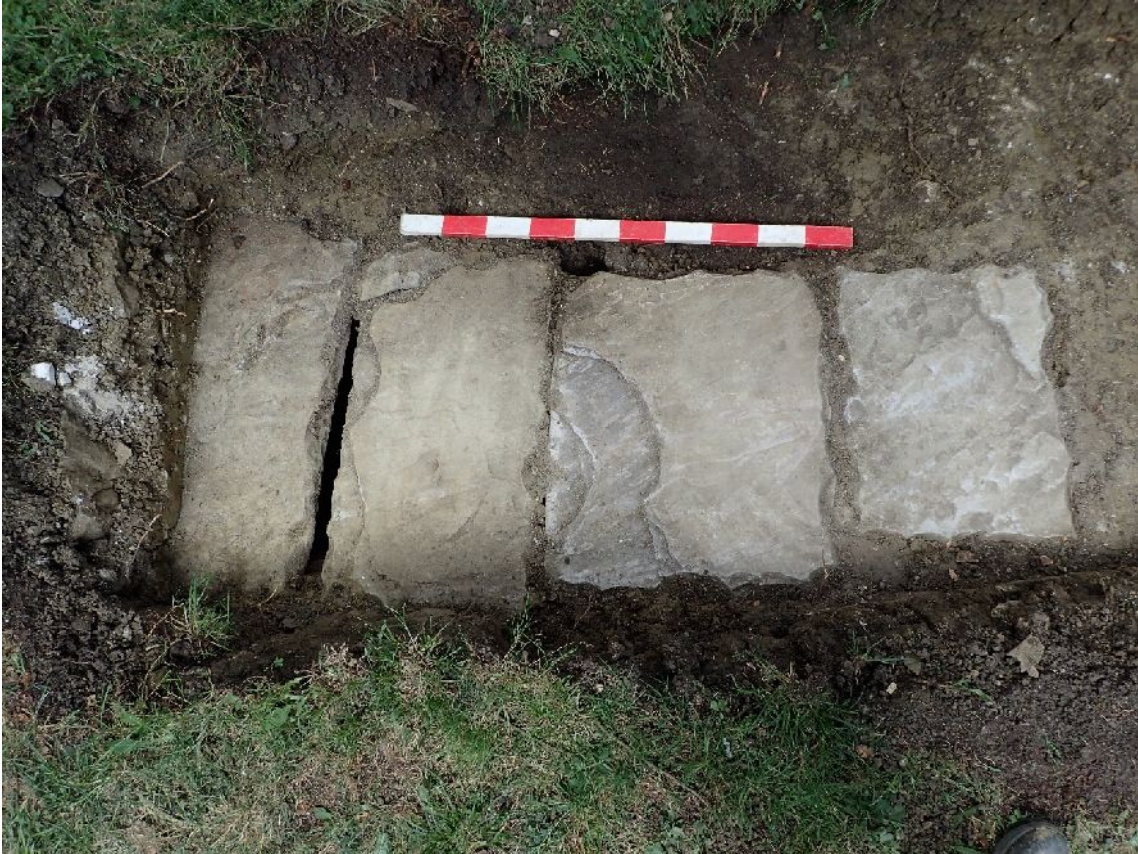
- 7.2 The stone capping covering a brick-lined void in Tr2 is more problematic. Although the stone capping might indicate the covering to a tomb, the sloping sides to the walls beneath is more likely to suggest two brick vaults constructed side by side, with the capping merely covering the void between the two. The brickwork could be as early as the late 18th century although a Victorian date is perhaps more likely.

Plate 3. Trench 2. F1: tapering capstones above brick-lined void (1m scale; facing N)

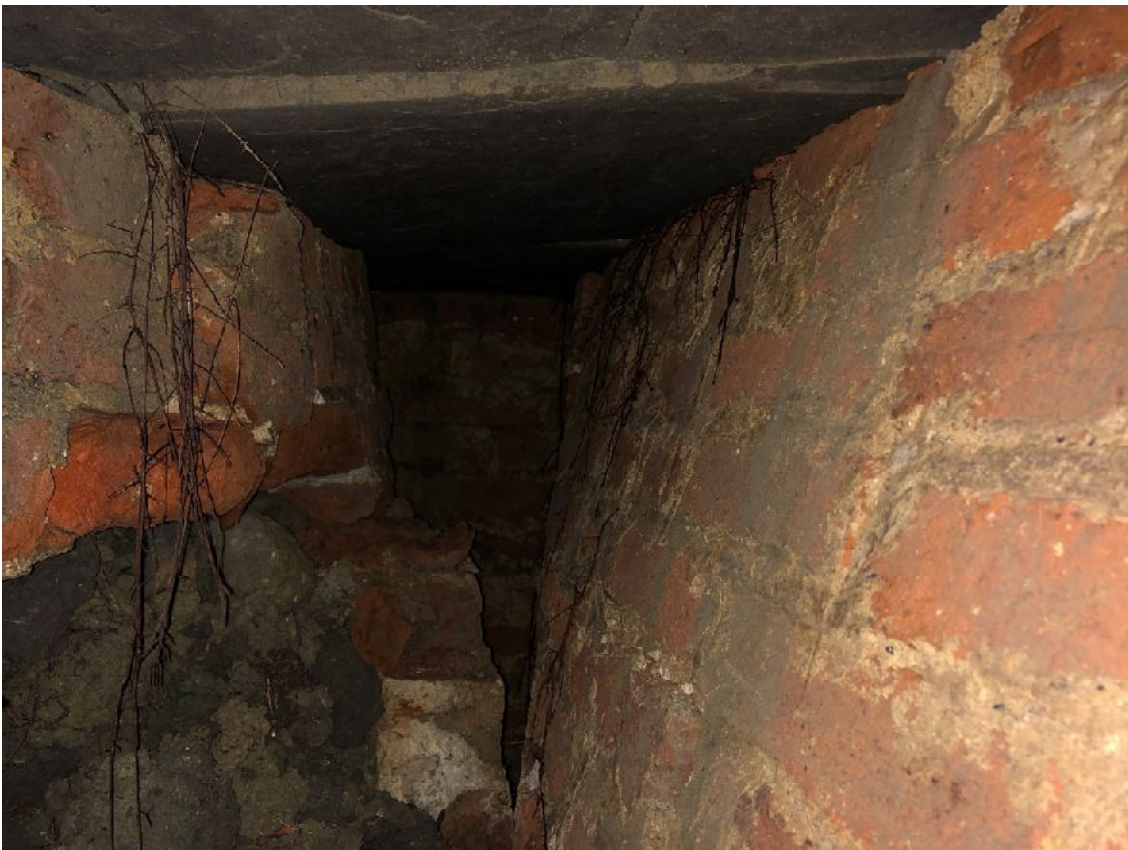
Plate 4. Trench 2. F1: sloping brick walls of possible vaults (facing E)

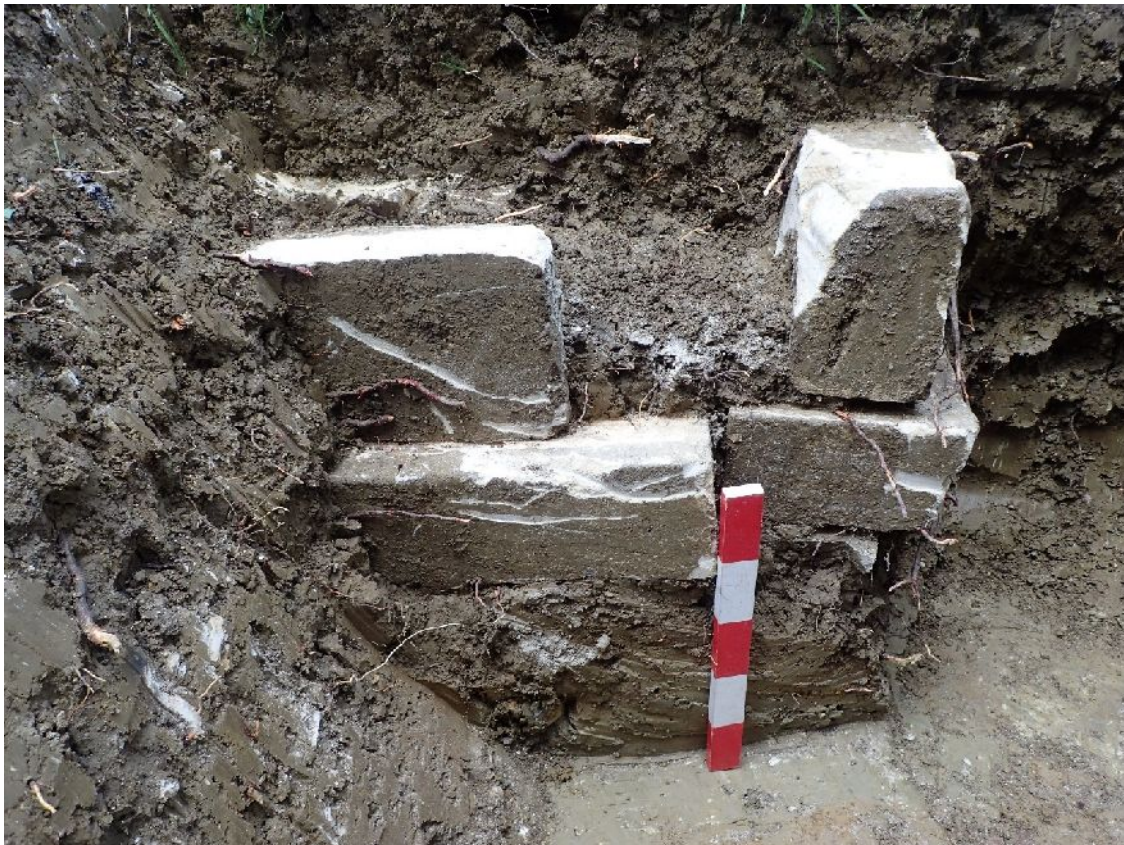
- 7.1 The only definitive evidence for burials was in Tr3 where the eastern end of a tomb was encountered at 0.45m below the ground surface; an earth-cut grave was also noted on the bottom of the trench at a depth of 1.20m. There was too little of the tomb exposed to establish the presence of a burial within the stone surround although the presence of a skull and an outline of a former coffin in the lower grave indicated a complete burial. Ironically, the lower grave probably represents a later interment than its stone-lined neighbour, possibly Victorian, although a medieval date should not be ruled out. Despite being buried, the tomb fits the type encountered elsewhere in the churchyard and, as such, perhaps a 17th/18th century date is reasonable.

Plate 6. Trench 3. F2: tomb stone lining (0.50m scale; facing N)
